670040

School Bus Passenger Protection

Derwyn M. Severy, Harrison M. Brink, and Jack D. Baird

Institute of Transportation and Traffic Engineering,
University of California, Los Angeles

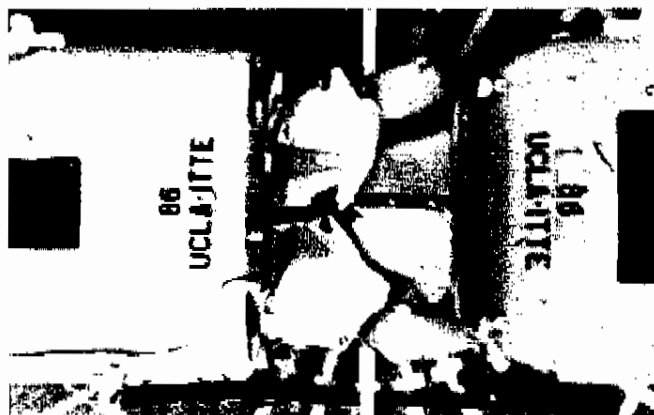
(e)). This unbalanced condition was intensified by slippage forward, relative to its frame, of the 1965 Superior bus body. Within the first 1/10 sec after contact, the front engine compartment of the new bus had been entirely crushed in. Further discussion concerning the structural performance of the buses will be reserved for a later section of Findings.

Fig. 10(d) - Continuing encroachment of old Mack-Superior bus (right) into engine cowl structure of 1965 GMC-Superior (left)

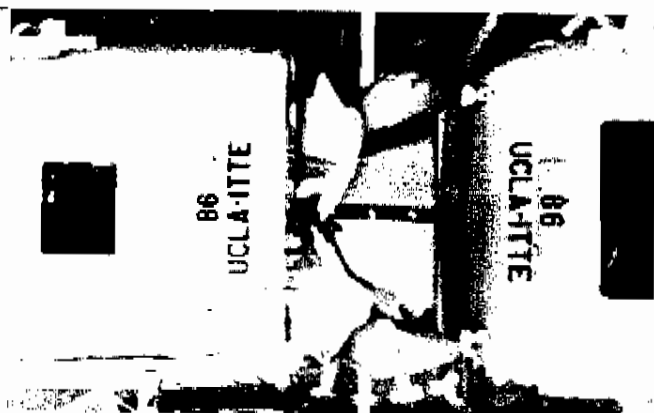
Fig. 10(e) - Maximum collapse of two bus structures

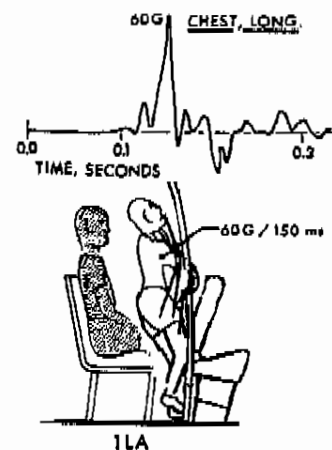
Fig. 16(a) - Thirteen-year-old thrown against horizontal handbar and against driver's seatback

minor inferred injuries despite his closeness to the front of the bus. The medical data relating to his inferred survival were inconclusive and his injuries were listed as severe. Following the crash, he was still belted and leaning forward because his seat had tilted forward owing to floor buckling. His right leg indicated an inferred fracture caused by the intruding structure.

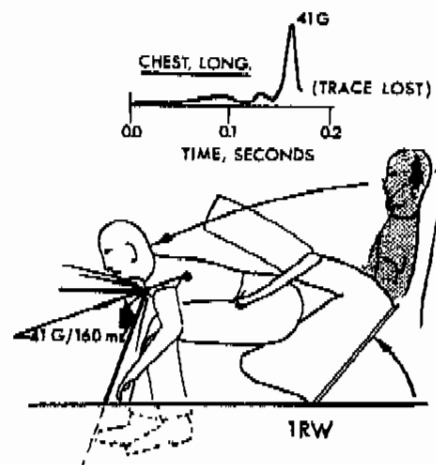
Fig. 28(a) - Adult, lap-belted to Martin air seat; both lap belt and seat ripped free of anchorages, adult struck intruding front-end structure

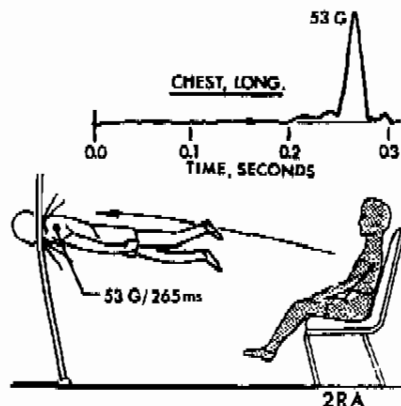
Fig. 29 (a) - Six-year-old, unrestrained, hurled against collapsing structure

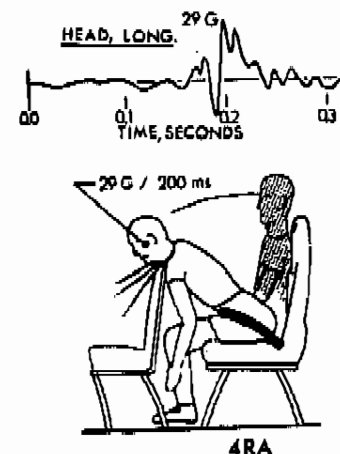
The use of a lap belt with low back seats exposed passengers to extreme hazards of the seatback acting as a fulcrum across the neck when they were jackknifed down across the horizontal surface of the seatback ahead of them (Fig. 31 (d)). Accordingly, where low seatbacks are installed, little benefit, if any, will be derived from use of seat belts

Fig. 31(a) - Even though restrained by a lap belt, chest of 13-year-old forcibly struck seat ahead and thereafter his head flailed the neck against seatback with a critical blow

for the typical front-end impact. Therefore, it is strongly recommended that seat belts not be installed in school buses unless higher seatbacks are also provided, with appropriate padding on all surfaces, and with seatback frame members that provide broad deformable surfaces and with adequate anchorages to prevent failure when passengers are thrown against them, even though restrained at the hips.

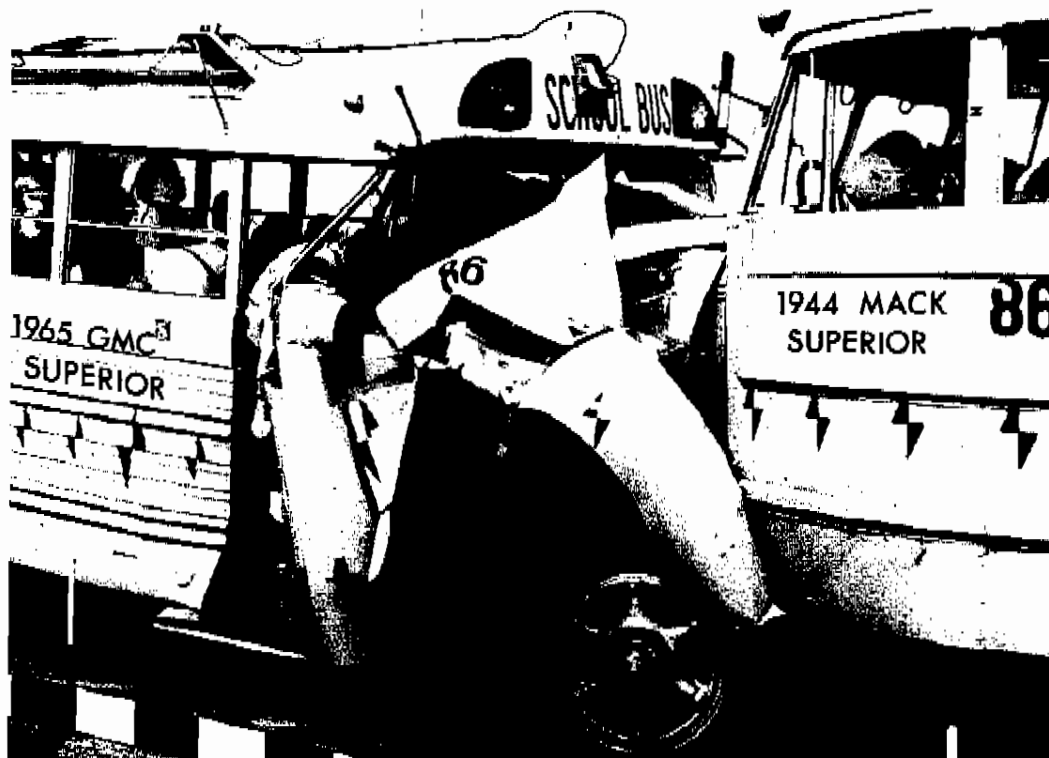
Fig. 37(a) - Two school buses of comparable size and weight, each traveling 30 mph, striking squarely head-on but demonstrate grossly different collision performances

sengers in either vehicle since this would reduce the collapse of the passenger compartment. Such a design admittedly may increase the impact peak acceleration for the passenger compartment, but, with appropriate passenger protective devices, this approach provides a substantially greater measure of safety than the current conditions of allowing the passenger compartment to be directly collapsed.

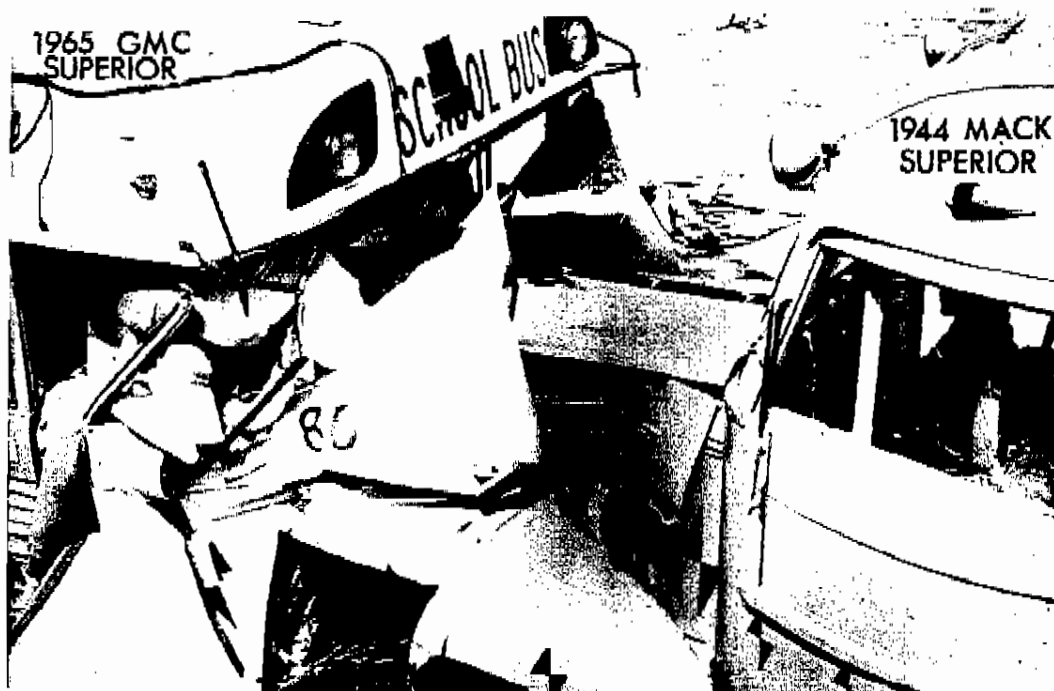
Fig. 37(b) - Following collision, driver's compartment for bus on right shows little change; by contrast, gross intrusion to driver's compartment for vehicle on left forced driver completely rearward of his normal position

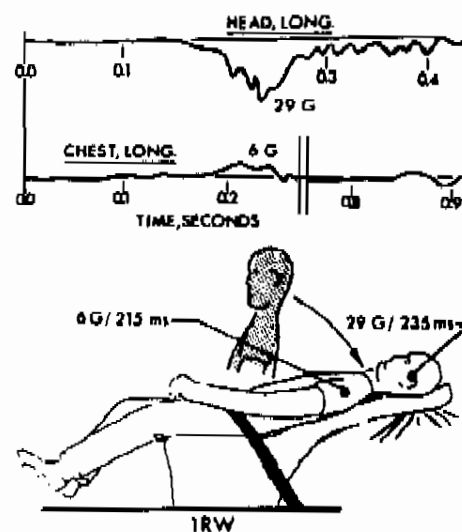
Fig. 46(b) - The lap-belted passenger in an air seat is protected against whiplash; lack of proper seatback support allows seatback to lay back against knees of passenger to his rear

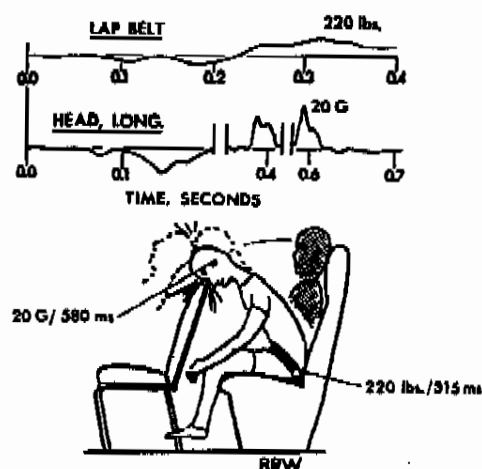
Fig. 53(c) - Rebound from backrest caused head injury with low back seat in front of this 13-year-old

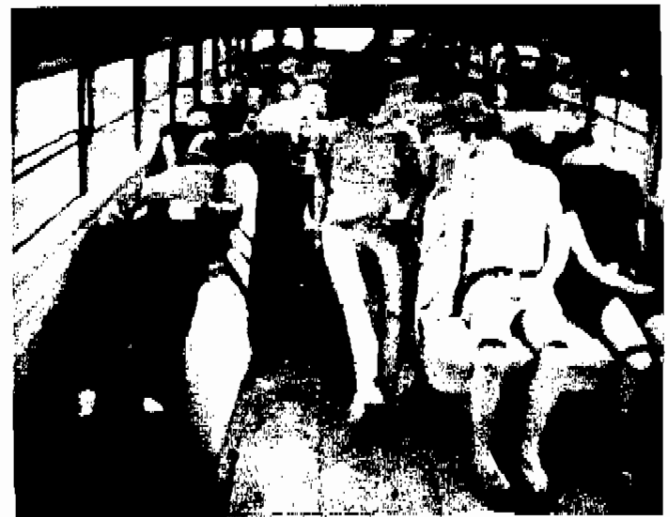
Fig. 55(d) - Except where heads were supported, passengers were whiplashed; standee in aisle was hurled rearward to floor

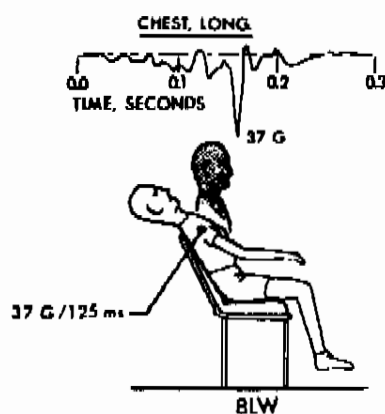
r. Seat 9L, a conventional Superior seat, was occupied by a 13-year-old in position 9LA, and by an adult (No. 1, Table 5), in position 9LW, both unrestrained. During impact, the 9LW adult's head whiplashed against the rear window directly behind him but did not fracture the tempered glass window. The 9LW adult was then thrown vertically, still maintaining his seated posture, impacting the top of the window frame with his head, receiving only minor injuries. Thereafter he came to rest in a normal seated position.

Fig. 61(b) - Unrestrained 13-year-old, whiplashed, sustains an exceptionally high chest acceleration from impact by the adult passenger in the seat directly behind him

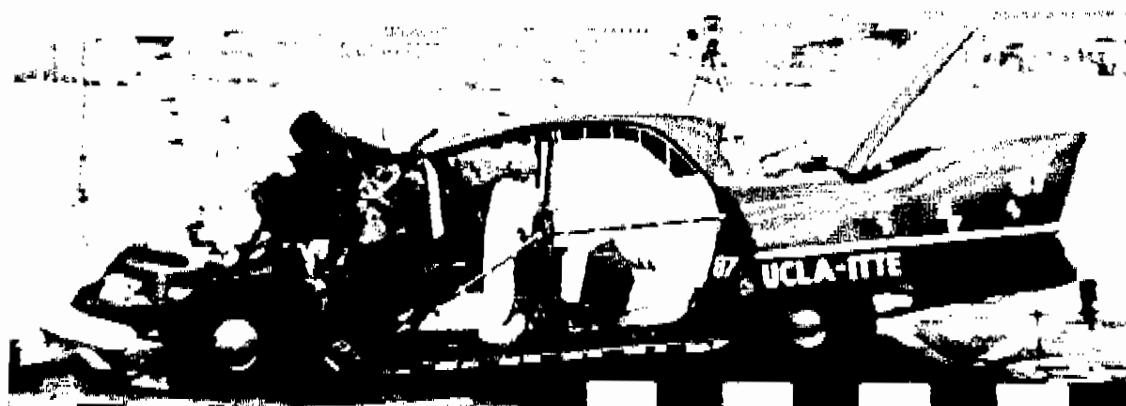
window was shattered and the right rear door glass remained intact (Fig. 64 (d)). All external lights were on and the headlights exhibited the characteristic indications of the heated filament distortion and failure. The rearward section of the engine pan was forced against the pavement 5 ft after the start of impact. Other gouges were located further from the position of contact. The rear seat anchorages were strengthened and the seatback did not break loose during impact. The right front armrest was torn off. The right front wing vent was not distorted and the glass remained intact. The rear of the engine tilted downward approximately 30 deg by the underriding action of the front end. Parts and debris dislodged from the Plymouth during collision were distributed to 70 ft ahead of the point of impact.

The school bus rear bumper was damaged most at its center with a 22 in. permanent indentation caused by the underriding Plymouth engine. A pattern from the right dual headlights of the Plymouth was embossed on the rear of the bus body sheet metal, 20 in. to the left of the right side. The bus frame was displaced 8 in. forward, relative to the chassis. The rear door of the bus was dented; dents and paint transfers were observed 10 in. above the base of the door, or 43 in. above the pavement. The bus was accelerated by this rear-end collision reaching a peak of 10 G at 45 ms.

Fig. 64(d) - Striking car's position of rest, showing collision damage sustained

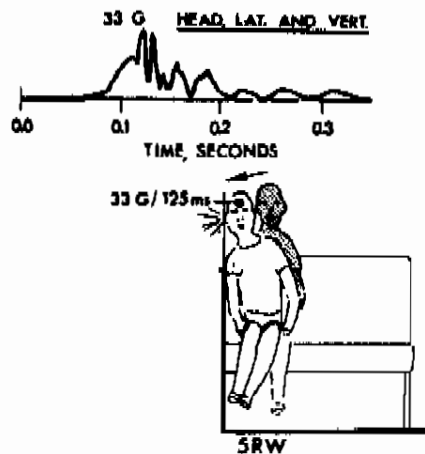
Fig. 75 (a) - Thirteen-year-old strikes his head against already fractured laminated side window

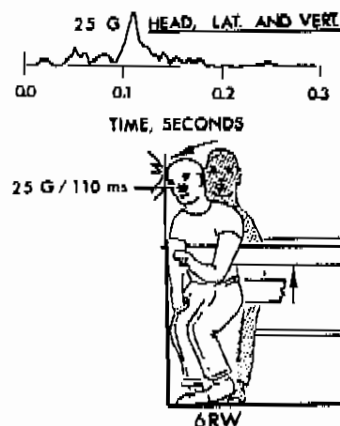
Fig. 78(a) - Adult No. 1 fractures laminated glass side window by shoulder and head impact

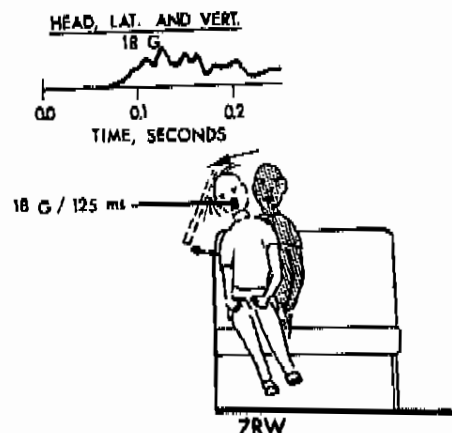
Fig. 80(b) - Thirteen-year-old received a peak head acceleration on striking window causing exit latch to fail

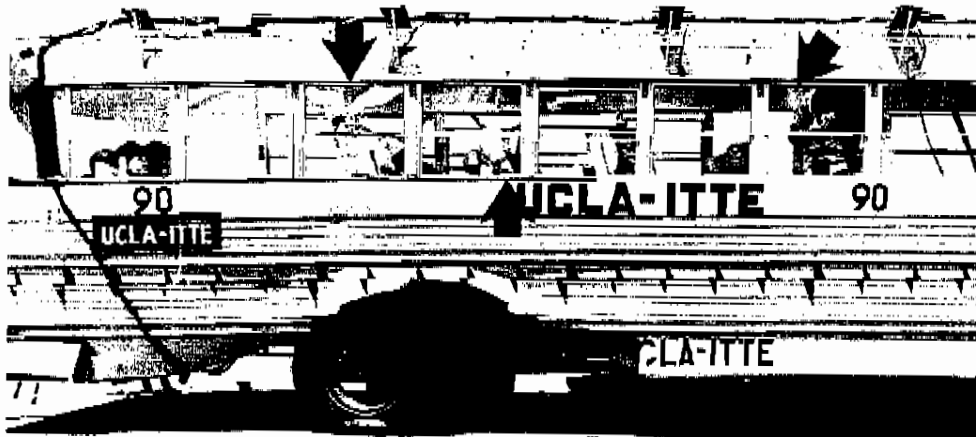
Fig. 87 - Collision damage to side of bus, with arrows depicting glass breakage

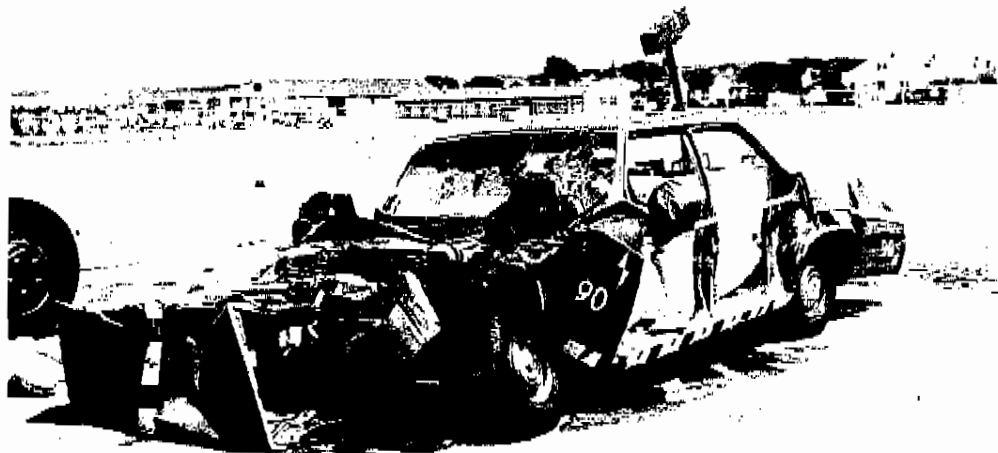
Fig. 88(b) - 1966 Chevrolet collision damage
