# **Sapa 40/30 RIG Test at 40 mph**

**2012 Chevrolet Malibu / 1995 Vanco Trailer**

Malcolm Deighton  
Sr. Application Engineer, NATC

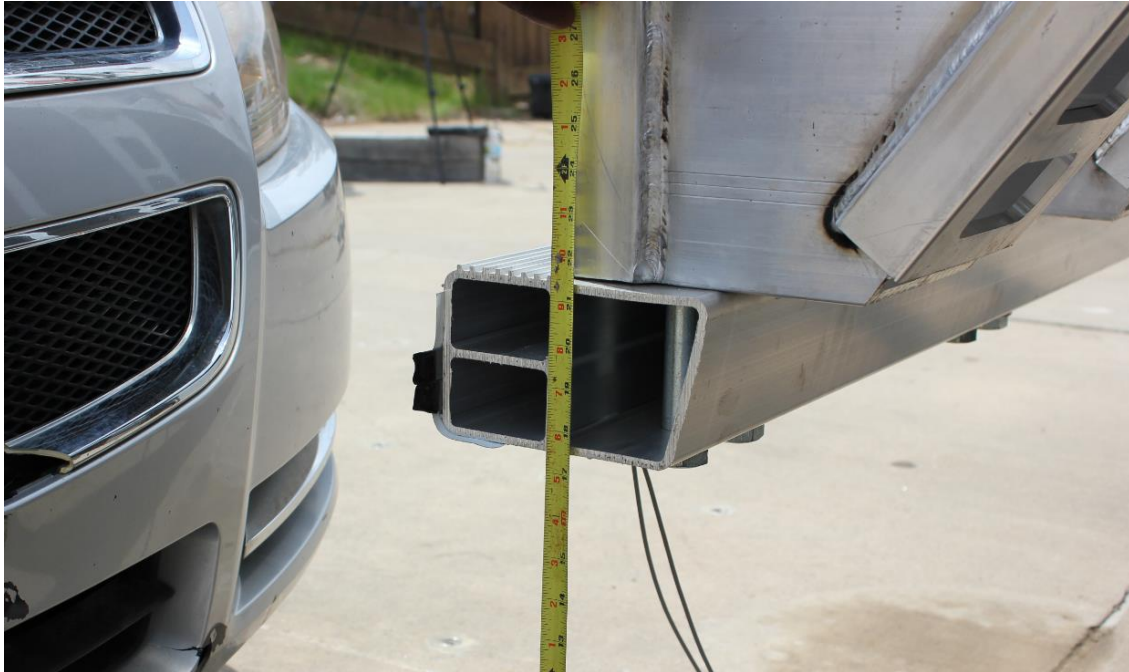
This testing reduced the Malibu / RIG overlap to approximately 44.67 cm (17.59 in) compared to the IIHS 30% protocol of 535.5 cm (21.09 in). This overlap resulted in a more rigorous evaluation.

*Figure 3*  
*Test Configuration – Bumper Height*

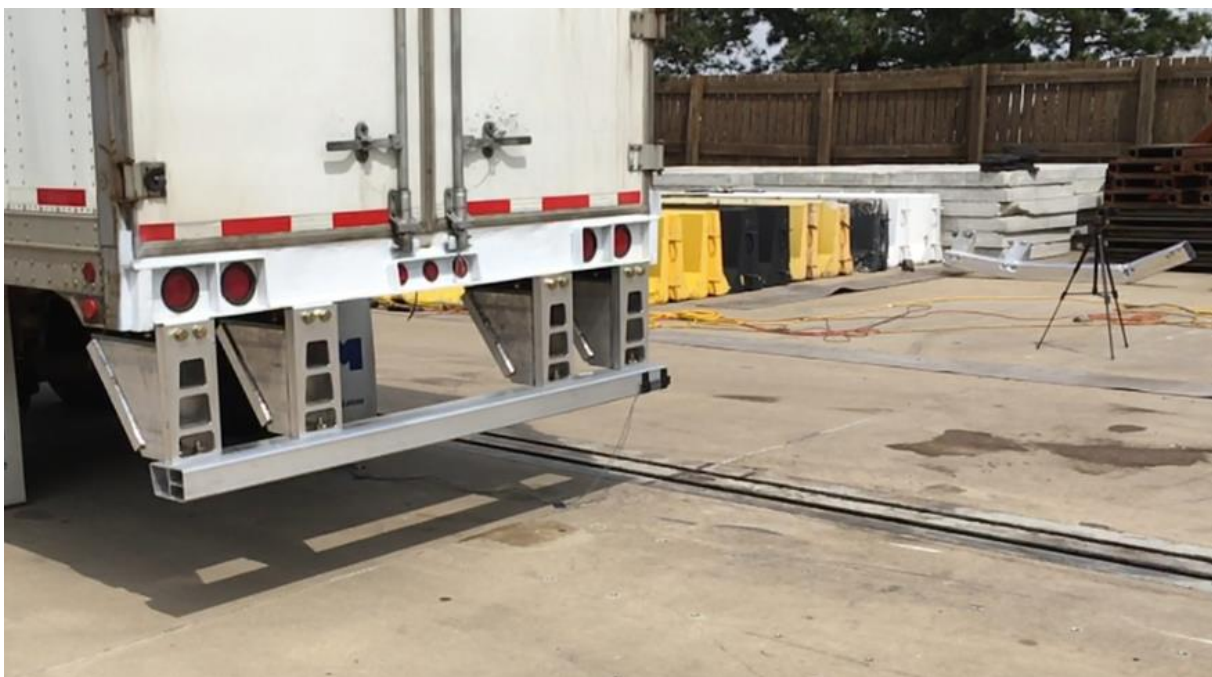
Pre-crash static measurements indicated that the Sapa 40/30 RIG horizontal member had a ground clearance of 44.5 cm (17.5 in) and a height of 10.48 cm (4.13 in) prior to the test. The RIG's four vertical support members were attached to the trailer frame with four bolts each. The horizontal member was fastened with two bolts to each vertical support.

*Figure 4*  
*2017 Sapa 40/30 RIG – Pre-Crash*

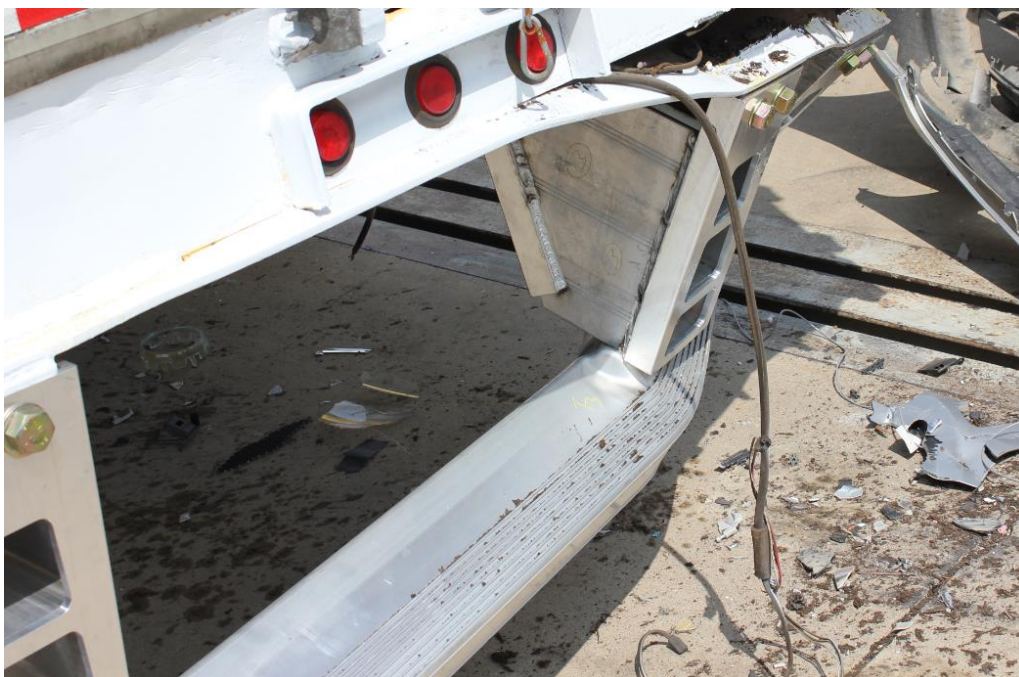
As the Malibu struck the 40/30 RIG, the right two vertical supports deflected forward and downward, partially tearing the rear sill of the trailer from the door frame and bending it downward. The RIG horizontal beam pivoted downward against the support fasteners and bent forward around the right side vertical supports, but it did not fracture. The RIG remained intact; all the fasteners remained attached to the trailer and the RIG horizontal member.

*Figure 5*  
*2017 Sapa 40/30 RIG – Post-Crash Right Vertical Support*

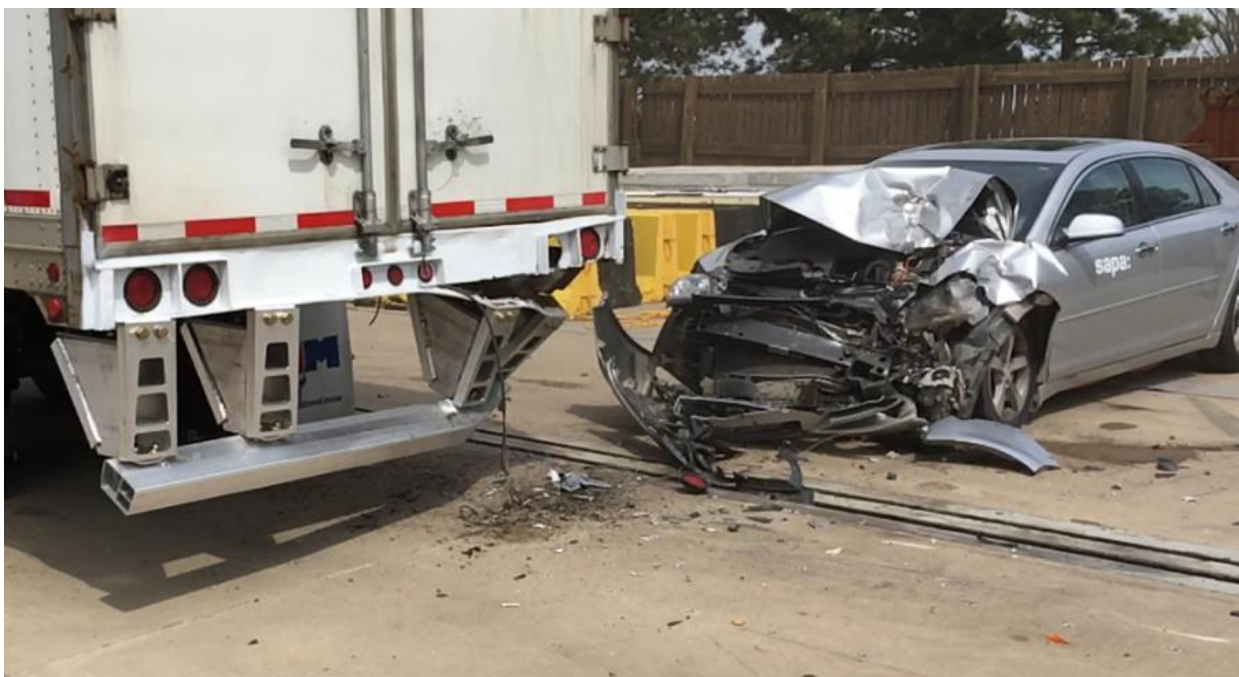
The RIG exerted substantial offset loadings into the Malibu's bumper and frame structure, causing the Malibu to rotate approximately 90 degrees counterclockwise, to sideslip, to rebound away from the trailer body, and to come to rest adjacent to the right rear corner of the trailer. The Malibu's windshield and A-pillar did not contact the trailer body. The strength and stiffness of the RIG was sufficient to prevent PCI.

*Figure 6*  
*2017 Sapa 40/30 RIG and Malibu – Post-Crash*

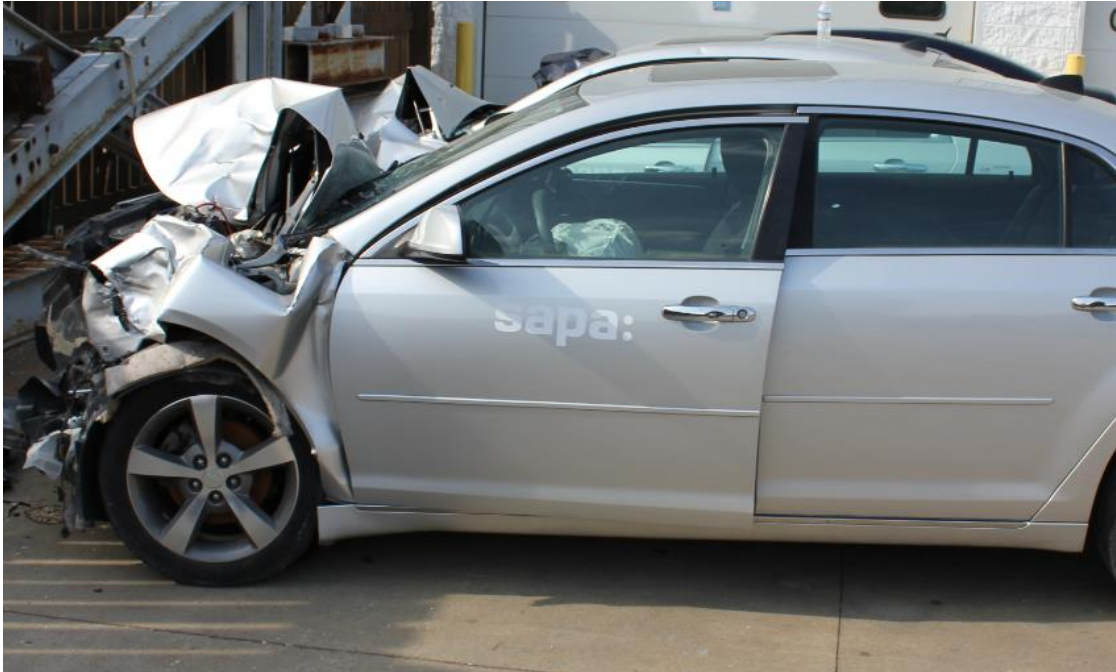
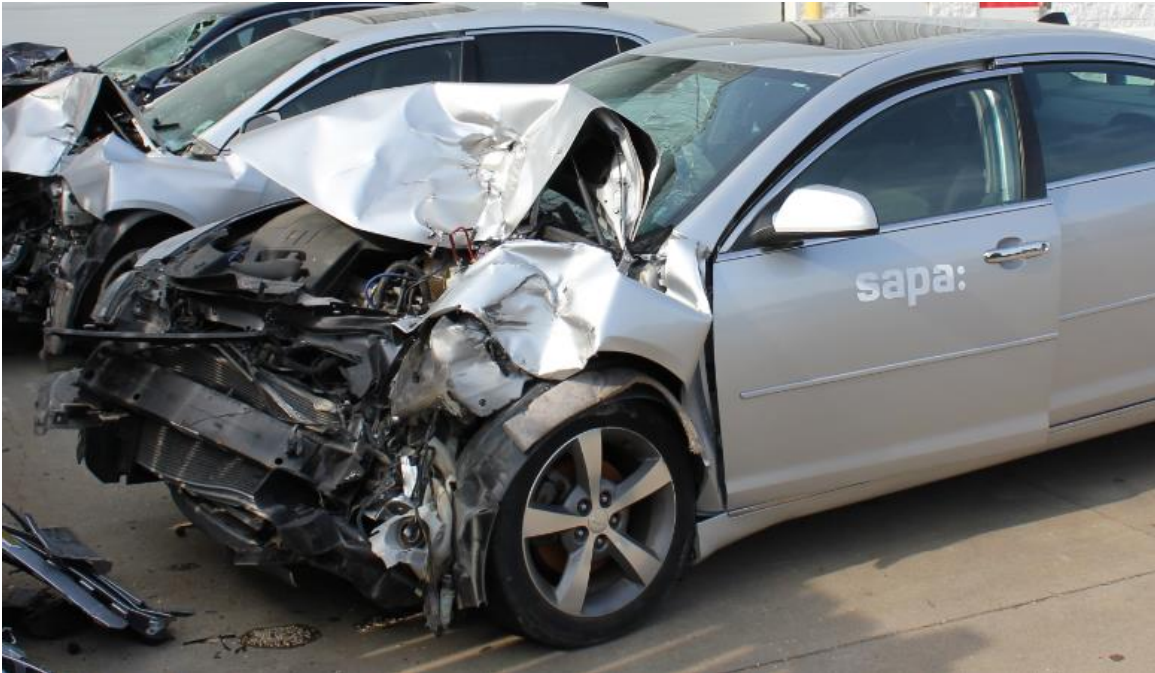
The Malibu's windshield was cracked due to contact from the hood. The driver's A-pillar did not have visible direct or induced damage. The driver's door was easily opened but had minor contact with induced collision damage on the left front quarter panel. There was no passenger compartment intrusion (PCI).

Crash energy was absorbed by deflection of the RIG horizontal and vertical supports, by deflection and material failure of the trailer body, and by deformation of the bumper, unibody, and subframe of the Malibu. Deformation of the Malibu's A-pillar and roof header was negligible and the occupant survival space was preserved.

*Figure 7*  
*2012 Malibu – Post Crash*

*Figure 8*  
*2012 Malibu – Post Crash*

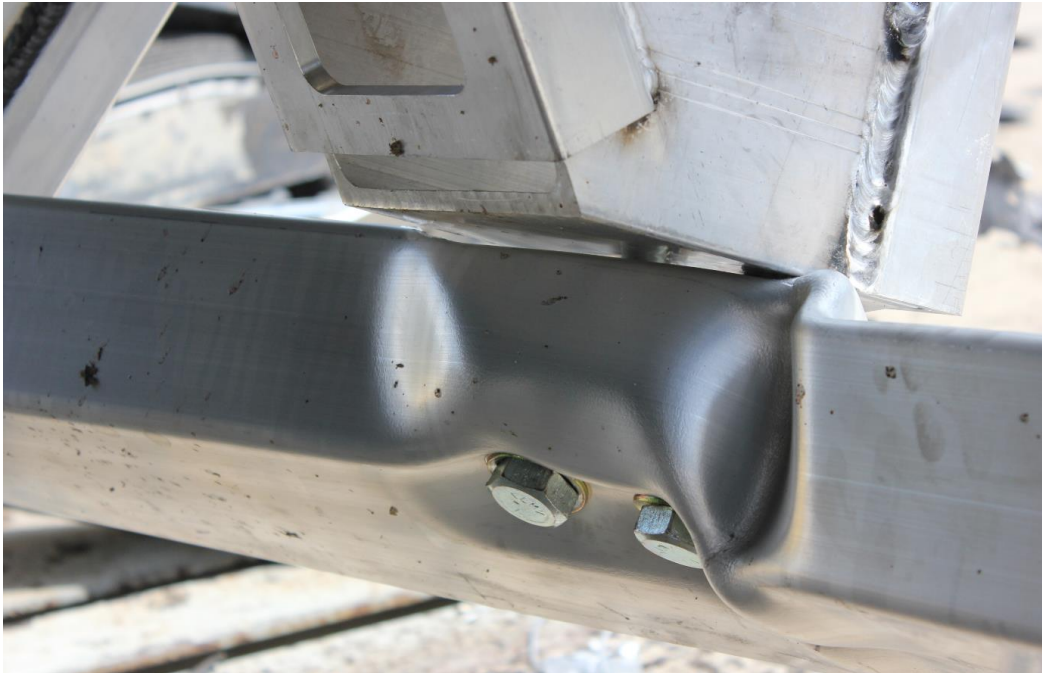
*Figure 8*  
*2017 Sapa RIG 40/30 – Post-Crash CA24 Bumper Deformation*

The novel application of this alloy to a semitrailer RIG via custom extrusion profiles enables superior strength/weight ratios, enhanced energy absorption, and more efficient crash performance compared to traditional RIG designs and materials. In this collision, the CA24 deformed substantially with no evidence of brittle fracture.

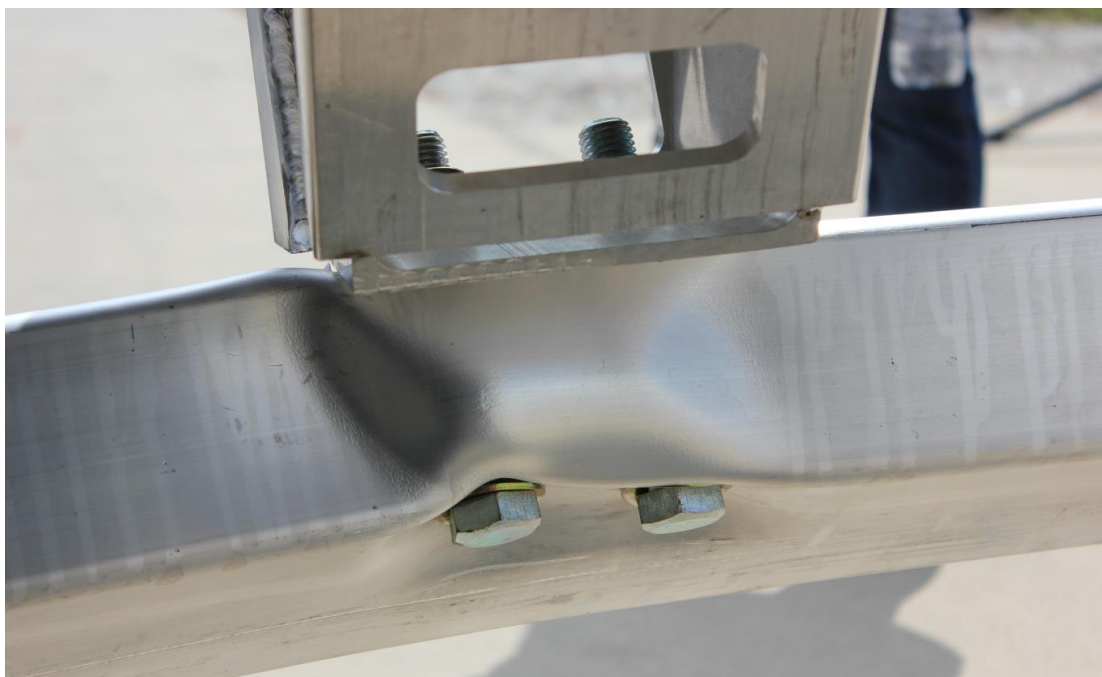
The 40/30 RIG deformed significantly further during the crash pulse than did the 35/30 RIG (49.53 cm compared to 2.54 cm). This deformation, which was largely due to the material failure of the trailer door sill, reduced the peak loading and the deceleration rate of the 2012 Malibu during the collision. Optimization of the RIG profiles with CA24 alloy will enable controlled deflection and energy absorption while avoiding uncontrolled material failure.

*Figure 9*  
*2017 Sapa 40/30 RIG – Post-Crash CA24 Bumper Deformation*

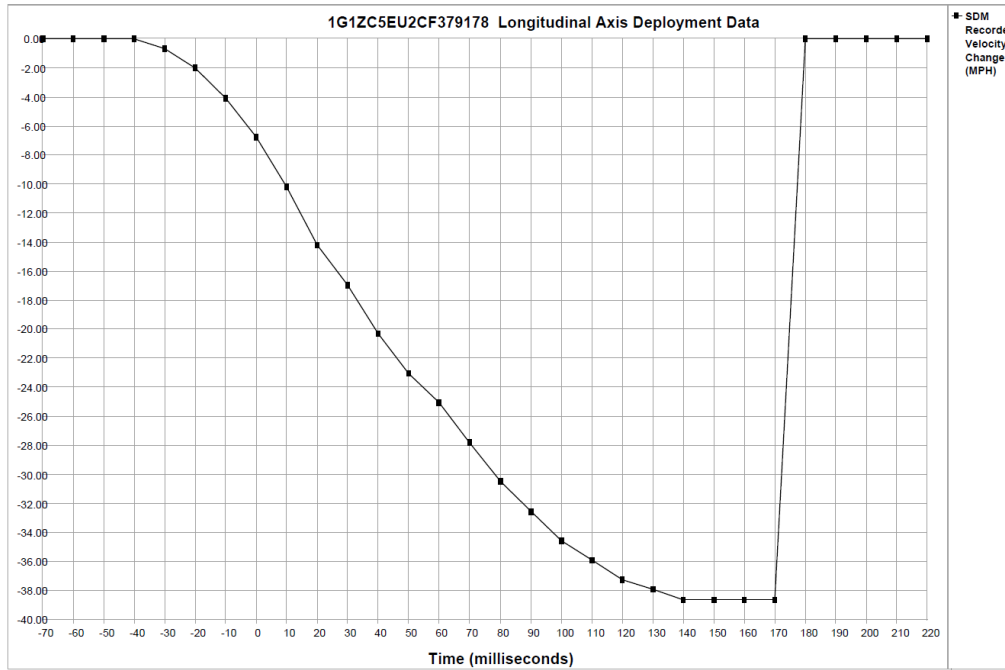
Figure 14  
2012 Malibu - CDR Longitudinal Axis Deployment Data Graph

Time (milliseconds)	-70	-60	-50	-40	-30	-20	-10	0	10	20	30	40	50	60	70
SDM Longitudinal Axis Recorded Velocity Change (MPH)	0.00	0.00	0.00	0.00	-0.68	-2.03	-4.07	-6.78	-10.17	-14.23	-16.94	-20.33	-23.04	-25.07	-27.79
Time (milliseconds)	80	90	100	110	120	130	140	150	160	170	180	190	200	210	220
SDM Longitudinal Axis Recorded Velocity Change (MPH)	-30.50	-32.53	-34.56	-35.92	-37.27	-37.95	-38.63	-38.63	-38.63	-38.63	0.00	0.00	0.00	0.00	0.00

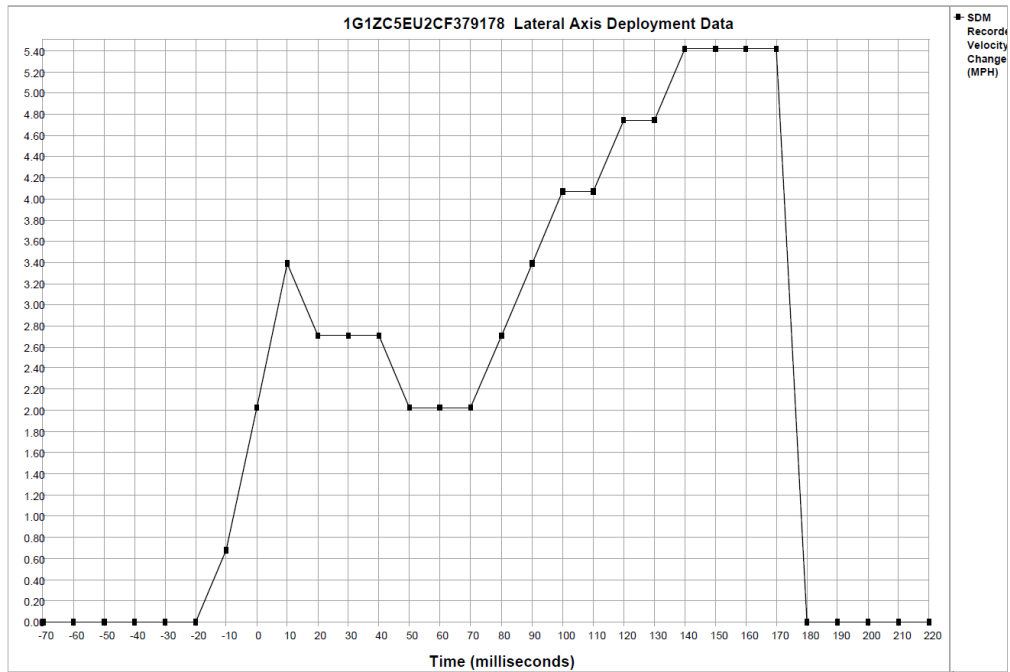
Figure 15  
2012 Malibu - CDR Lateral Axis Deployment Data Graph

Time (milliseconds)	-70	-60	-50	-40	-30	-20	-10	0	10	20	30	40	50	60	70
SDM Lateral Axis Recorded Velocity Change (MPH)	0.00	0.00	0.00	0.00	0.00	0.00	0.68	2.03	3.39	2.71	2.71	2.71	2.03	2.03	2.03
Time (milliseconds)	80	90	100	110	120	130	140	150	160	170	180	190	200	210	220
SDM Lateral Axis Recorded Velocity Change (MPH)	2.71	3.39	4.07	4.07	4.74	4.74	5.42	5.42	5.42	5.42	0.00	0.00	0.00	0.00	0.00
