Insurance Institute for Highway Safety Large Truck Underride Research

2009 Chevrolet Malibu Front-into-Trailer Side Underride Guard

64.3 km/h; Malibu perpendicular into trailer center
CF17005

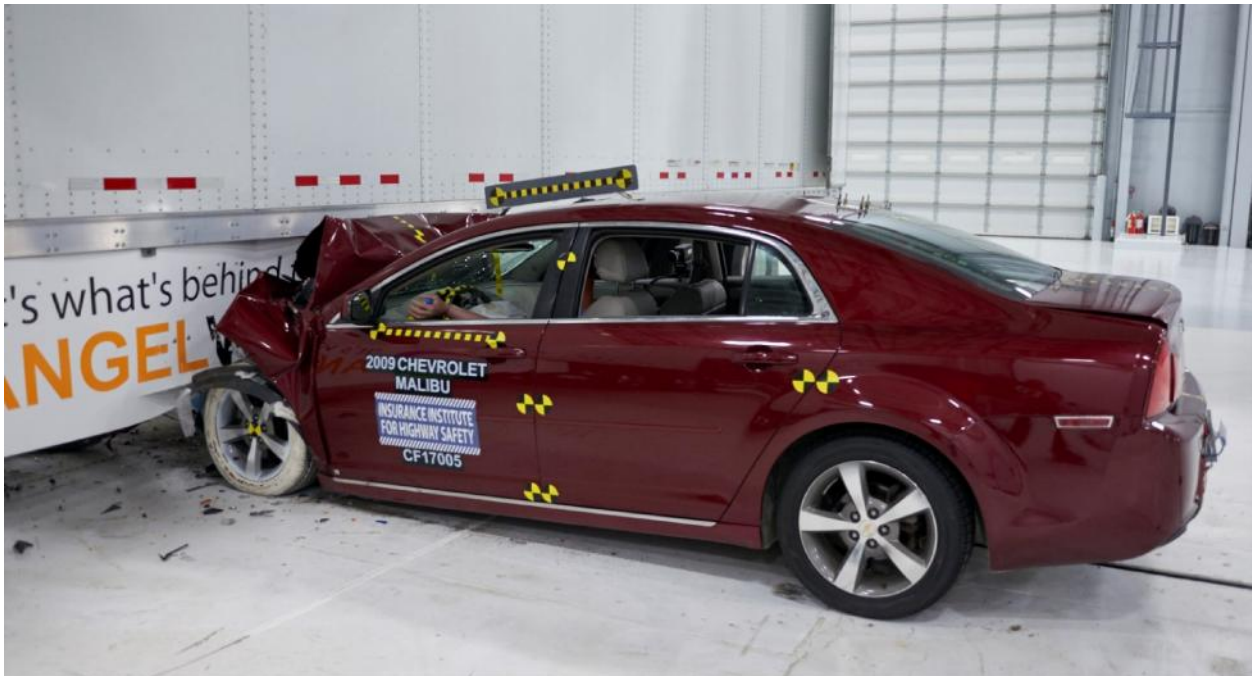
Figure 2
Postcrash – Trailer and 2009 Chevrolet Malibu

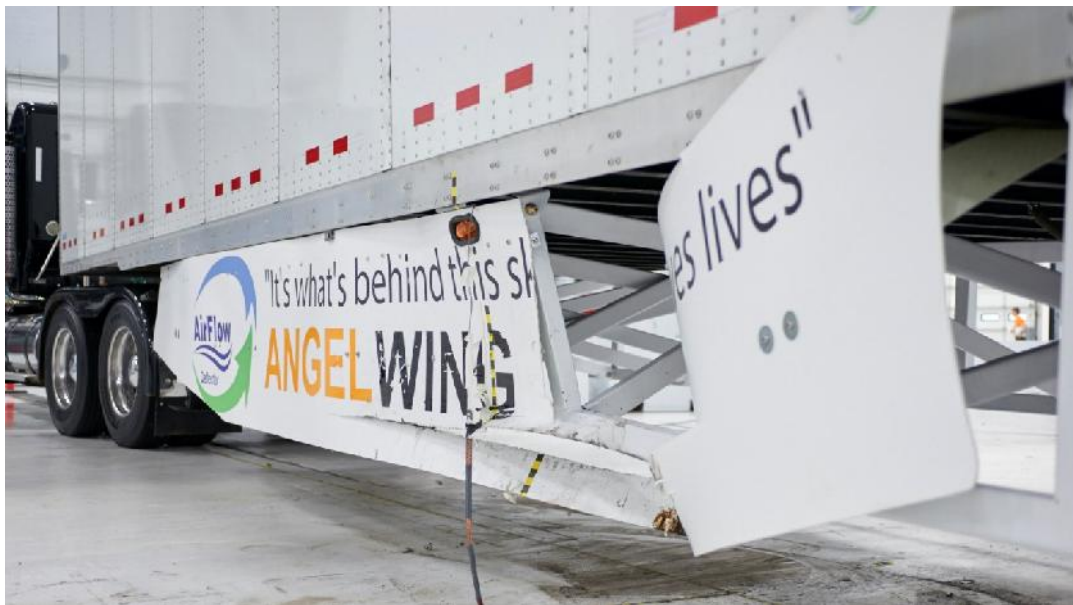
Figure 6

During the crash, the vertical members on the struck side of the underride guard bent inward, and the crossbeam supports nearest the impact point buckled. The nonstruck side sill of the Vanguard was pushed outward as it was loaded by the crossbeams of the underride guard. Two of the lower attachment flanges on the nonstruck side of the guard broke free from the lower longitudinal. The rest of the structure remained intact and the Malibu rebounded with no underride.

Postcrash – Underride guard damage, struck side of trailer chassis

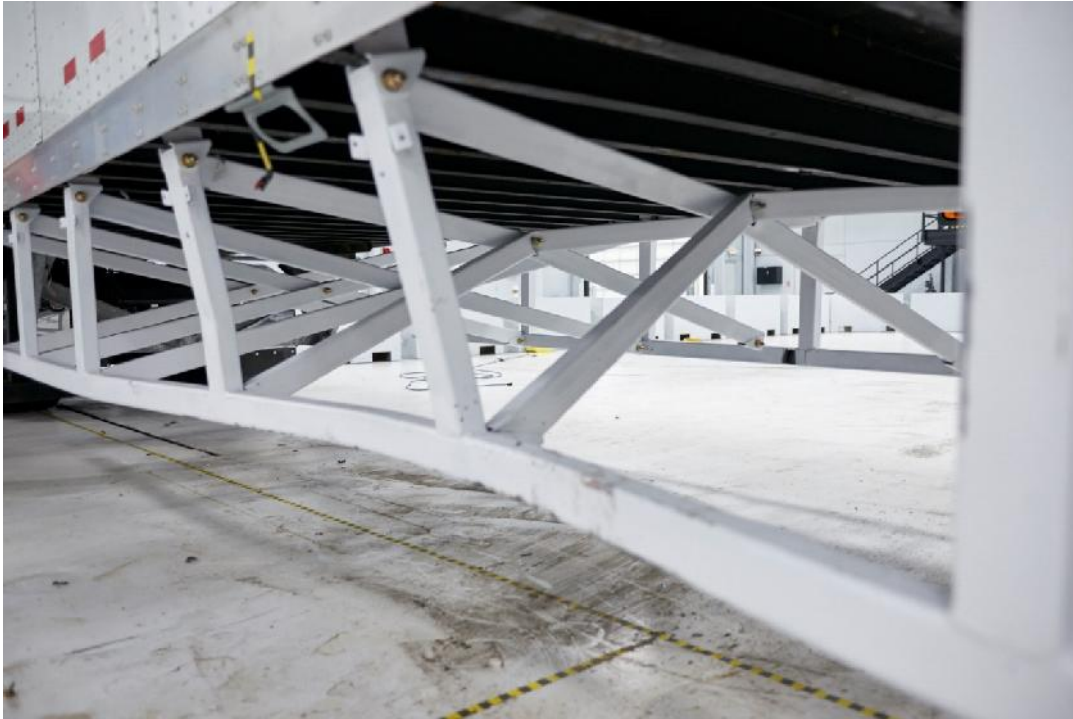
Figure 7
Postcrash – Underride guard damage, without skirt

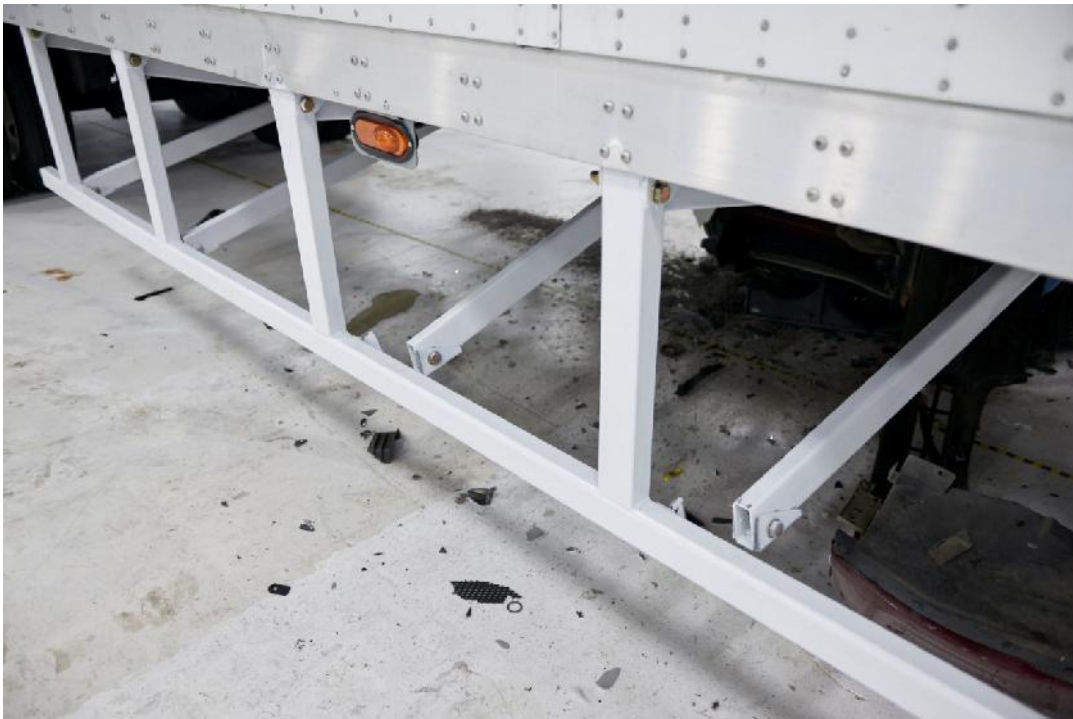
Figure 8
Postcrash – Underride guard damage, nonstruck side of trailer chassis

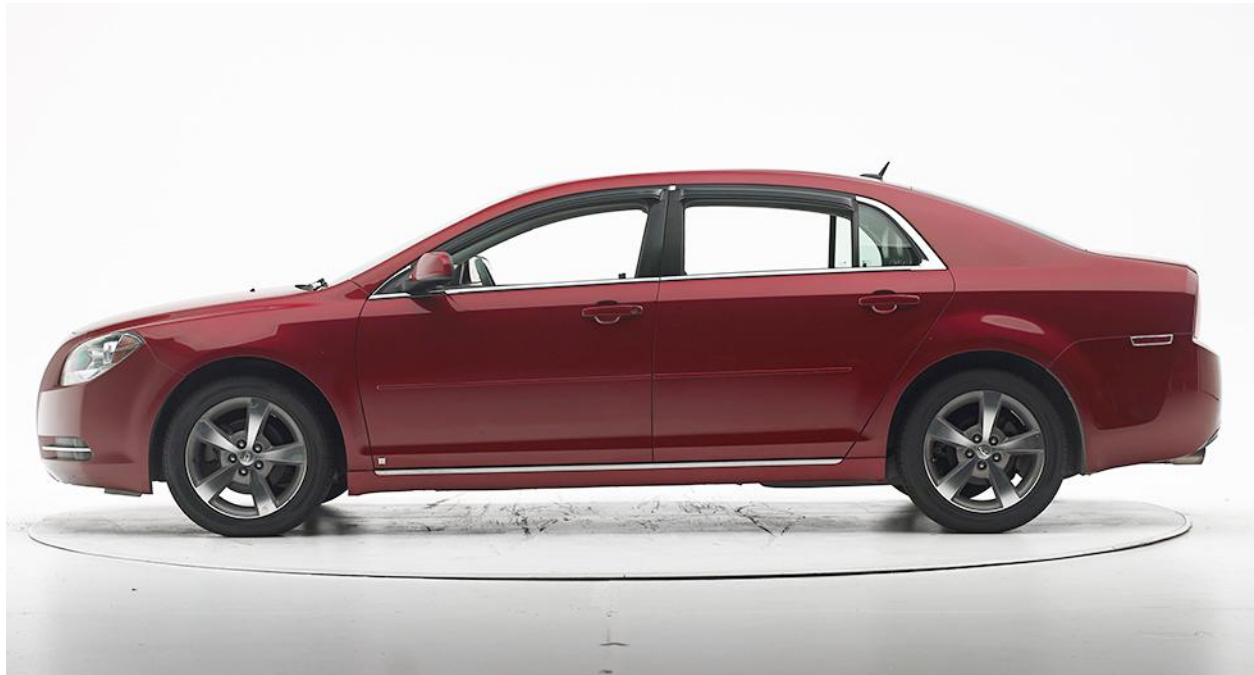
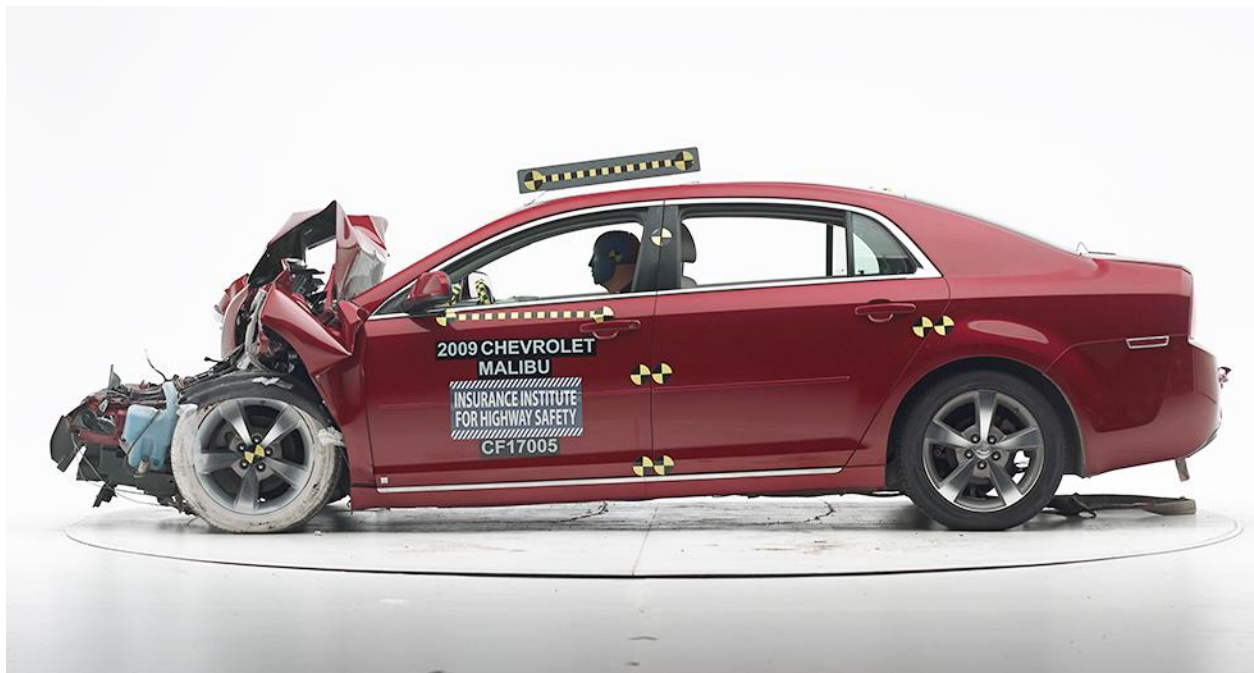
Figure 9
2009 Chevrolet Malibu – Precrash and postcrash side views

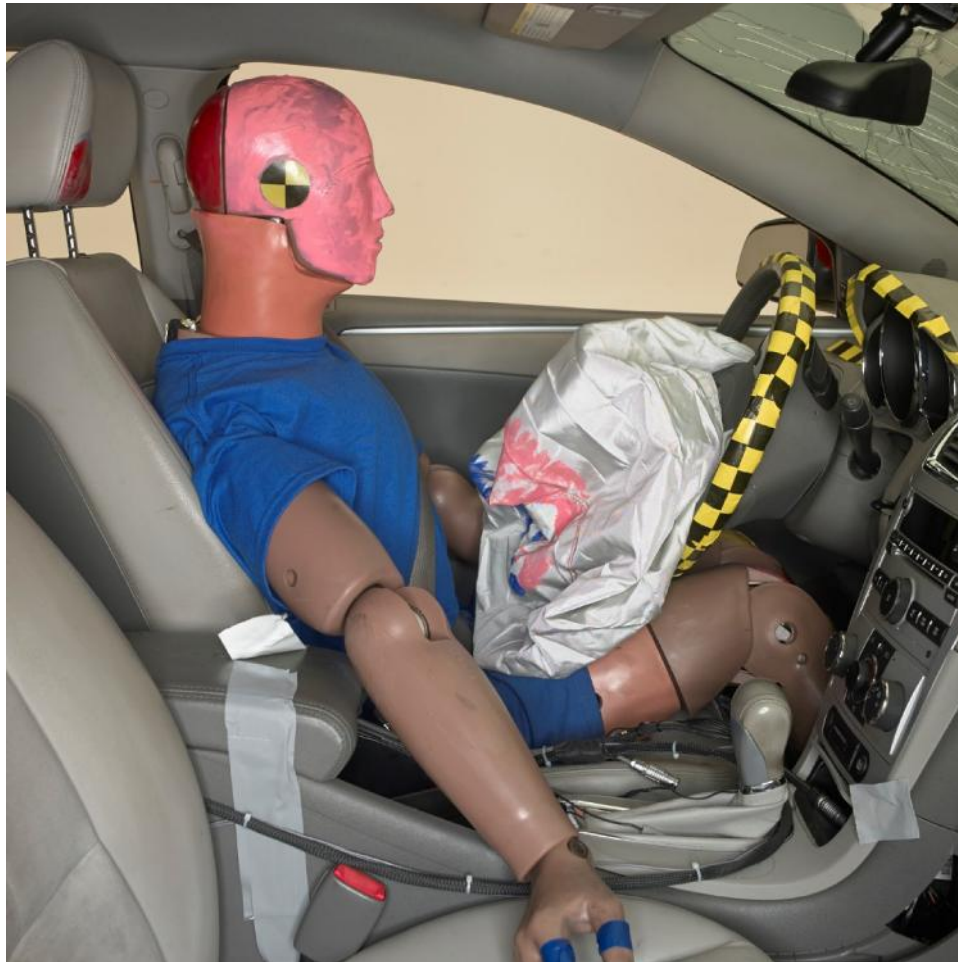
During the crash, the dummy's head loaded the fully-inflated frontal airbag. During rebound, the rear of the head contacted the driver head restraint.

Figure 10
2009 Chevrolet Malibu — Driver dummy, postcrash
