A History of Trailer Rear-Impact Guard (RIG) From Utility's Perspective

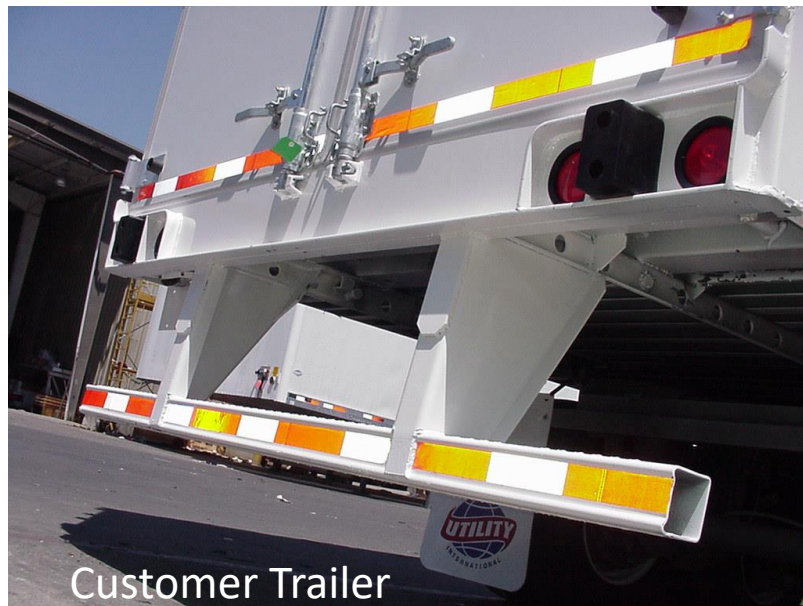
Customer Trailer

Utility's RIG, implemented on dry van models in 2000, could pass multiple, consecutive NHTSA tests without losing the RIG structural integrity.

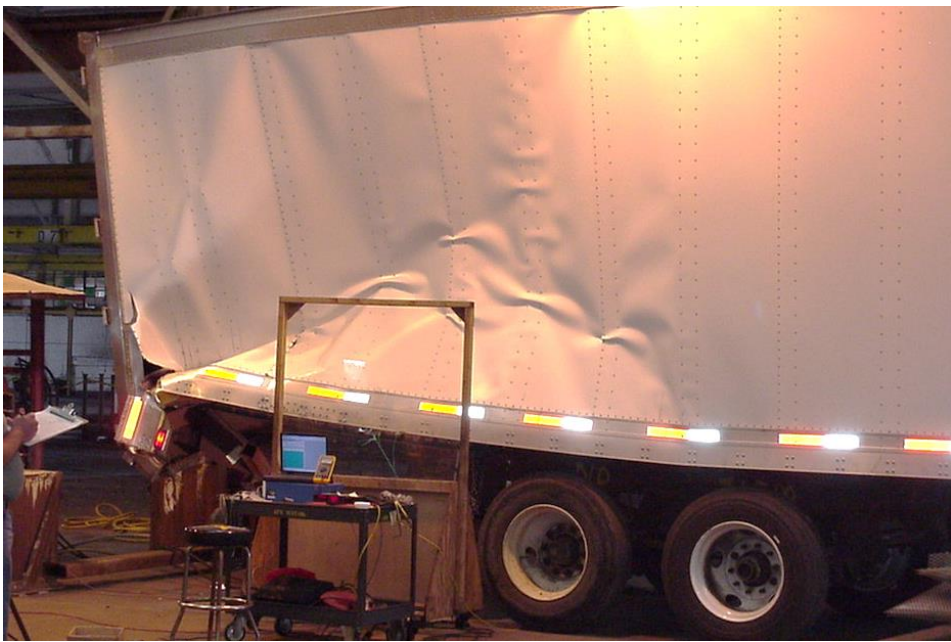
Utility dry van RIG
extreme-mode-of-failure
test conducted on a test
trailer with **Exponent**.

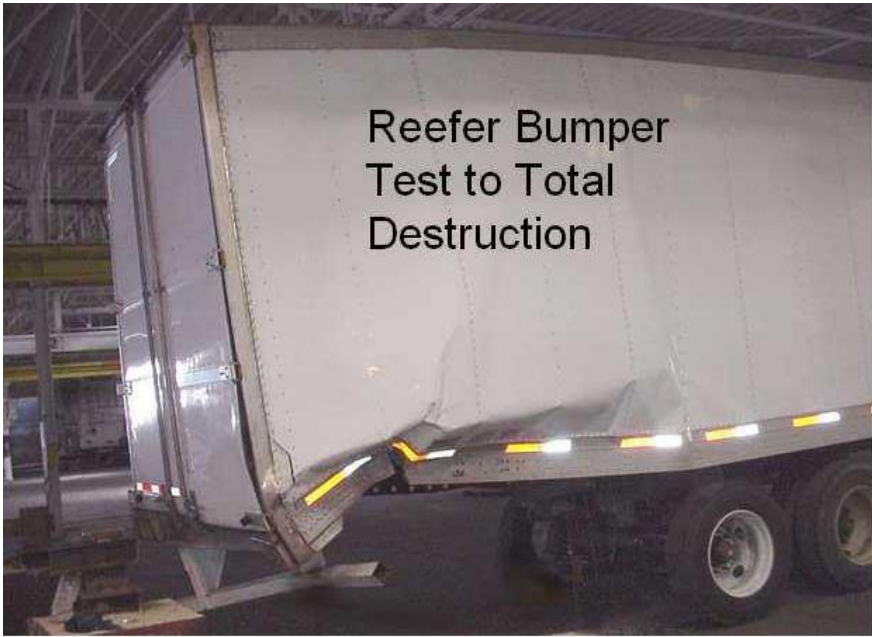
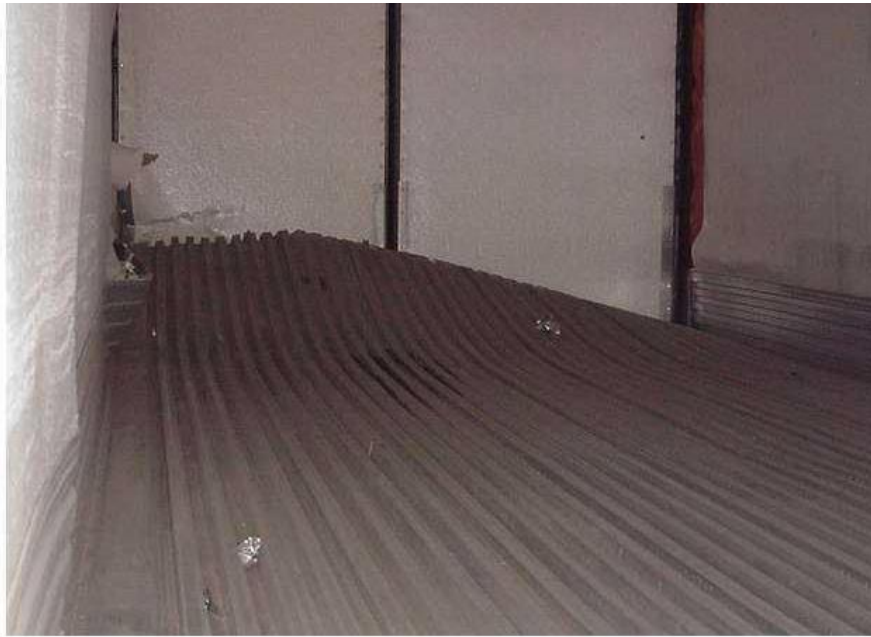
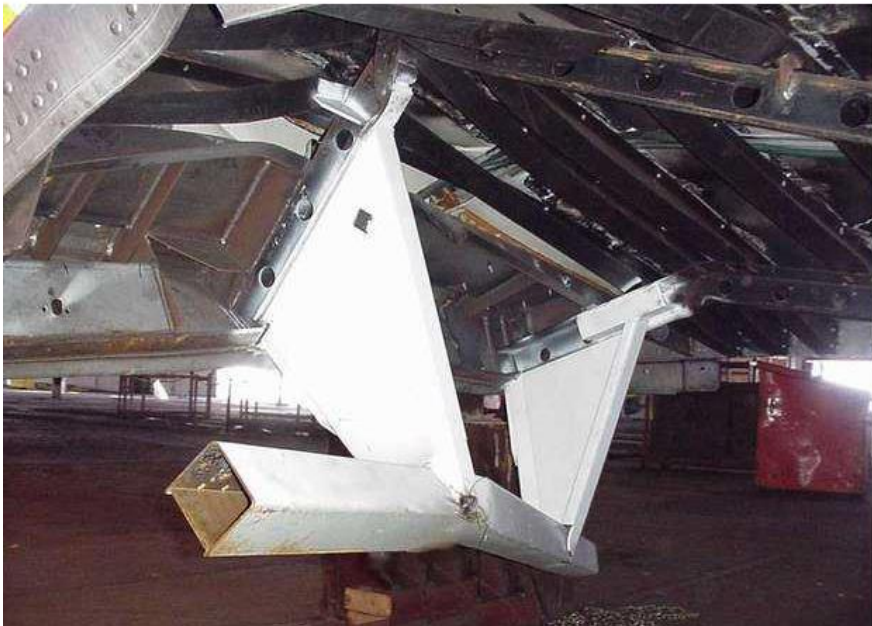
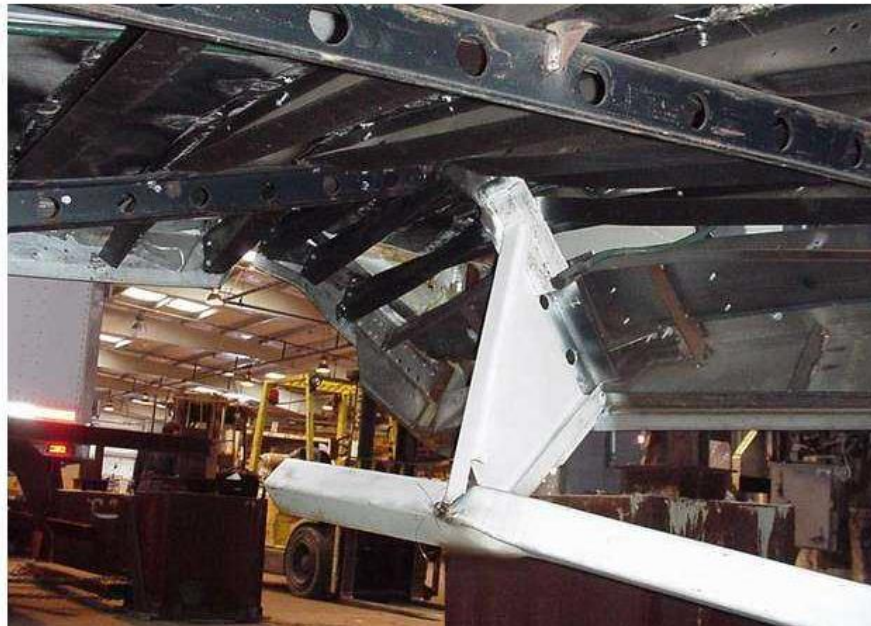
Reefer Bumper
Test to Total
Destruction

**Utility
refrigerated van
RIG extreme-
mode-of-failure
test conducted on
a test trailer with
Exponent.**

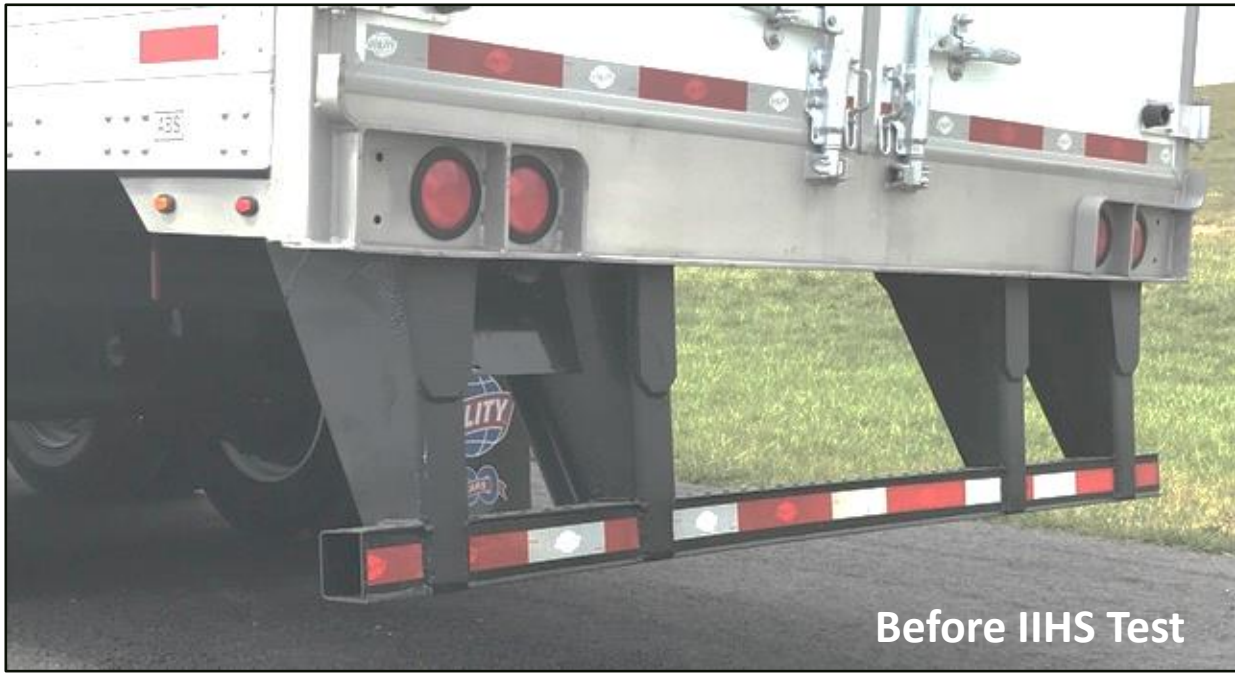
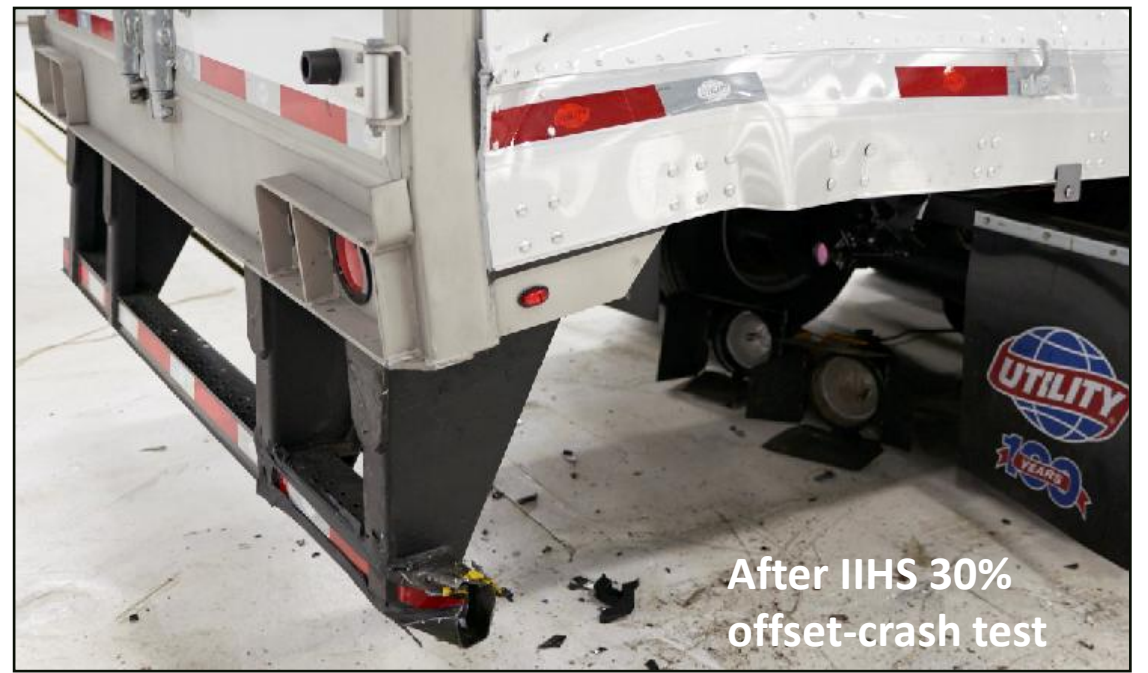
The Utility dry van trailer with optional 3rd and 4th verticals added to the existing standard Utility RIG.

This trailer passed the IIHS 30% offset crash test in 2017.

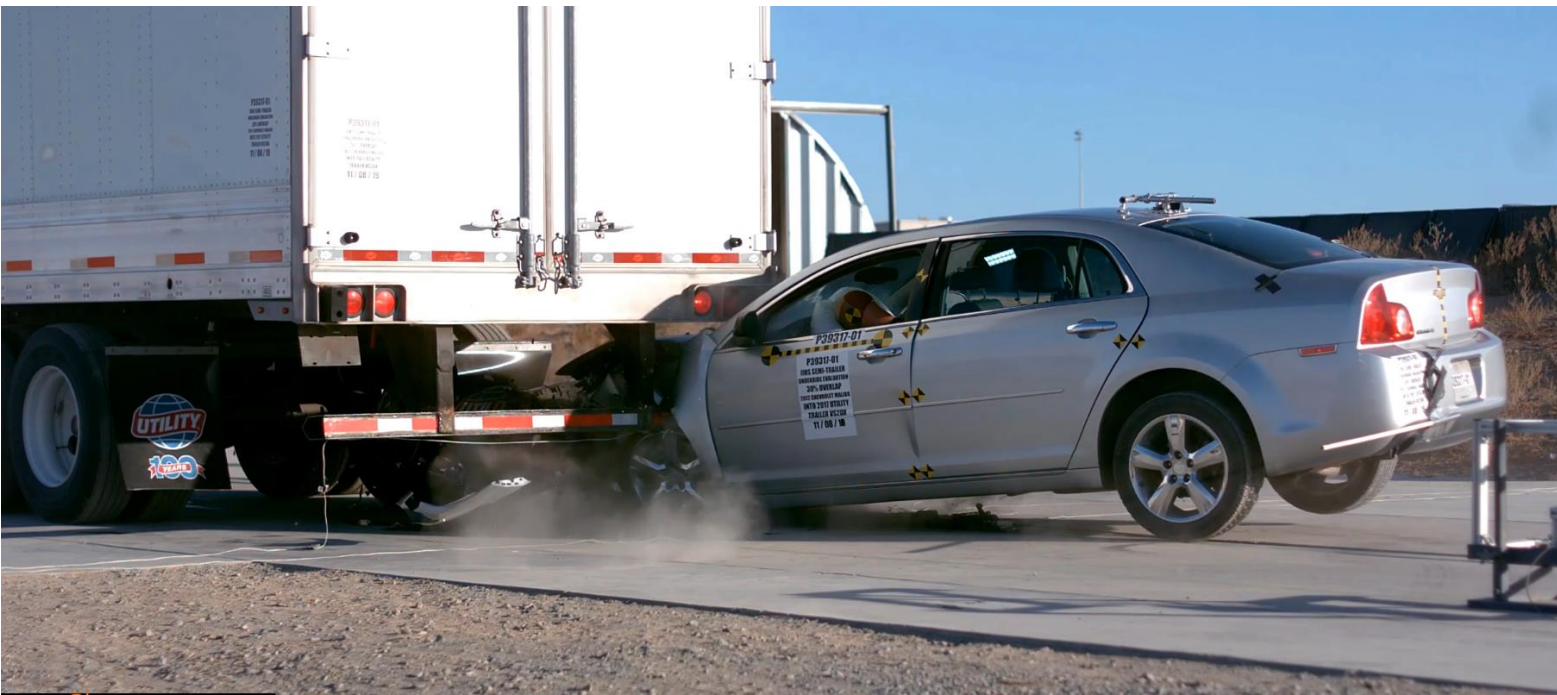
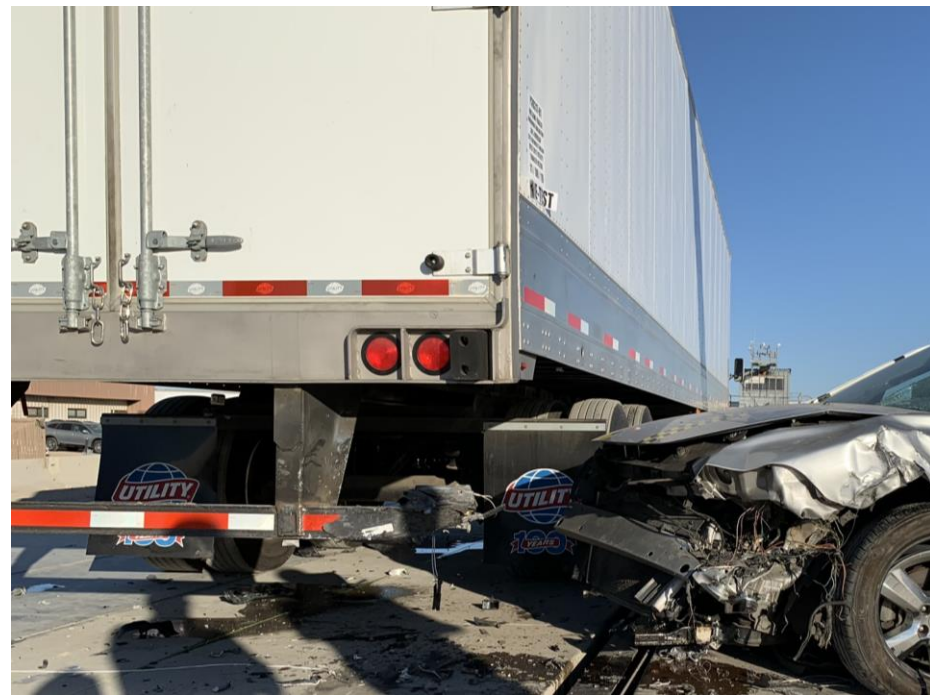
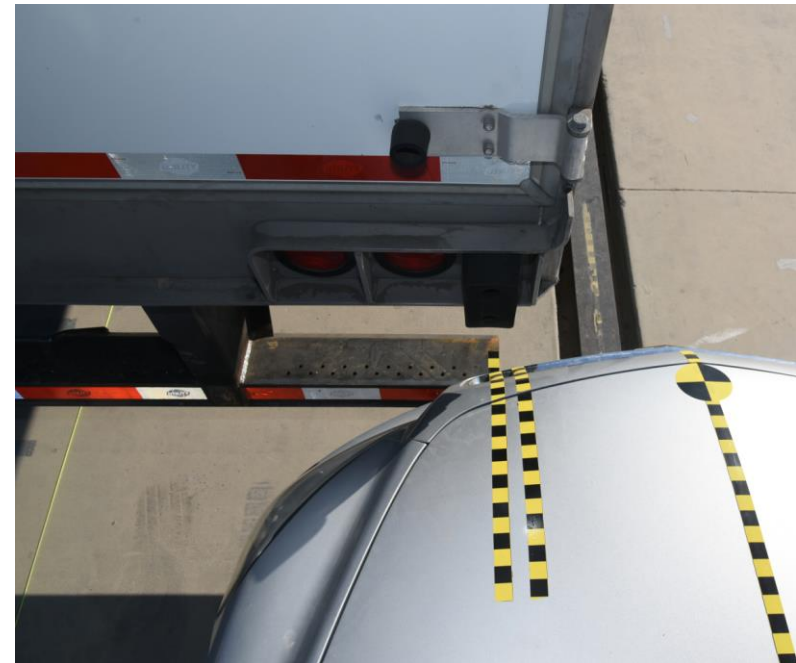
In 2018, Utility develops the 7" deep horizontal bumper tube that later replaced the 4" X 4" bumper tube on all of Utility's standard base-model-trailer RIGs. The new horizontal passed the 30% offset test shown here.

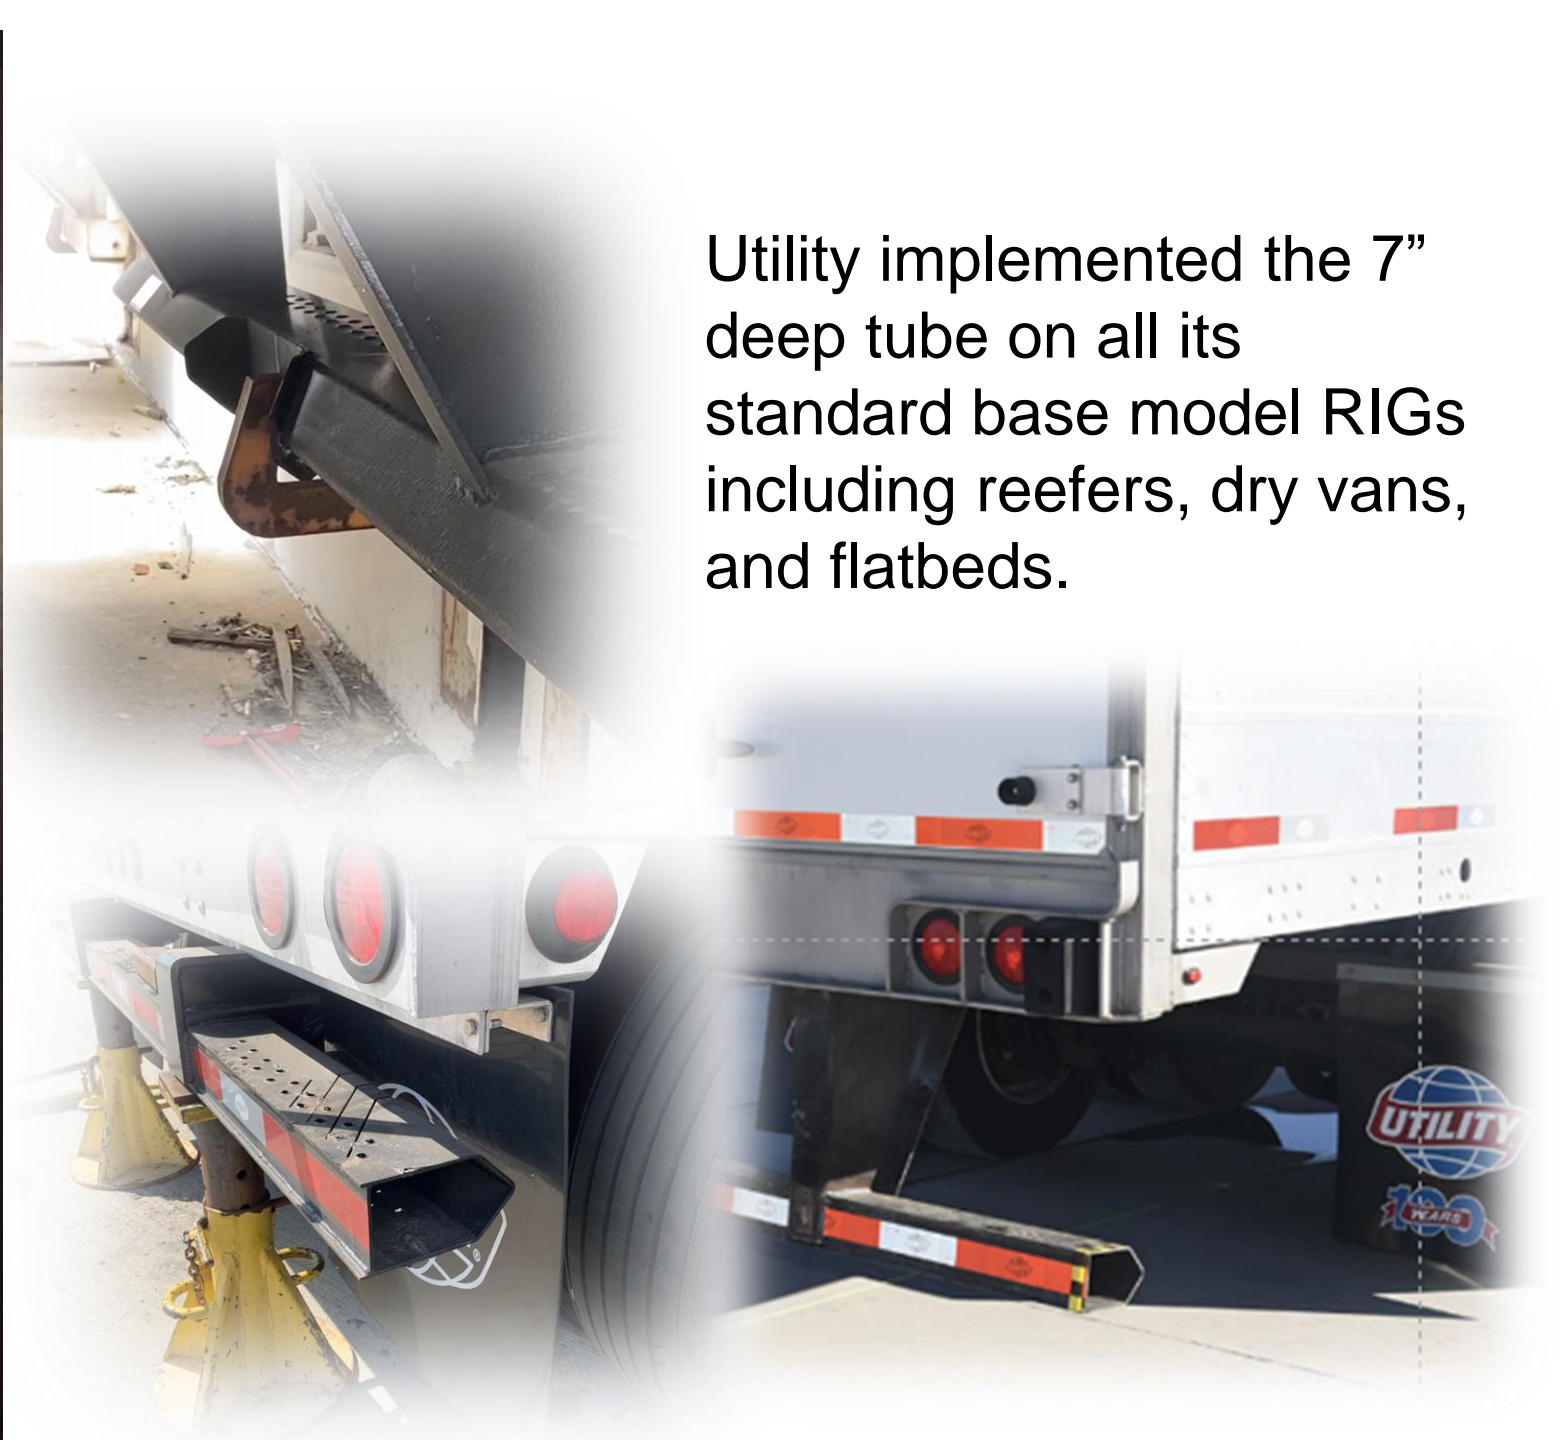
IHS
TOUGHGUARD

Utility implemented the 7”
deep tube on all its
standard base model RIGs
including reefers, dry vans,
and flatbeds.

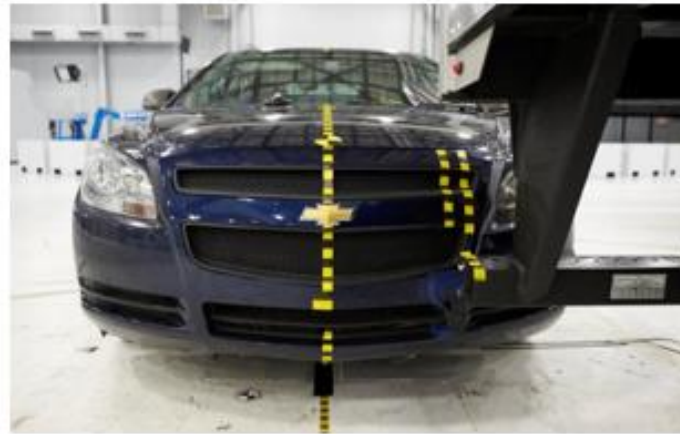
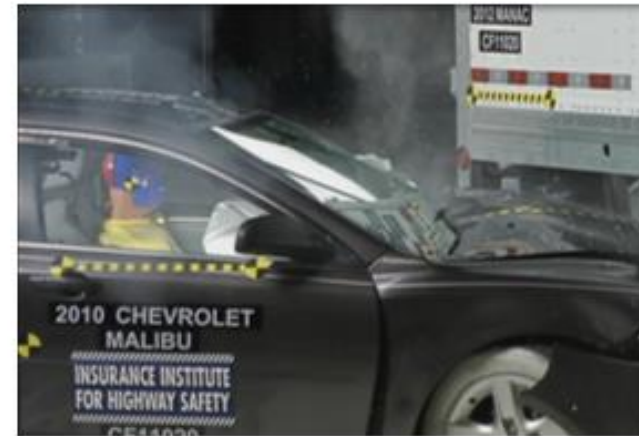
IIHS 30% Offset RIG Crash Test

Original test on Curbside

Mirrored Curbside to Roadside

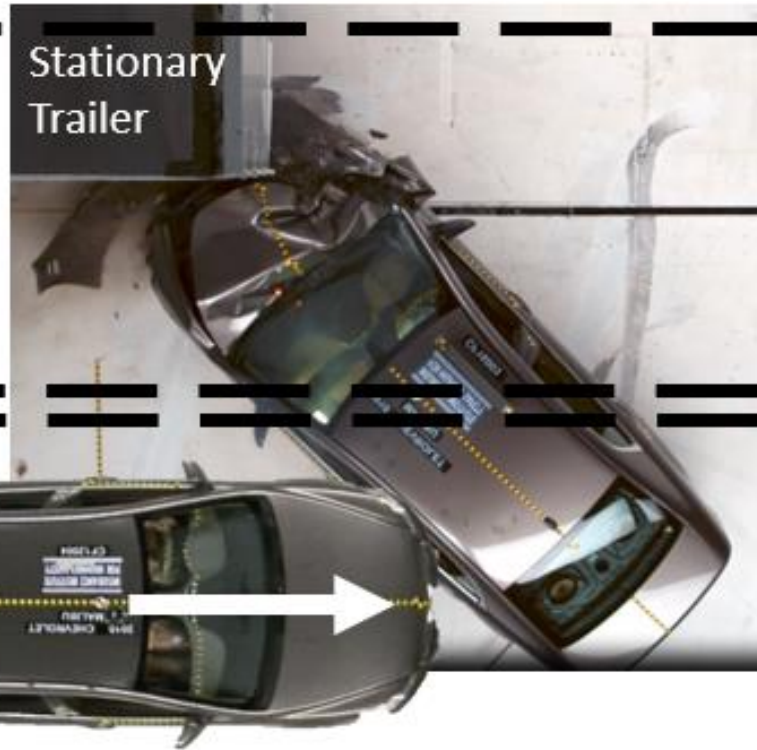
Typical 4-Vertical RIG

Westbound 35-MPH
Crash Vehicle.

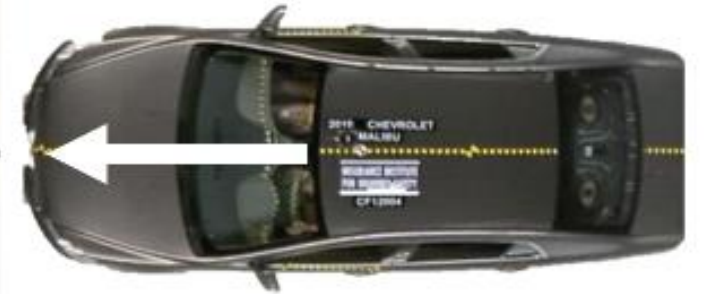
(35-MPH Eastbound Innocent now included in crash.)
