***STOP***  
UNDERRIDES

## A Guide to Today's Crash Testing:

*What Failure Looks Like —  
The Actual Hazard  
That Road Users  
Face Today*

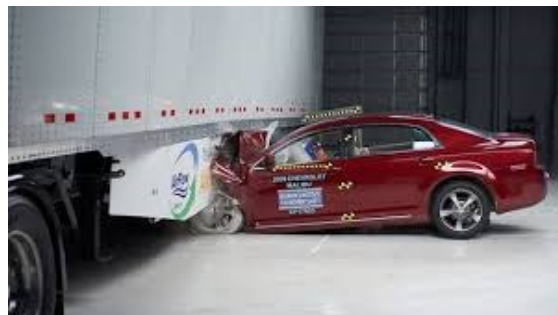
[Cyclist Guarded Crash Test](#), 9/13/2024

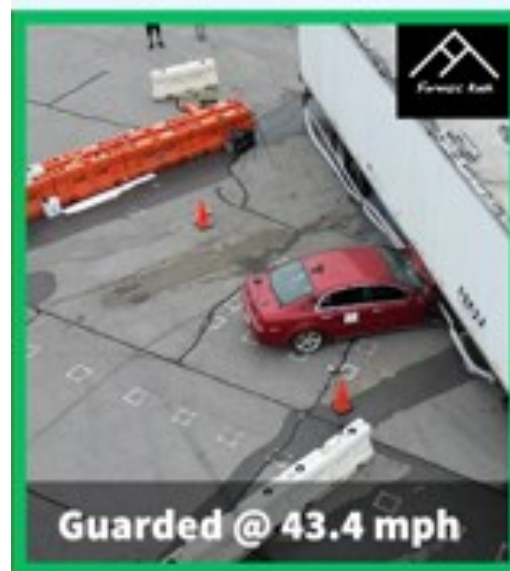
**Below:** Collision Safety Consulting [crash test](#) into tractor-trailer equipped with a *SafetySkirt* side impact guard on August 3, 2023, at the NCSHP in Raleigh at 43.4 mph.

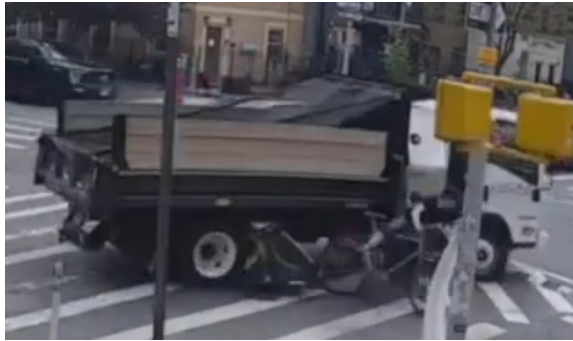
Above: [Fatal cyclist side underride](#), 5/1/2023

These photos were taken at crash scenes and crash tests where cars or cyclists collided with the **UNGUARDED** sides of commercial motor vehicles.

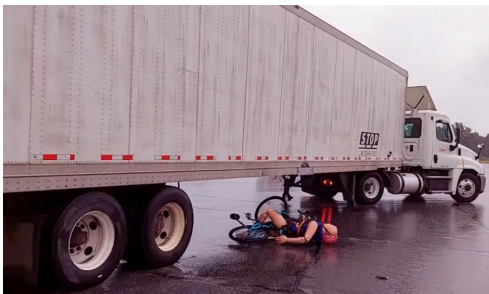
[Cyclist Unguarded Crash Test](#), 9/13/2024

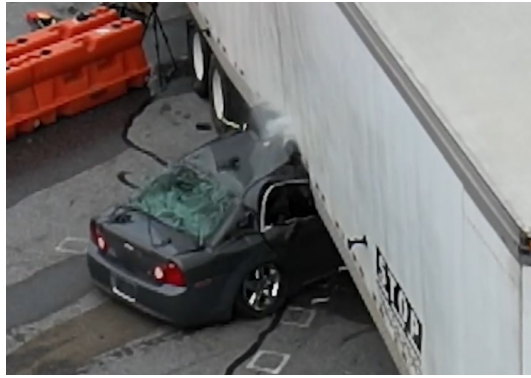
[UNGUARDED Crash Test](#), 8/3/2023

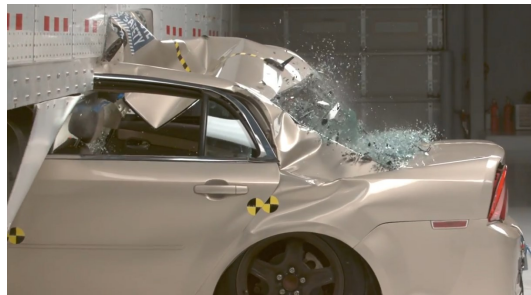
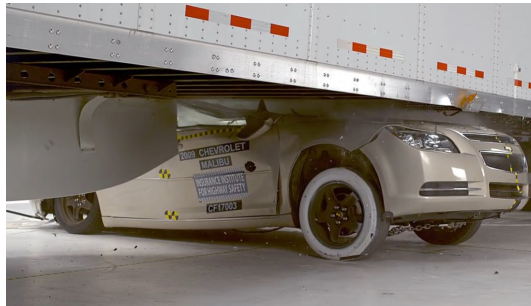
Above & Below: [IIHS 2017 Unguarded](#)
