670040

School Bus Passenger Protection

Derwyn M. Severy, Harrison M. Brink, and Jack D. Baird

Institute of Transportation and Traffic Engineering,
University of California, Los Angeles

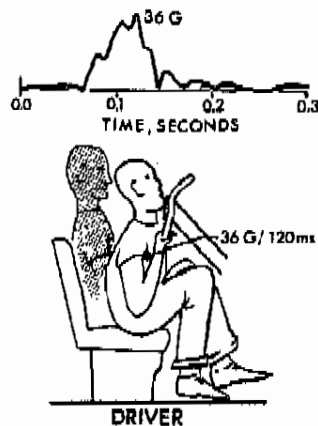
Fig. 14(b) - Driver of 1965 GMC-Superior bus. (Note: Chest (long.) indicates that chest transducer was sensitive in direction of bus's longitudinal axis and refers to driver's pre-crash seated posture.)

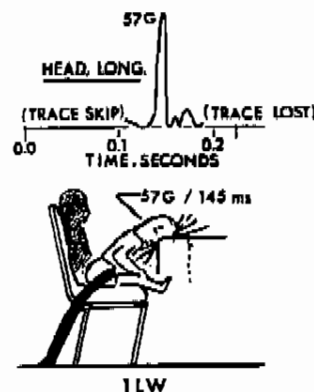
The 3-year-old, sitting in seat 1, Left side, Window position (1LW) was restrained by a lap belt and rode out the crash rather well until his head hit the rearward intruding heater enclosure at the left of the driver (Fig. 17). At this time, 145 ms after bumper contact, he received a peak head deceleration of 57 G.

Fig. 17 - Lap-belted 3-year-old struck his head against intruding heater structure

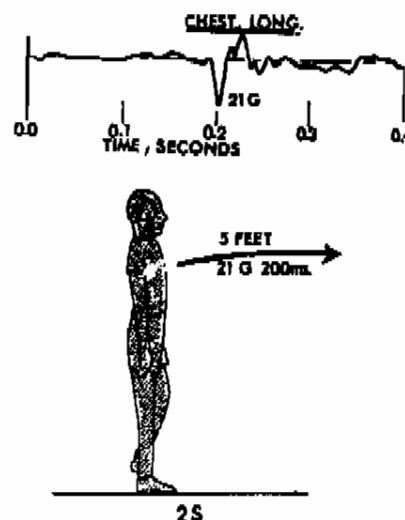
c. Standee 2S, a 13-year-old standing in the aisle opposite seats 1 and 2 (see Fig. 13), was thrown forward against the front of the bus, maintaining his standing posture all the way. His peak chest deceleration of 21 G occurred at 200 ms as he impacted the front portion of the passenger compartment (Fig. 18). Just before this impact he rotated to his left; therefore, his single chest accelerometer was not aligned with the direction of impact and his actual peak deceleration was considerably higher than indicated. The post-collision medical analysis indicated that he would have sustained serious injuries.

Fig. 18 - Standee at front of bus was hurled against door operation lever forcing it deeply into his waist

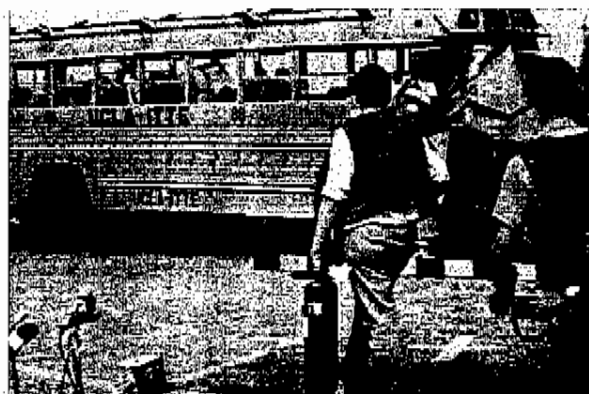
Fig. 16(b) - Thirteen-year-old lands on driver at 1250 ms. Smoke from a post-crash fire starts to enter passenger compartment on right. Prompt action by UCLA crew extinguished this engine compartment fire eliminating hazard to passenger compartment. An important consideration is the almost hopeless problem of promptly evacuating a bus load of unconscious and dazed children through inadequate escape routes

started to enter the passenger compartment at the front from an electrical short that, if allowed to progress, might have resulted in a devastating fire. Although this fire was extinguished promptly by project personnel assigned to this task, the event indicates the almost hopeless task of promptly evacuating a bus load of unconscious and dazed children, especially considering the inadequate escape routes and the present condition of no restraints being worn by school children (Fig. 39 (b)). The moderate size school bus, as typified by the 1965 GMC-Superior bus crashed for these experiments, should be provided with a minimum of four clearly marked and wide escape hatches. In addition to the front right and center rear exits, there should be an exit at or near the center right side and center left side. The right and left center-side exits should comply with the Federal Aviation Agency specification for emergency exits used on passenger aircraft as to labeling, lighting, size, protection against inadvertent openings, and protection against mischievous manipulations of escape levers. In this connection, it would be advisable to have a buzzer sound off for the driver when either of the emergency escape hatches have their sequential protective device moved in order to discourage misdirected use or accidental opening of the escape hatches.

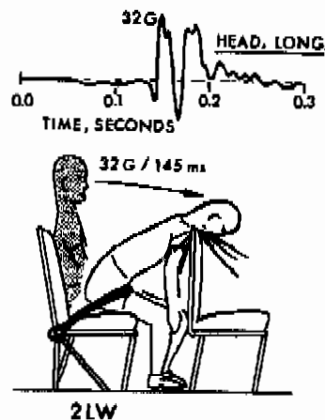
The 2LW occupant, who impacted the seatback ahead, received a head deceleration of 32 G at 145 ms (Fig. 19 (b)); as his head extended over the seat his neck received a critical injury from the seatback. The passengers in 2L then returned to a normal seated position after which there was some rearward overshoot of their heads. Thereafter their body postures assumed a slumped-forward final rest position.

Fig. 19(b) - Exposure comparable to his companion, 2LA, except passenger struck no one in front of him

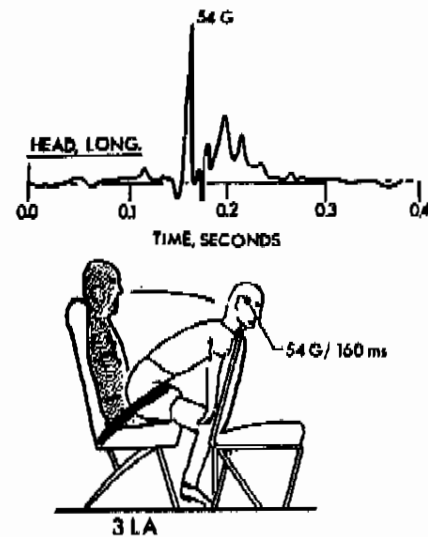
e. Seat 3L was a National seat (see Fig. 3 (f)), occupied by a lap-belted 13-year-old, 3LA, and an unbelted 6-year-old, 3LW. As the collision progressed, the belted 13-year-old jackknifed about his belt and struck the seatback of 2L with enough force to give his chest a 54 G impact at 160 ms (Fig. 20(a)); his head then whipped over the top of the seatback (Fig. 20 (b)). This action caused a neck injury considered fatal by the medical scientist who conducted the post-collision analysis.

Fig. 20(a) - Belted 13-year-old, 3LA, jackknifed about lap belt striking chest against seatback

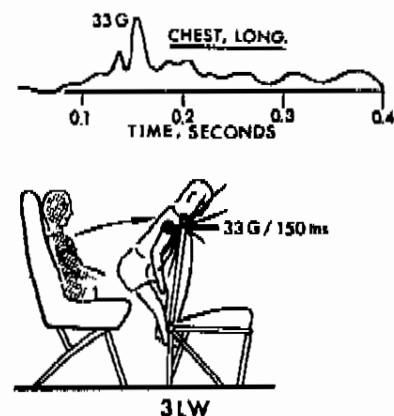
In a similar manner, the 6-year-old was thrown forward, and because of his lesser height and his unbelted condition, struck his chest in an almost identical manner against the top of seatback 2L, thereby receiving a 33 G impact at 150 ms (Fig. 20(c)). His head flexed over the top of the seatback bringing extreme manipulation to the neck (Fig. 20

Fig. 20(c) - Unbelted 6-year-old pitched against seatback

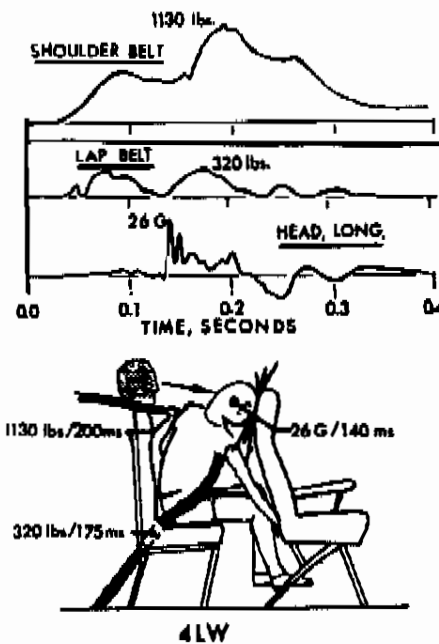
f. Seat 4L was a high back Superior seat (see Fig. 3 (c)), with the aisle 13-year-old 4LA lap-belted, and the window 13-year-old 4LW restrained by a three-point belt. Occupant 4LW lunged forward against this three-point restraint and rotated to his left, counterclockwise, owing to the nonsymmetrical application of restraining forces by the diagonal chest strap. This rotation appeared to be 90 deg, which essentially freed him from his upper torso restraint (Fig. 21 (a)). As he rotated, his head flailed to the right, striking the seatback of 3L with a peak deceleration of 26 G at 140 ms. In addition to this forceful head impact, the extreme rotation of his upper torso may have caused back injuries. The inferred injury level for this occupant was moderate.

Fig. 21(a) - Thirteen-year-old restrained by combination cross-chest and lap belt rotates out of chest restraint

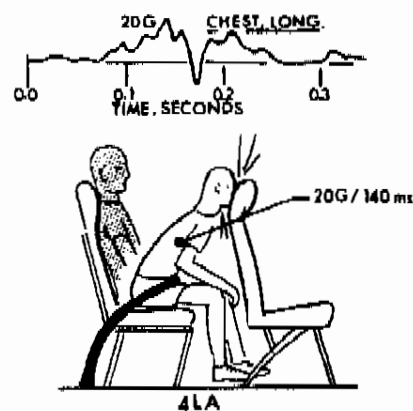
The 4LA 13-year-old pivoted about his lap belt, striking his head and shoulders against the high-padded seatback of National seat, 3L. The peak chest deceleration of 20 G occurred at 140 ms (Fig. 21(b)). His inferred injury level was also considered moderate.

Fig. 21(b) - Thirteen-year-old pivots about lap belt striking padded seatback ahead

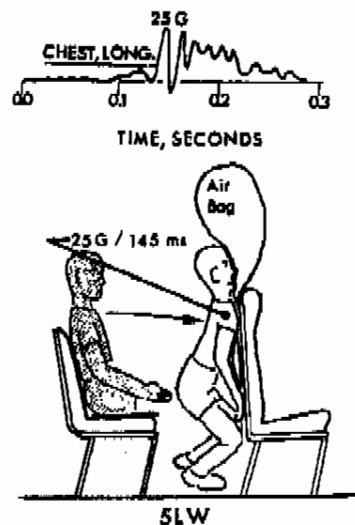
Fig. 22(b) - Thirteen-year-old squarely impacts air bag

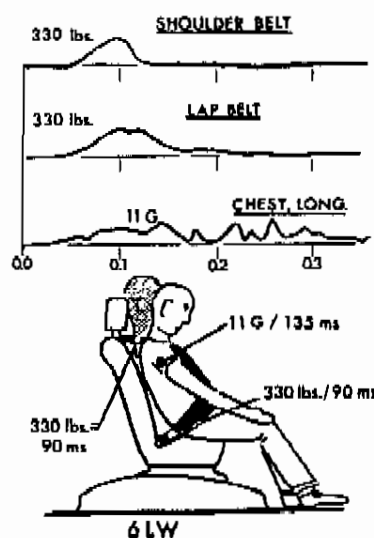
this tendency (Fig. 23 (b)). While in this position, he received a peak chest deceleration of 11 G at 135 ms (Fig. 23 (c)). The extent of submarining was checked at this instant by failure of the rear seat floor attachments. The entire seat 6L rotated forward about its front anchorages, thereby eliminating further restraint evaluation (Fig. 23 (d)). The 6L seat, with its belted adult was pitched, backrest forward, over the back of the seat 5L and continued forward until its occupant, 6LW, plunged his head into the 5L air bag. Moderate injuries were inferred from his forward motion and subsequent loadings. The adult, 7LW, seated directly behind him, was likewise thrown forward following the ejected 6L seat, and struck the air bag after 6LW had been displaced from it (see Fig. 22 (e)).

Fig. 23(c) - Peak G occurs before seat anchors fail

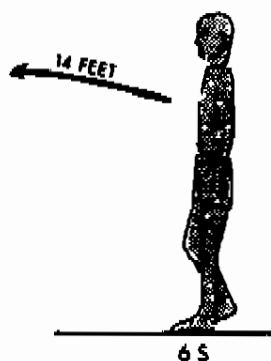
Fig. 24 - The 13-year-old standing occupant, 6S, was thrown forward 14 ft to front of bus

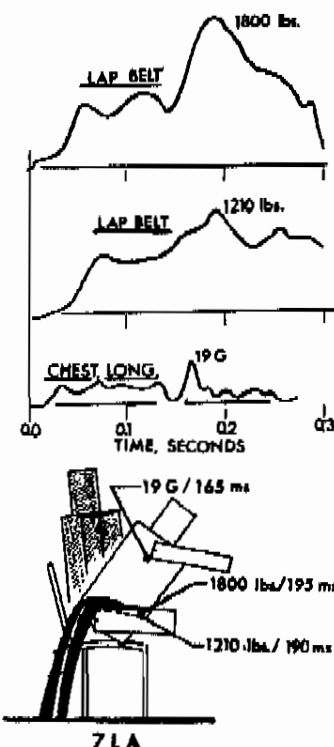
The mechanical adult simulation was included in this study to develop further computer solutions of forced kinematics for the lap-belted human undergoing collision deceleration. His peak chest deceleration was 19 G at 165 ms (Fig. 25(a)). The pre-crash seated posture of the iron man was slightly reclined to the rear of vertical; during collision, he rotated forward beyond the vertical reference 52 deg (Fig. 25 (b)).

Fig. 25(a) - Mechanical analog of belted human subject provided data for theoretical calculations

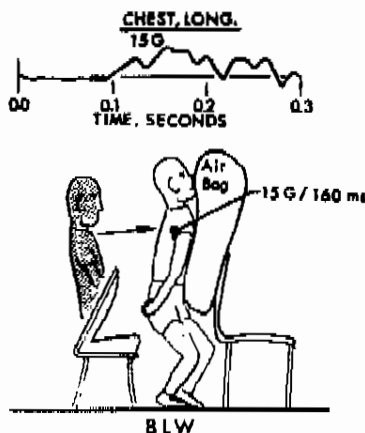
Upon impacting the air bag, the chest deceleration of 13-year-old 8LW, reached its peak of 15 G at 160 ms (Fig. 26 (b)). The passenger next to him, 8LA, received a chest deceleration of 12 G at this same time; however, he was later hit in the back by occupant 9LA and received

Fig. 26(b) - Peak chest deceleration was only 15 G for impact with this air bag

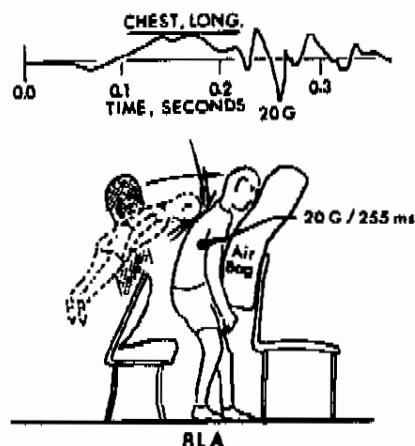
Fig. 26(c) - This passenger's chest deceleration of 12 G into air bag was subsequently increased to a 20 G peak when struck from behind by dummy 9LA

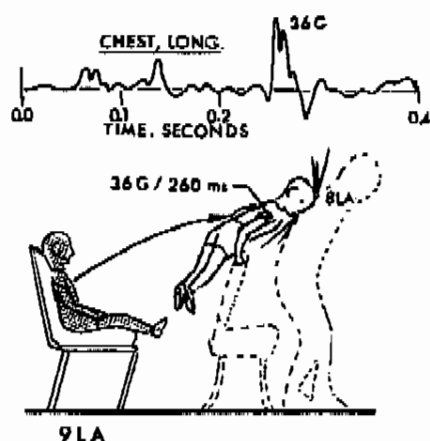
Fig. 27(b) - Three-year-old, 9LA, struck back of 13-year-old, 8LA

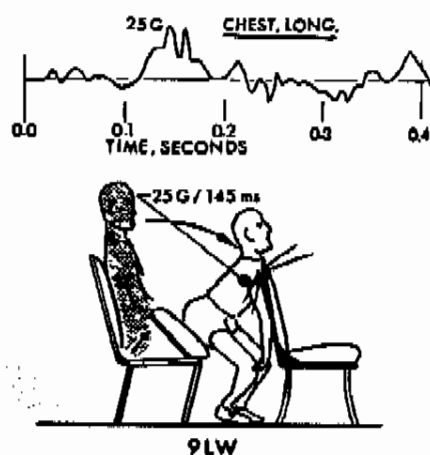
Fig. 27(c) - Thirteen-year-old, unbelted, thrown against backs of passengers ahead of him, deflects toward ceiling, subsequently coming down head first into aisle

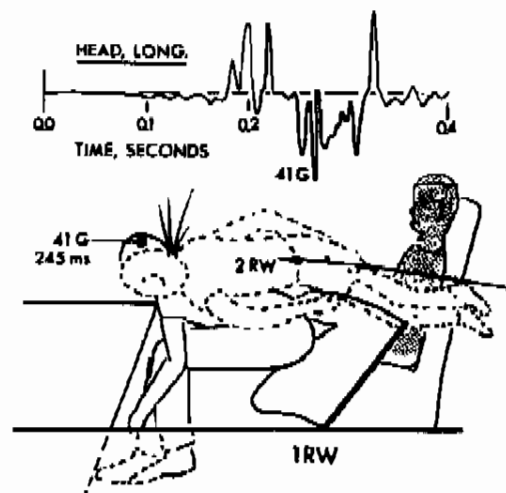
5). He was restrained by a lap belt that formed a continuous loop around the seatback and was sewn into the seat fabric. His peak chest deceleration was 41 G at 160 ms, which occurred when he impacted the intruding front-end structure although still restrained by the lap belt (Fig. 28 (a)); however, his peak head acceleration of 41 G occurred at 245 ms, at which instant he was rebounding from a lap-belted, jack-knifed position when struck by the right shoulder of 2RW being hurled partially through the windshield area (Fig. 28 (b)).

Fig. 28(b) - Thirteen-year-old from 2RW hurled forward to strike his shoulder against the adult's head from 1RW

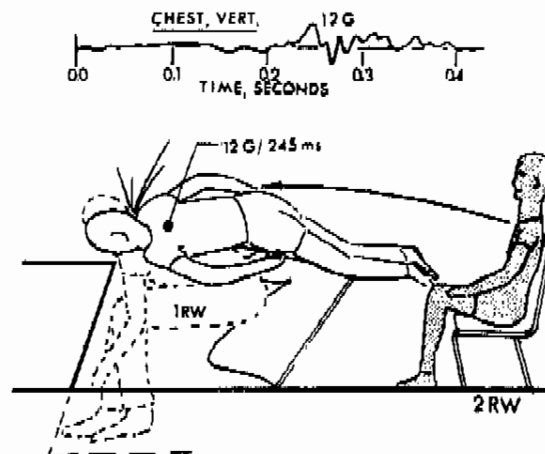
The 6-year-old passenger, 2RA, received a 53 G chest deceleration at 265 msec (Fig. 29 (a)), but the other passenger, the 13-year-old, 2RW, recorded his chest deceleration in the vertical axis only, which reached 12 G at 245 ms (Fig. 29 (b)); the longitudinal axis was electrically disconnected during collision. The unbelted 2R passengers had already vacated their seat (Fig. 28 (b)), when their backrest was crushed forward by the three onrushing occupants from the seat behind them; therefore, they did not receive the extreme abusive forces from these 3R occupants (Fig. 29 (c)). However, the critical forces encountered by not being belted and being thrown forward were probably fatal.

Fig. 29 (b) - Unrestrained 13-year-old pitched over air seat and against collapsing front structure

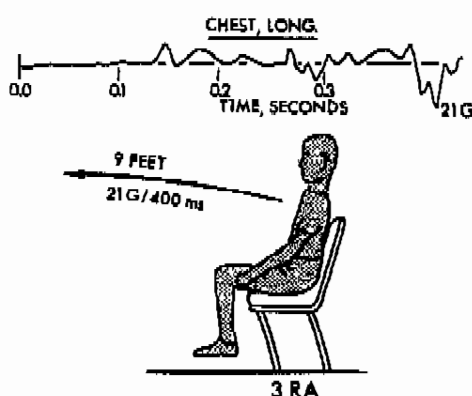
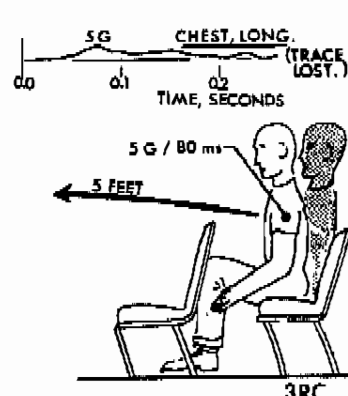
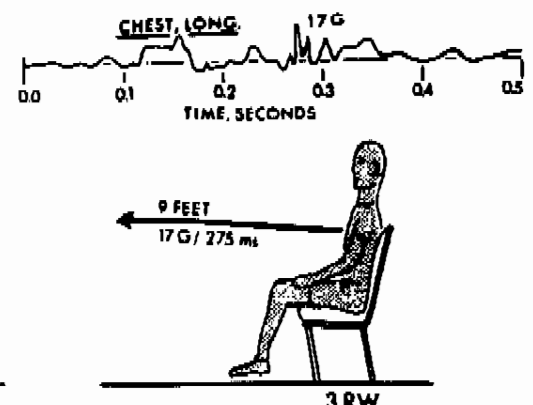
Fig. 30(c). (d). (e) - Thirteen-year-old (aisle), adult (center), and 13-year-old (window), respectively, all unrestrained, were pitched over seat ahead of them

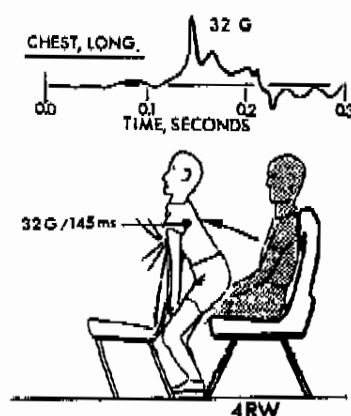
Fig. 31(b) - After striking seatback, this unrestrained 13-year-old is pitched head first over it

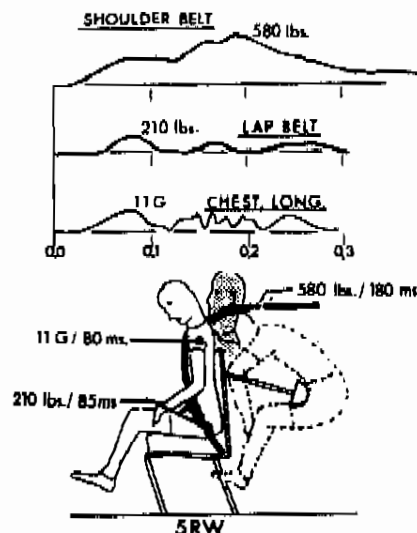
The passenger in 5RW remained in a good seated posture throughout the collision. He was restrained against the collision forces in a very effective manner, except that his seatback was pushed forward against him, adding to his restraint loadings as a result of direct loading through the swing-bar restraint by the passengers to his rear. His peak chest deceleration was 11 G at 80 ms (Fig. 32(a)). His lap belt tensiometer registered 210 lb at 85 ms and his shoulder strap tension was 330 lb when he received his peak chest deceleration, building up to 580 lb at 180 msec when loaded from the rear.

Fig. 32(a) - Cross-chest belt forces were increased by inertial forces from dummies to his rear

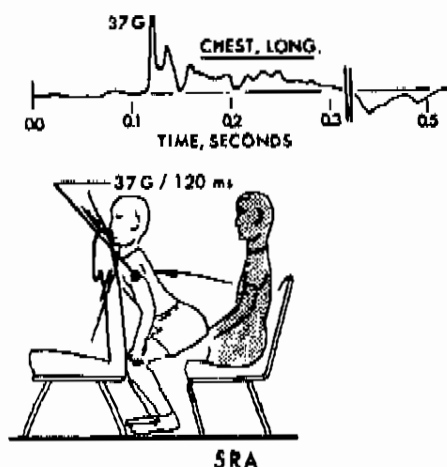
The unrestrained 13-year-old, 5RA, struck the high back American seat ahead where he received a chest deceleration of 37 G at 120 ms (Fig. 32(b)). He then rebounded back into his seat. This high back seat provided significant restraining action by preventing the unrestrained 13-year-old from being pitched to the front of the bus where his impact forces would have been considerably higher. His high chest loading with the seatback ahead could have inflicted serious injuries because he contacted framework with insufficient padding. His injuries were diagnosed as a probable survival.

Fig. 32(b) - High back seat prevented this 13-year-old from being hurled to front of passenger section

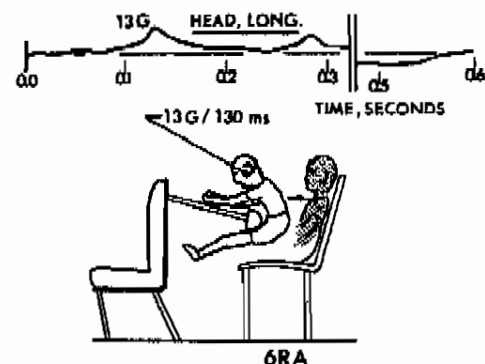
Both passengers strained forward during the impact and the aisle seated 3-year-old was adequately restrained from striking the forward structure by the horizontal padded bar (Fig. 33(a)). He received a head deceleration of 13 G at 180 ms (Fig. 33(b)), and his injuries were considered relatively minor.

Fig. 33(b) - Three-year-old flexed about padded bar during impact without striking other objects

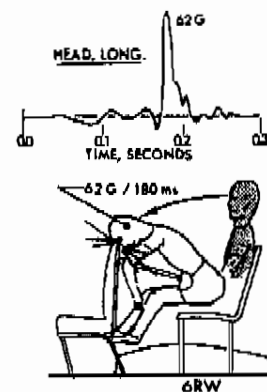
The 13-year-old, 6RW, on the other hand, flexed over the bar and struck his head a critical blow at the bridge of the nose, on the horizontal portion of seatback 5R (Fig. 33(a)). The extreme deformation of his head is shown as well as the buckling of his arms from flailing against the seatback. This impact gave him a 62 G head deceleration at 180 ms (Fig. 33(c)). His violent interaction with the seatback ahead indicated severe to fatal injuries.

Fig. 33(c) - Restraining bar, as with restraining belt, provides an unsatisfactory solution for school passengers unless seat-back ahead is high and properly constructed to minimize head, neck, and chest impact injuries

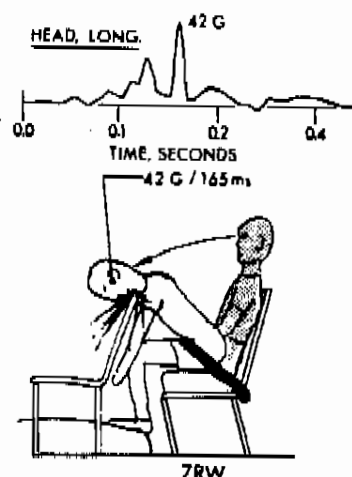
Upon impact, the three passenger simulations were thrown forward, each restrained by their belts. Occupant 7RW received a 42 G head deceleration at 165 ms (Fig. 34(b)) when he impacted the seat ahead with his chest. He did not

Fig. 34(b) - Belted 13-year-old snapped head downward receiving critical blow to his neck

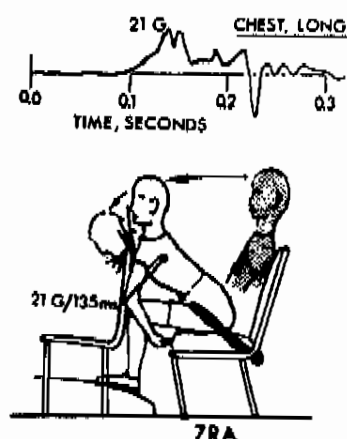
Occupant 7RA sustained a 21 G chest deceleration at 135 ms (Fig. 34(c)). As he continued his forward rotation about his lap belt, he slammed his head downward completely over the low seatback ahead, dealing a probable lethal blow to his neck (Fig. 34 (d)). This exposure, typical

Fig. 34(c) - Although sustaining only a 21 G chest acceleration, a probable fatal blow was applied to his head and neck when he struck top of seatback ahead

of findings from these studies, points out the danger of reaching "arm-chair conclusions" based on somewhat unrelated findings of other seat belt experiments. Seat belts should not be added to buses unless attention is also given to the seatback height and design.

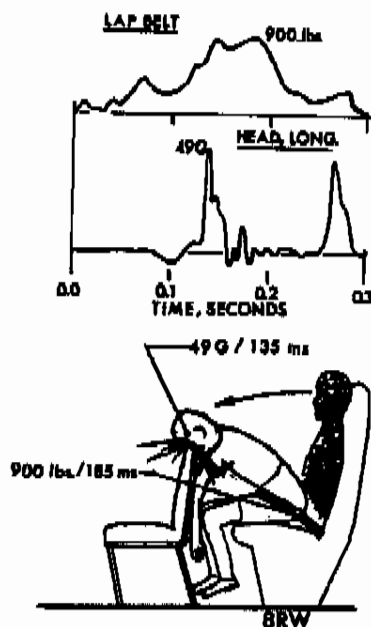
When passenger 8RA started to push the 7R seatback forward (Fig. 35 (a)), the window-seated passenger rotated about his lap belt, striking the top of the seatback and sustaining a peak head deceleration of 49 G at 135 ms (Fig. 35 (b)). After the seatback was pushed from his reach, he received a second head deceleration, 40 G at 270 ms, as he slammed his head against the rigid seat belt manifold bar ahead of him (Fig. 35 (c)). His lap belt built to a peak of 900 lb at 186 ms as the seatback was pushed from his reach. The medical scientist concluded these head injuries were severe to fatal. Following impact, passenger 8RW returned to a normal seated posture. Except for the design deficiencies of the 7R seatback ahead of him, this lap-belted passenger would have ridden through this crash in a relatively uneventful manner.

Fig. 35(b) - Injury-producing rigid structures must be kept from contact of passengers during collisions

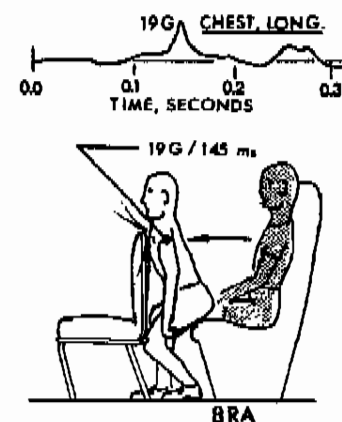
The unrestrained 13-year-old, 8RA, was thrown into the 7R seatback. As he crushed it forward he sustained a peak chest deceleration of 19 G at 145 ms (Fig. 35(d)). Thereafter the conventional-type seatback ahead yielded and

Fig. 35(d) - Unrestrained 13-year-old 8RA strikes seatback ahead with chest

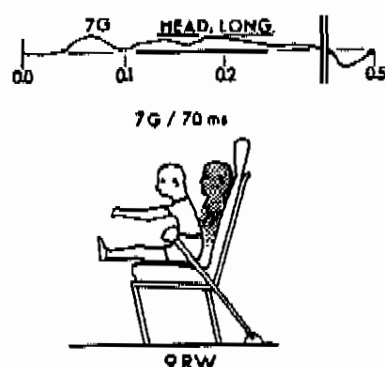
shorter torso measurements, tended to receive these forces at the viscera as he flexed over the restraint. The gate-bar was, however, padded and provided a broad distribution of forces. This restraint, for the 3-year-old, prevented him from contacting the forward structure during this impact and he received a head deceleration only 7 G at 70 ms (Fig. 36 (a)). The 13-year-old, on the other hand, because of his substantially longer head-to-hip length, flailed forward and struck his head against the 8R seatback; although this aircraft-type seatback was partially padded, the frame was exposed at the side where his head struck, causing him to receive a head deceleration of 46 G at 155 ms (Fig. 36 (b)).

Fig. 36(a) - Three-year-old adequately restrained by gate-bar

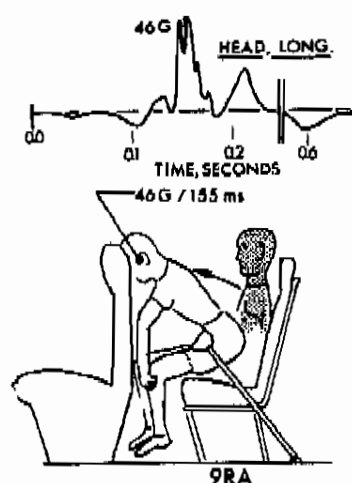
Fig. 36(b) - Even high back seats can deal serious blows to partially restrained passengers when rigid frame members are contacted

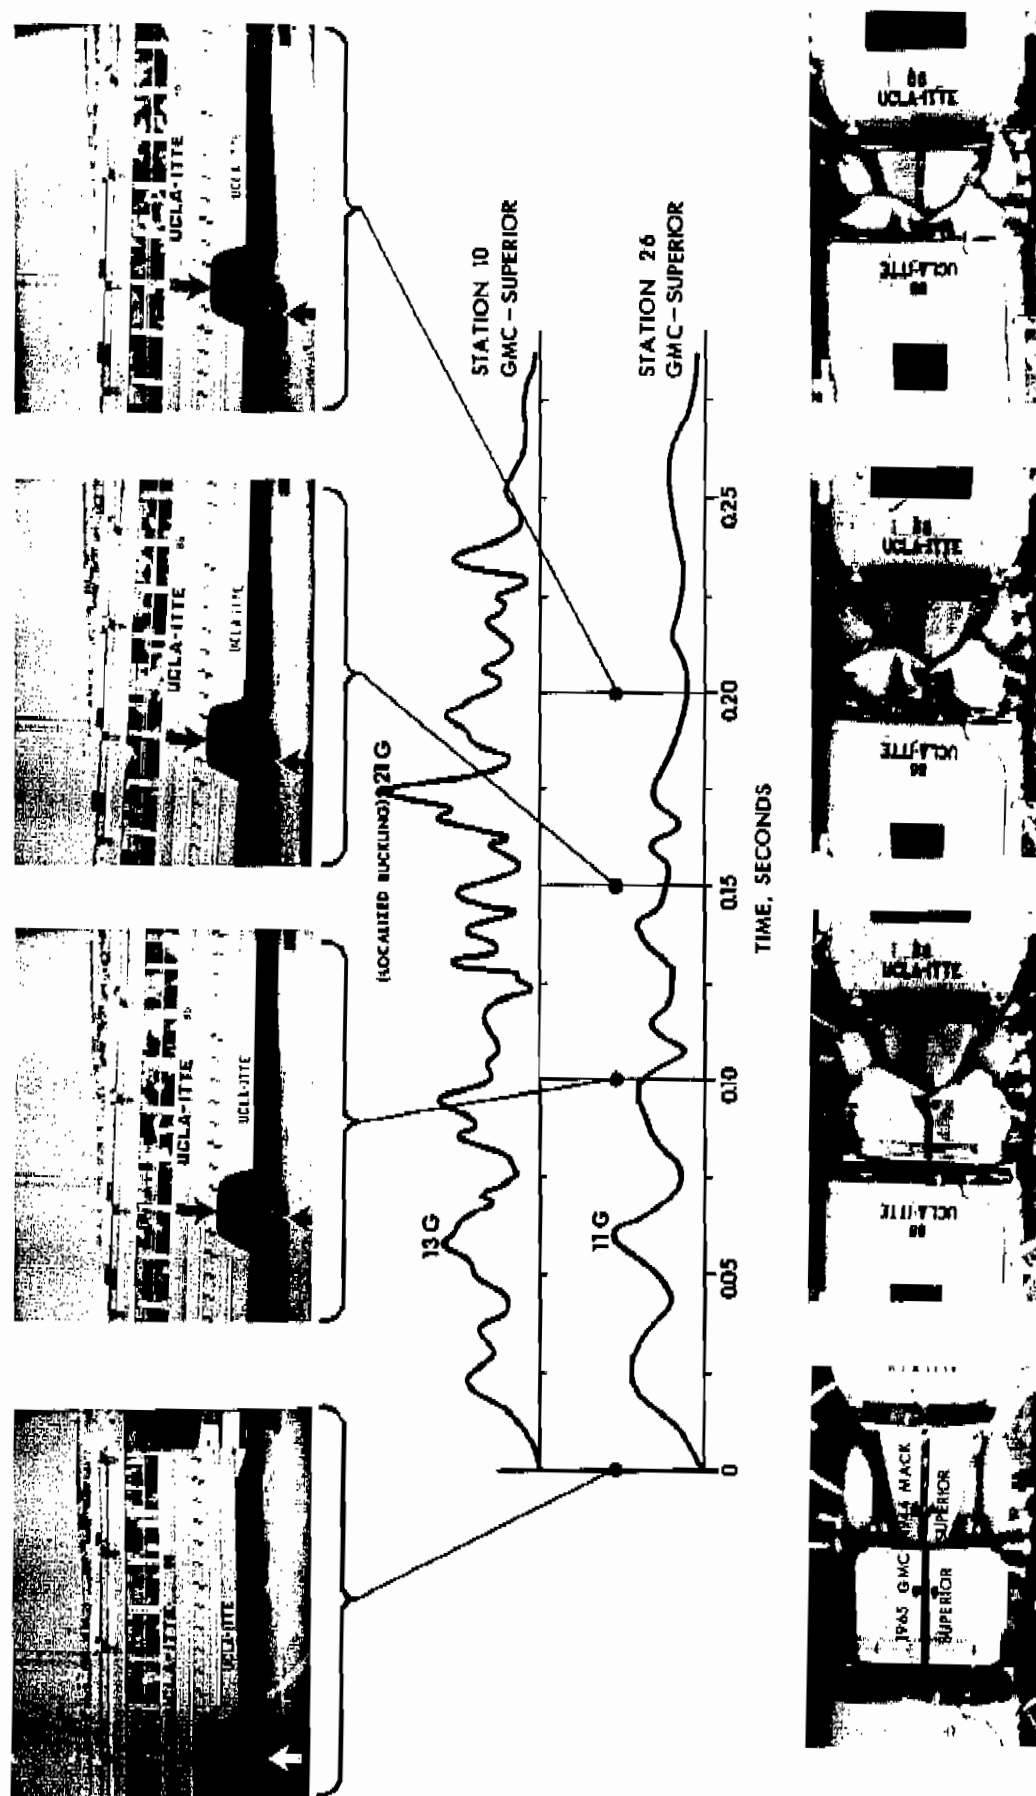
positioned on the bus body floor cross-members at 10 ft from the front bumper and the other biaxial unit was bolted to a similar body frame member 26 ft from the front bumper. These stations recorded 13 G at 55 ms and 11 G at 60 ms respectively (Fig. 38). A second peak acceleration of 21 G at 175 ms occurred at the 10 ft station. This larger second peak was floorpan buckling in the immediate area of the vertical axis accelerometer. In fact, this accelerometer case was rotated 90 deg and entrapped in one of the floor convolutions. This buckling of the floorpan was

Fig. 38 - 1965 GMC-Superior bus body deceleration pattern during a 30 mph head-on collision

caused by the body shifting forward 17 in., as observed in the sequence photos (Fig. 38).

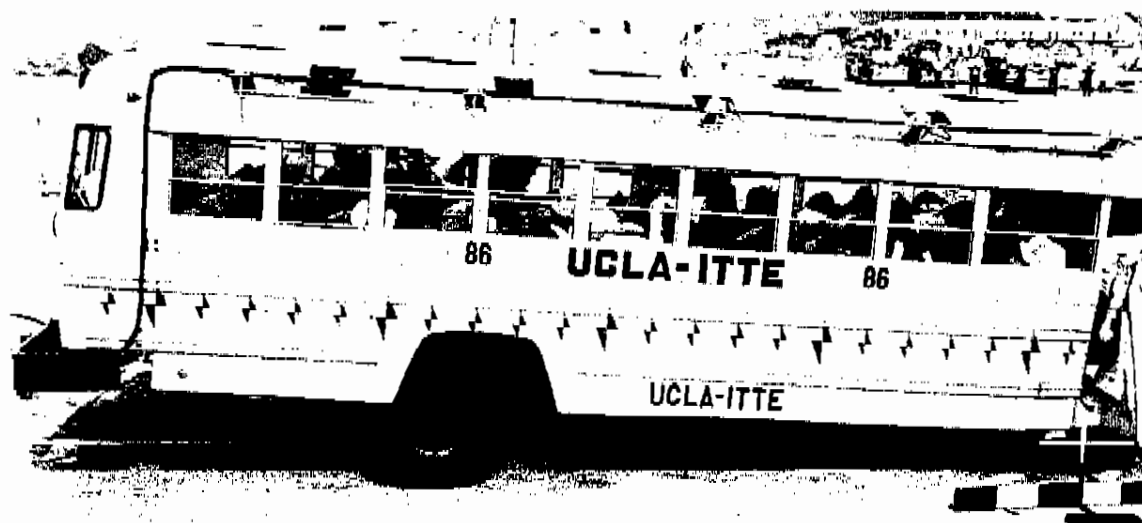
Following collision, there was an 11-in. permanent displacement between the frame and the 1965 GMC-Superior bus body (Fig. 39(a)). This is important to note, with respect to observations of the driver's movements, because the motion picture camera that was directed at the driver was actually moving forward with the collapsing bus body and roof structure, whereas the driver's seat was anchored to the portion of the bus floorpan that did not have a similar 11-in. collapse. This situation occurred because buckling of the floorpan developed approximately three vertical convolutions directly behind the driver's seat (see Fig. 15). The 30 in. foreshortening of the passenger compartment represented by the convolutions was made up of the 11 in. body shift and the balance attributed to front end intrusion. Inadequate anchoring of floor sills to the frame allowed the inertial load of the entire bus body to be concentrated on the forward sill under the driver. This slippage between the bus body and frame occurred when the four shearbolts at the front failed to prevent this differential motion. The buckling tendency related to the use of clamp attachments between body and frame, thus allowing the body to shift longitudinally, relative to the frame (Fig. 39(a)). With respect to Fig. 39(a), note also unrestrained passengers being pitched forward during collision.

Within 1/10 sec following contact of the two vehicles in this head-on collision, two unrestrained 13-year-olds from seat 1L landed on top of the driver, rendering his constructive efforts to facilitate evacuation of these children an impossibility, assuming he wasn't killed during the onset of collision forces owing to the unexpected front-end collapse around him. In addition, at this same time, smoke had

Fig. 39(a) - Unrestrained passengers may be seen being pitched forward during collision

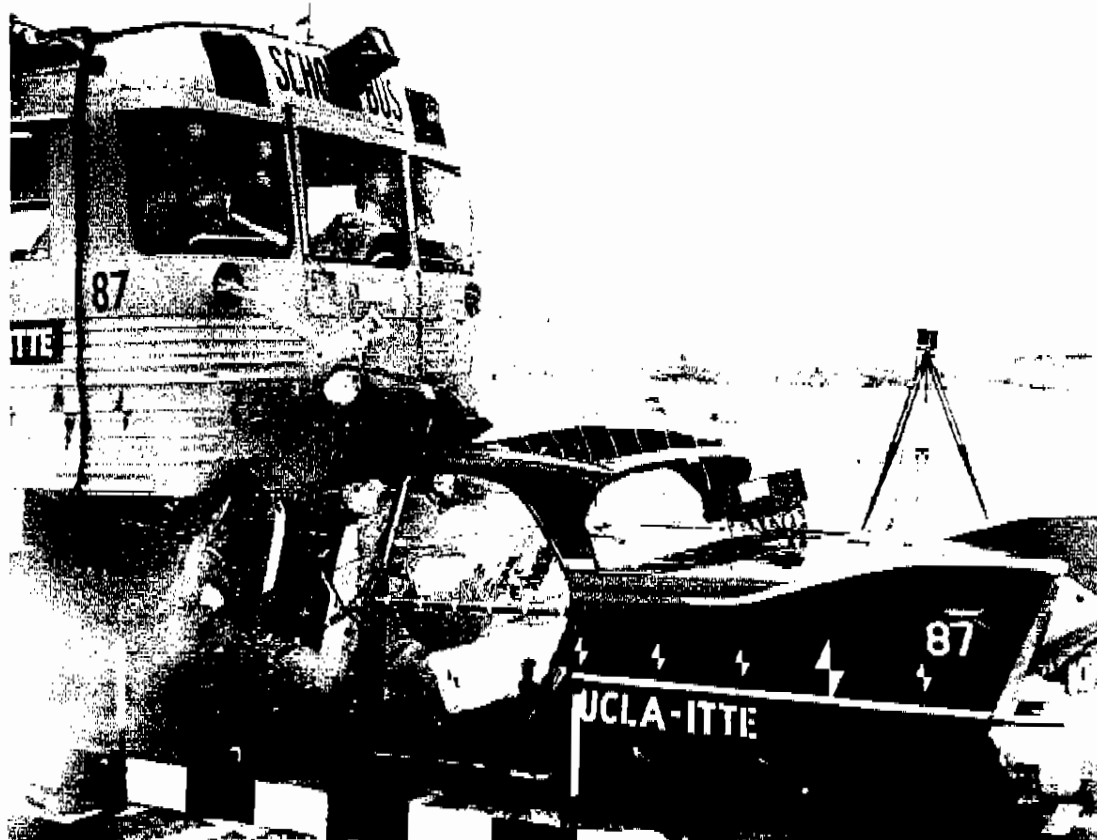
EXPERIMENT 87 - A rear-end collision between a 1965 GMC-Superior school bus and a 1960 Plymouth Savoy 4-door sedan was conducted; the 17,500-lb stationary school bus was struck by the 4400-lb sedan traveling 60 mph (Fig.

Fig. 41 - Stationary school bus rear-ended by 1960 Plymouth sedan traveling at 60 mph

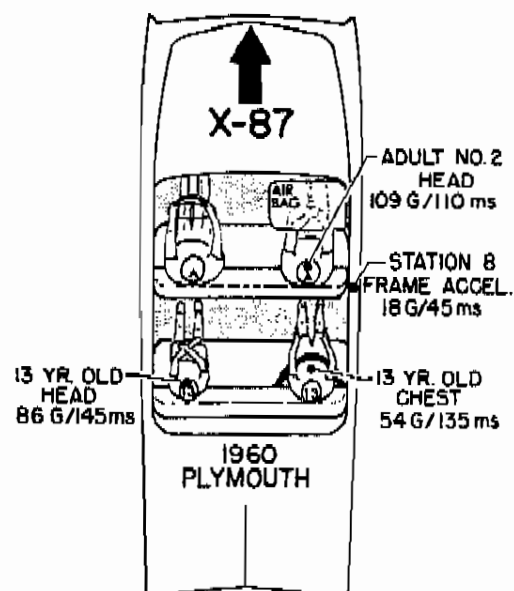
1. 1960 Plymouth - The driver and front seat passenger were adult-type anthropometric dummies seated on a conventional passenger car bench seat. The driver was unrestrained and the front seat passenger was restrained in the direction of forward motion by an air bag (Fig. 42 (a)). Two 13-year-old solid-pour dummies were seated in the rear on a bench seat. The left rear passenger was unrestrained; the right rear passenger was restrained with a lap belt. At impact with the rear-end of the bus, the driver and front seat passenger were sandwiched between the crushed-back instrument panel and their seat, which was being thrown forward. The air bag restraining the right front seat passenger ruptured during collision; the passenger sustained 109 G at 110 ms following vehicle contact (Fig. 42 (b)).

This high G indicates the air bag offered little protection, considering the striking car only reached a peak deceleration of 18 G at 45 ms after contact. This low frame deceleration was attributed to the relatively long deceleration distance provided by this rear-ending car underriding the high rear bumper until the bus bumper reached the car's windshield (Fig. 41). The steering column showed no evidence of having been extended rearward, but was severely damaged from the driver crushing around the steering wheel

Fig. 42(b) - Striking car seating assignment and peak deceleration values recorded for occupants and car frame

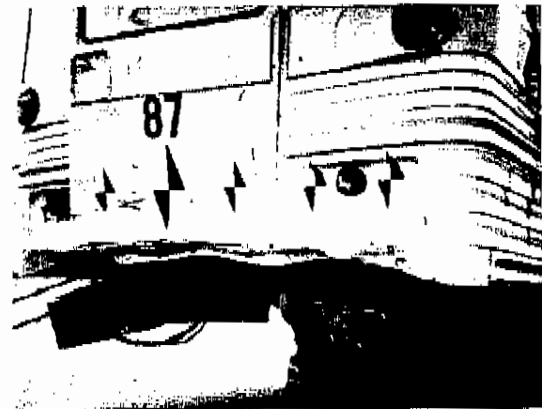
as he was thrown forward. The constant position of the steering column, notwithstanding the collapse-action of the front end, is attributed to the lack of contact by the opposing bus structure with the car front bumper and frame. The steering column is attached to the frame and would have been forced rearward had the frame encountered opposing bus structures. (Figs. 43(a)-(c)).

Fig. 43(c) - Passenger car underrode bus

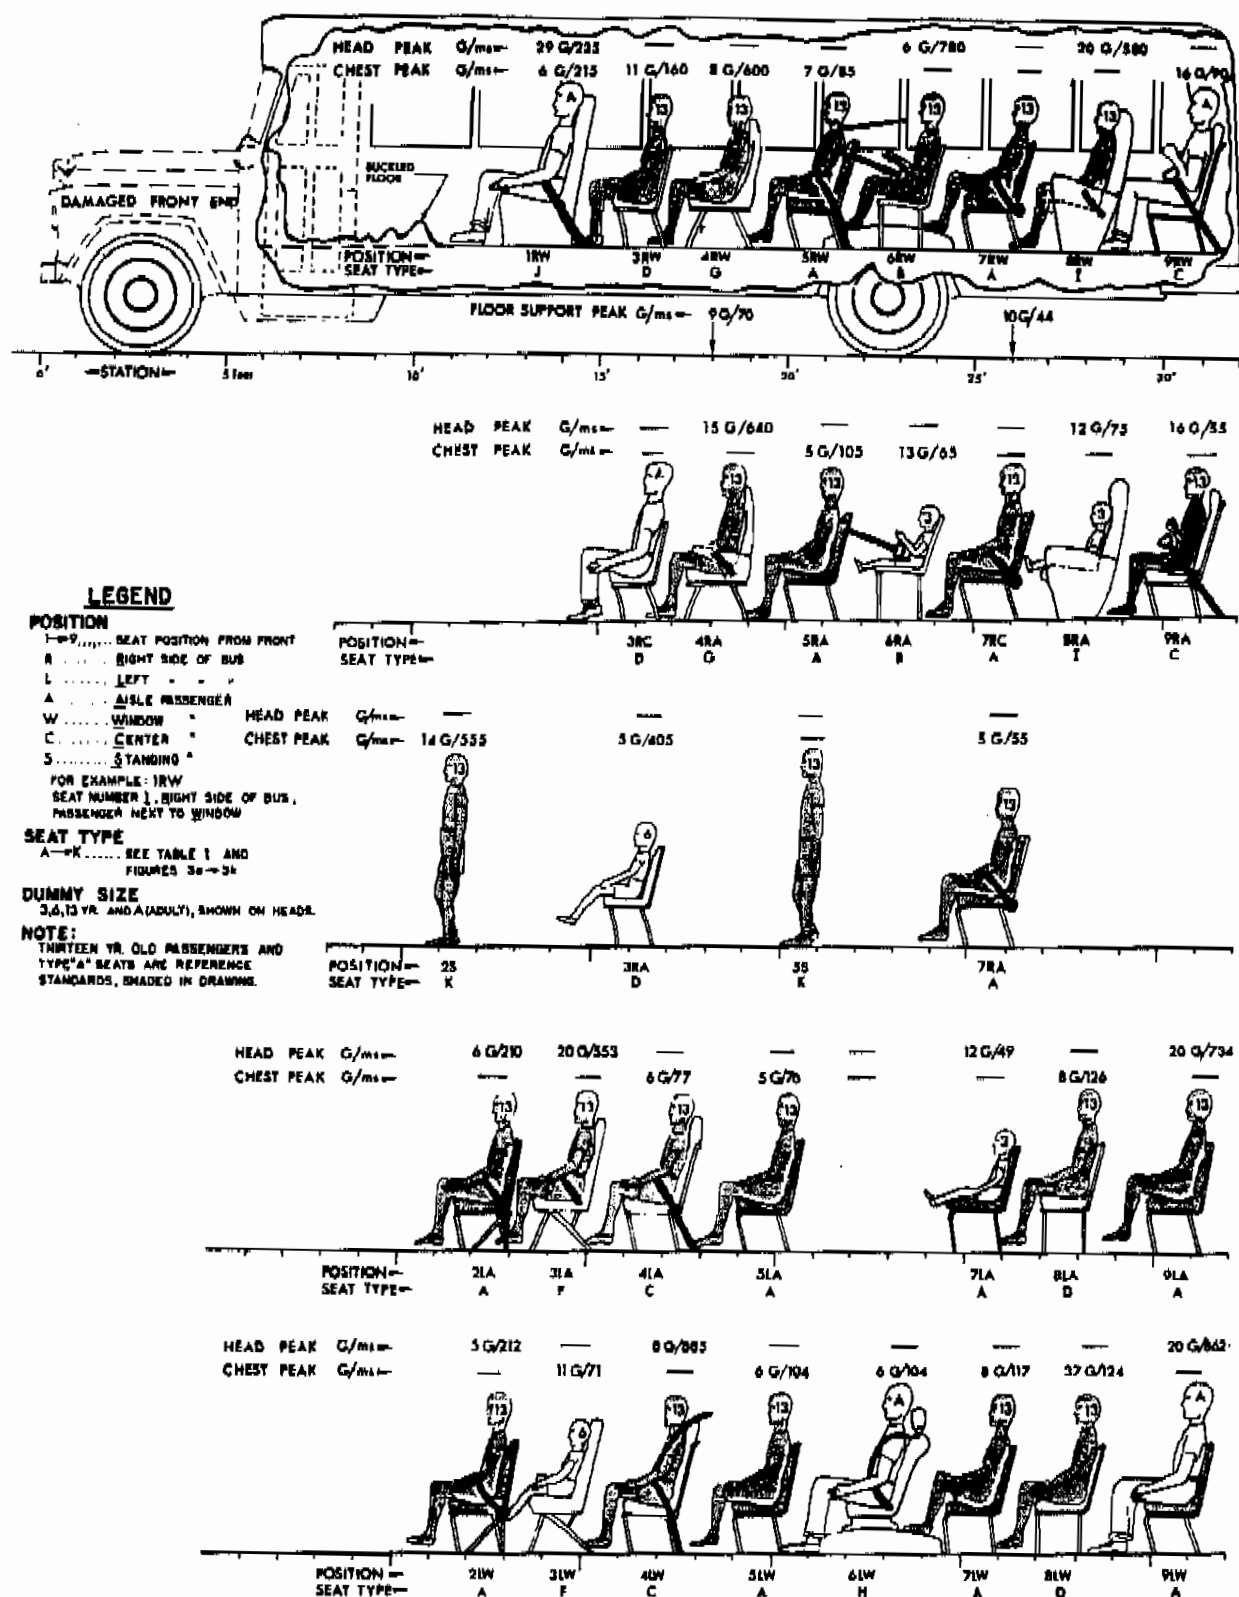
Fig. 45(a) - Passenger assignment, 1965 GMC-Superior bus, showing also seat types, restraint systems, and peak accelerometer values

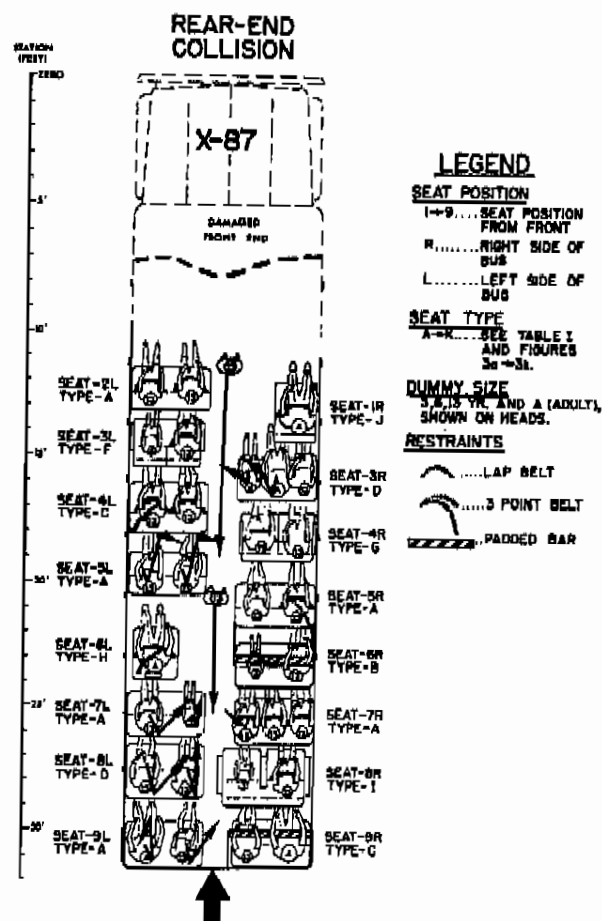
Fig. 45(b) - Forced movements of passengers during rear-end collision, and their positions of rest

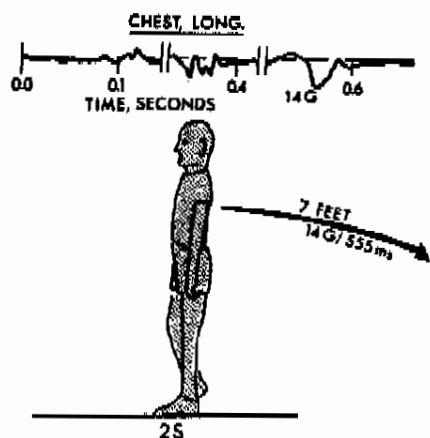
Fig. 47(b) - Standee is thrown 7 ft to rear before landing on aisle floor

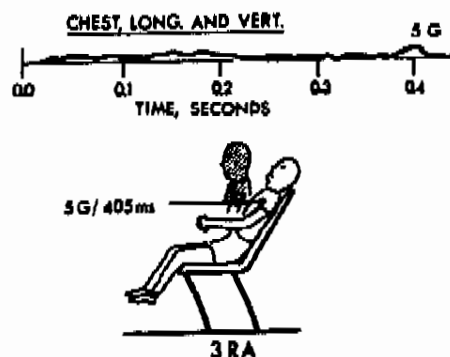
Fig. 48(b) - This 6-year-old's head was pitched against horizontal bar of his seatback

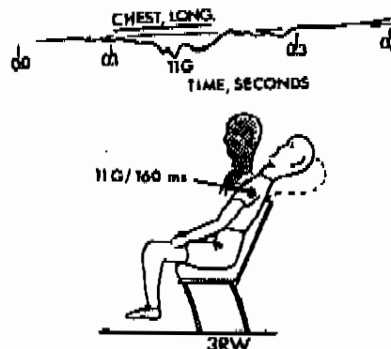
to severe because of this low seatback condition. During the rear-end collision, the 13-year-old sustained an 11 G chest acceleration at 160 ms (Fig. 48(c)). He received a severe whiplash and then rebounded to a semi-reclined position on the front edge of the seat.

Fig. 48(c) - Low seatback allowed head to flail rearward

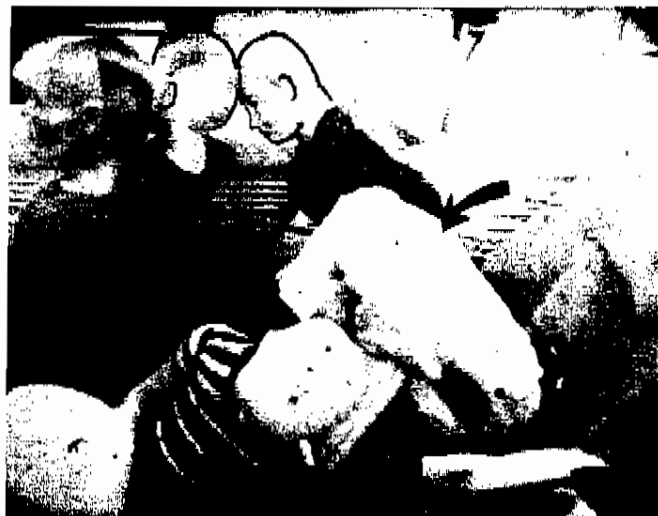
3R, sustaining a severe inferred injury (center, Fig. 49 (a)). This 13-year-old, 4RA, sustained a 15 G head deceleration at 640 ms (Fig. 49(c)).

Fig. 49(a) - After riding out collision acceleration satisfactorily, this 13-year-old (foreground) rebounded against a dangerous low back seat sustaining a serious head-snap action

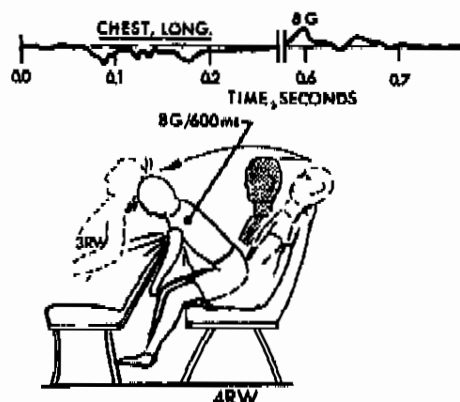
Fig. 49(c) - This high back American seat provided excellent head support during rear-end collision

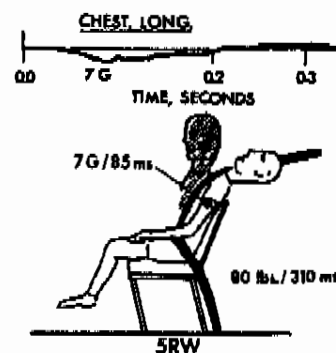
Fig. 50(b) - Restrained 13-year-old in low back seat, whiplashed

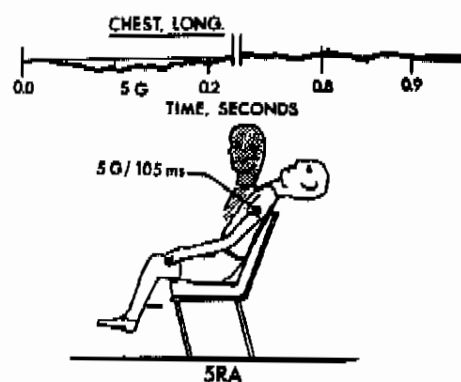
Fig. 50(c) - Unrestrained 13-year-old in low back seat, whiplashed

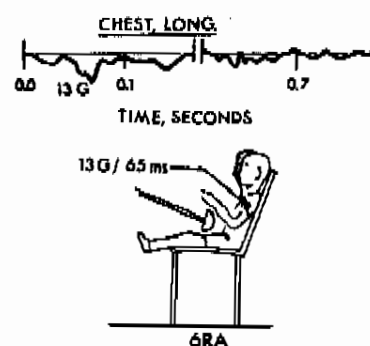
his head rearward, relative to his shoulders, as he sustained a 13 G chest acceleration at 65 ms (Fig. 51(b)). When the 13-year-old 6RW reached his maximum whiplash excursion his longitudinal axis accelerometer could not record this higher vertical acceleration. Upon rebound he was elevated 1 ft off the seat and returned downward, striking his head on the window post, sustaining a 6 G head deceleration at 780 ms (Fig. 51(c)). Both passengers came to rest in a normal seated posture. Because the hips were permitted to elevate, 6RW sustained whiplash injuries which were considered less severe than belted occupants in low-back seats. The 3-year-old, 6RA, passenger's inferred injuries were considered minor.

Fig. 51(b) - This low back seat did provide satisfactory head support for tiny 3-year-old, even though average size school child would be injured riding in this seat during a rear-ender

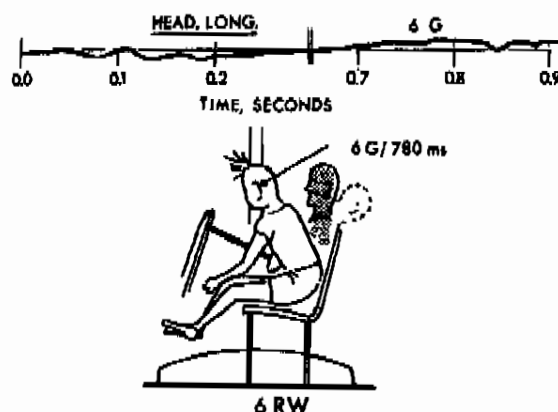
Fig. 51(c) - On rebound, 13-year-old strikes his head a glancing blow on window post

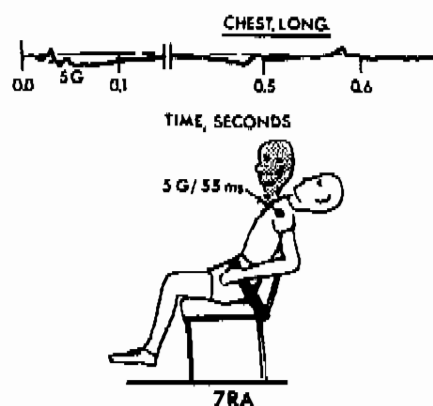
received a 5 G chest acceleration at 55 ms (Fig. 52(b)). The lap belt restraining 7RC allowed the hips to elevate vertically, permitting the shoulders and upper torso to press against the seat in a semi-prone position, accounting for a delay in the onset of the severe whiplash. On rebound this occupant loaded his lap belt to less than 50 lb (Fig. 52 (c)). Passengers 7RC and 7RW returned to a normal seated posture and 7RA slumped over into the aisle still restrained by his

Fig. 52(b) - This 13-year-old, third occupant on conventional Superior seat, did not receive effective support from his backrest

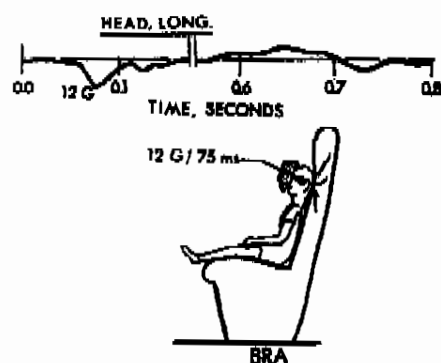
Fig. 53(d) - Three-year-old rode out this rear-end collision in an uneventful manner

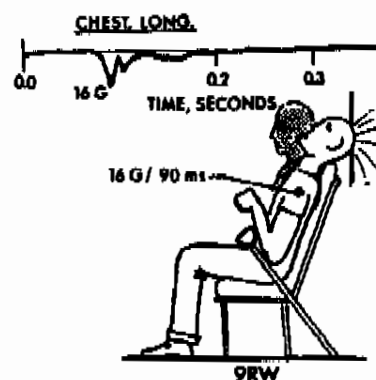
Fig. 54(a) - Whiplashed adult punched his head through rear window

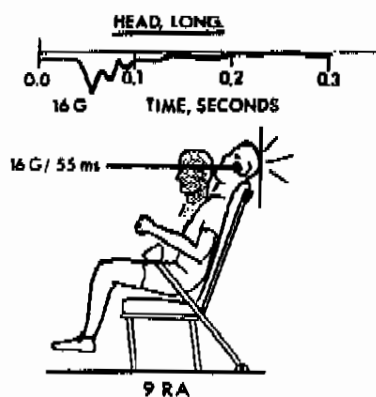
ing the collision, first fracturing then pushing out the entire right rear-end window. Owing to the gate-bar restraining action, his vertical hip movement was restricted, but he did elevate in his seat sufficiently to contact the top frame of the window. A minor whiplash was received when his head punched the window out. This 9RW adult sustained a 16 G chest acceleration at 90 ms (Fig. 54(a)), and came to rest in a normal seated posture. The 13-year-old in position 9RA had his head snapped rearward against the right rear doorpost, abruptly stopping the onset of whiplash action; he elevated slightly in his seat before coming to rest in a normal seated posture. He received a 16 G head blow at 55 ms (Fig. 54(b)). Only a subtle rebound action occurred for these 9R passengers.

Fig. 54(b) - Onset of whiplash action for 13-year-old abruptly stopped by head impact with doorpost behind his seat

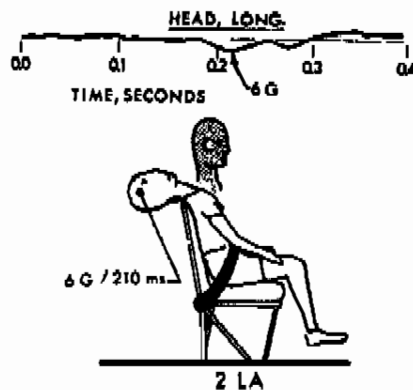
The passenger in 2LA sustained a 13 G chest acceleration at 66 ms and a 6 G head acceleration at 210 ms (Fig. 55(b)). The passenger in 2LW sustained a 5 G head acceleration at 210 ms (Fig. 55(c)). The rebound action pitched the upper torsos of these two 13-year-olds violently forward, as in a frontal type impact, but did not dislodge them from their seats owing to their lap belts. Their heads flailed

Fig. 55(b) - Whiplash of lap-belted 13-year-old

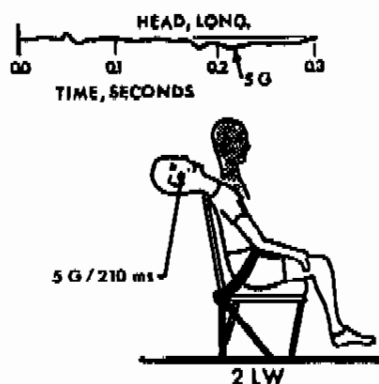
Fig. 55(c) - Replication: this 13-year-old sustained whiplash acceleration with his co-occupant having same restraint configuration

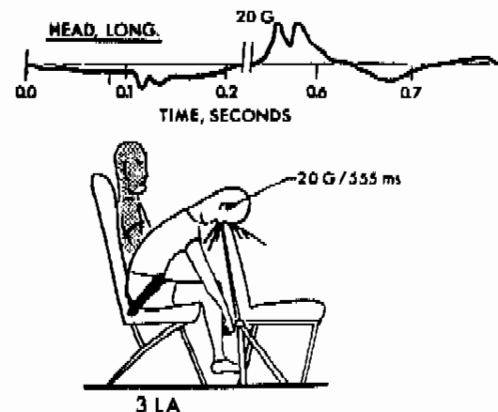
Fig. 56(a) - Protective qualities of high seatback 3L were compromised by rebound impact with low back seat ahead, causing injury-producing forces
