670040

School Bus Passenger Protection

Derwyn M. Severy, Harrison M. Brink, and Jack D. Baird

Institute of Transportation and Traffic Engineering,
University of California, Los Angeles

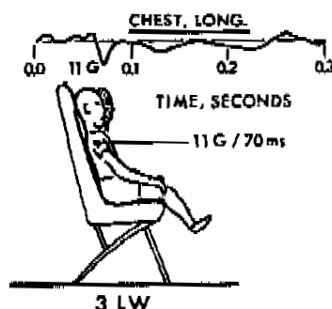
k. Seat 3L, a National seat with a high back (see Fig. 3 (f)), was occupied by a 13-year-old in position 3LA, restrained by a lap belt, and an unrestrained 6-year-old, (No. 2, Table 5), seated at the window position. The 13-year-old, after riding out the acceleration with good head support, flexed forward over his lap belt and forcibly struck his face against the top horizontal bar of low back seat 2L, sustaining a 20 G blow at 555 ms (Fig. 56(a)). This would definitely have been a severe injury-producing impact, possibly causing a broken jaw, loss of teeth or other facial injuries (Fig. 56(b)). The 6-year-old unrestrained passenger, in position 3LW, sustained an 11 G chest acceleration at 70 ms, without injury (Fig. 56(c)). On rebound he remained in a relatively normal seated posture (Fig. 56(b)).

Fig. 56(c) - Unrestrained 6-year-old rode out crash in an uneventful manner owing to his shorter torso height and well-padded, high back National seat

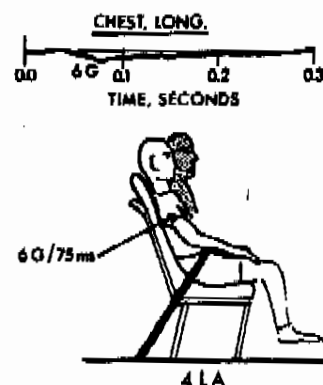
At the onset of collision forces both occupants loaded the backrest and consequently deformed it rearward. Thirteen-year-old 4LA received a 6 G chest acceleration at 75 ms (Fig. 57 (a)). However, the window seated 13-year-old did not record his peak head acceleration until he rebounded and cycled into his backrest for the second time. At this time he sustained 8 G head acceleration at 885 ms as his head struck his backrest and the shoulder of the rebounded

Fig. 57(a) - Head and torso inertia of this lap-belted 13-year-old contributed to deforming backrest rearward

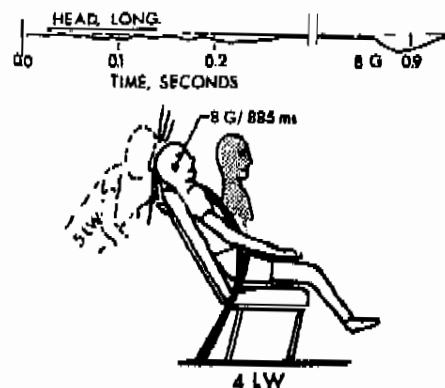
13-year-old to his rear (Fig. 57 (b)). The three-point restraint for 4LW carried tensiometers, but, owing to the deflecting seatback, belt loads were too low to be significant (less than 50 lb).

Fig. 57(b) - Thirteen-year-old with cross-chest lap-belt combination rode out rear-end collision without sustaining inferred injuries

Although this high back Superior seat did appear adequate for 13-year-old passengers during a rear-end collision, the seatback height (26 in.) allowed slight contact with the back of their necks; high school students need higher seatback heights (28 in. or higher) for adequate protection.

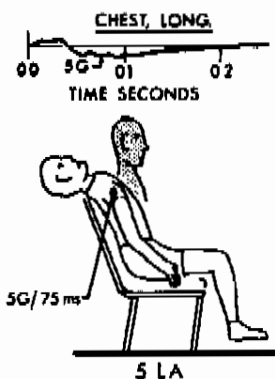
Fig. 58(b) - Whiplashed 13-year-old unrestrained in conventional Superior seat

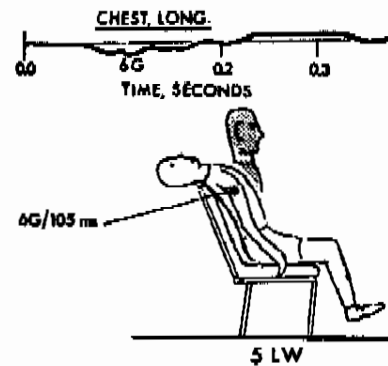
Fig. 58(c) - Unrestrained 13-year-old received whiplash identical to his co-occupant

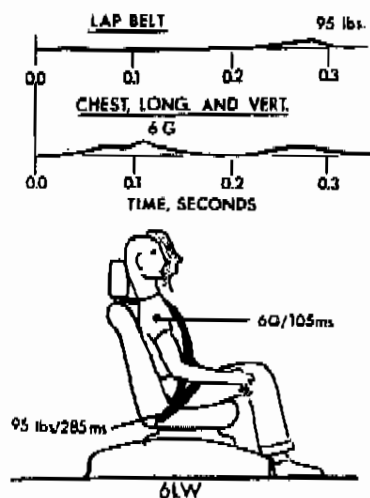
o. Seat 6L, a Cox seat (see Fig. 3 (h)), was occupied by an adult dummy (No. 6, Table 5), restrained with a three-point cross-chest lap belt combination. The built-in head support and belt anchorages appeared quite adequate; the normal seated posture of this passenger was correctly maintained throughout the rear-end collision (left side, Fig. 58(a)). At the onset of collision, adult 6LW started to forcibly press rearward against his seatback and later sustained a 6 G chest acceleration at 105 ms (Fig. 59). Thereafter, on rebound, he loaded his lap belt to 95 lb at 285 ms. There was minimal rebound action for this adult passenger and the Cox seat performance was excellent for this rear-end collision exposure.

Fig. 59 - Adult in Cox seat undergoing rear-end collision acceleration, rode out collision in an uneventful manner owing to excellent performance of seat and restraints

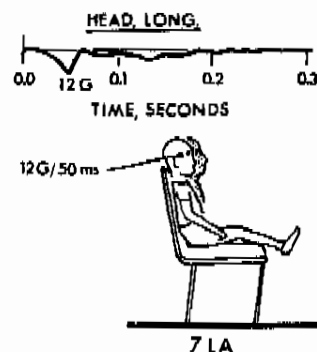
forced against his backrest receiving an 8 G chest acceleration at 115 ms (Fig. 60(a)). His head flailed rearward to an extreme whiplash position (Fig. 60 (b)). The unrestrained 3-year-old appeared to receive satisfactory support from the seatback owing to his shorter torso height. Because his head was supported by the backrest, he sustained a head acceleration of 12 G at 50 ms, considerably earlier than other whiplashing passengers (Fig. 60 (c)).

Fig. 60(c) - Because of shorter torso, 3-year-old received adequate support from conventional Superior backrest

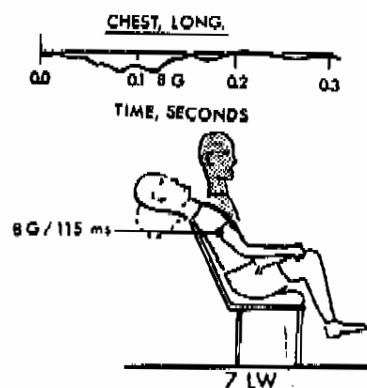
Fig. 60(a) - Thirteen-year-old receives an 8 G peak chest acceleration and a severe whiplash

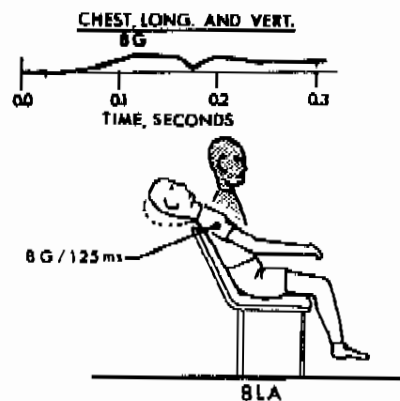
q. Seat 8L, an ABC Unified School District seat (see Fig. 3 (d)), was occupied by two 13-year-olds, both unrestrained. During the impact the 13-year-old passenger in position 8LA sustained an 8 G chest acceleration at 125 ms (Fig. 61(a)). At this same time his companion, 8LW, received a peak chest acceleration of 37 G (Fig. 61 (b)). This large acceleration variation between like occupants in seat 8L was at-

Fig. 61(a) - Unrestrained 13-year-old sustained a severe whiplash

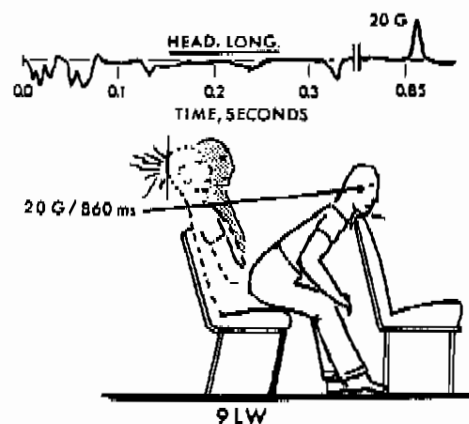
r. Seat 9L, a conventional Superior seat, was occupied by a 13-year-old in position 9LA, and by an adult (No. 1, Table 5), in position 9LW, both unrestrained. During impact, the 9LW adult's head whiplashed against the rear window directly behind him but did not fracture the tempered glass window. The 9LW adult was then thrown vertically, still maintaining his seated posture, impacting the top of the window frame with his head, receiving only minor injuries. Thereafter he came to rest in a normal seated position.

Fig. 62(a) - Adult strikes rear window before his head impacts with seatback ahead

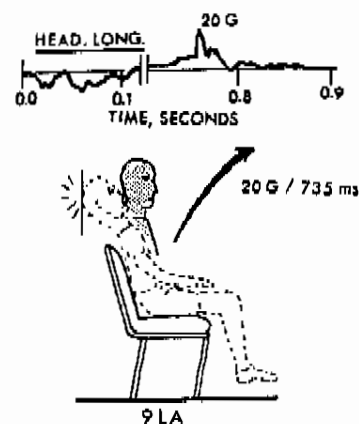
Fig. 62(b) - Thirteen-year-old impacts rear window, accelerates violently upward, then slumps forward striking his head

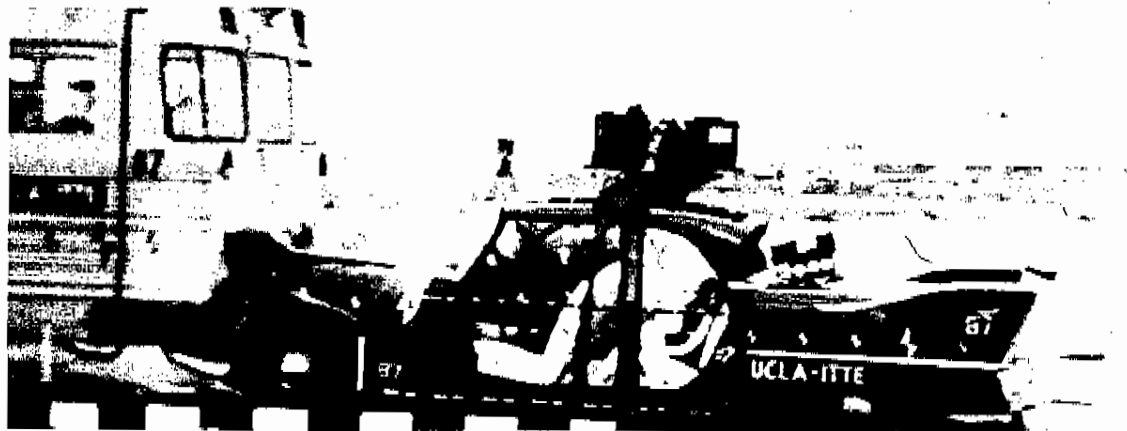
The Plymouth front frame structure and front bumper showed no contact with the rear bumper of the bus because the bumpers were of different heights (Fig. 64 (a)). The Plymouth front bumper retained its original shape; there was no damage to the bumper supports attached to the frame or the frame itself. When the Plymouth reached its maximum

Fig. 64(a) - 1960 Plymouth at start of underriding

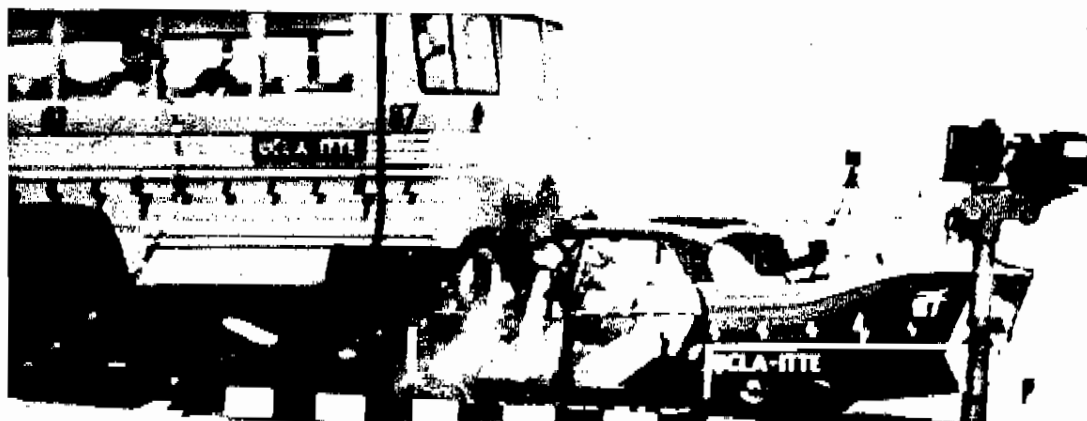
underriding position, the car's instrument panel had advanced to the crash center, the point the bus's rear bumper had been over before the bus began to accelerate from collision forces (Fig. 64 (b)). This underriding condition was further facilitated by the 8-in. forward slippage of the 1965 Superior bus frame, relative to the bus body (Fig. 64 (c)). The underriding action of the striking passenger vehicle forced the car against the pavement; this accounted for the

Fig. 64(b) - Maximum penetration of two colliding vehicles

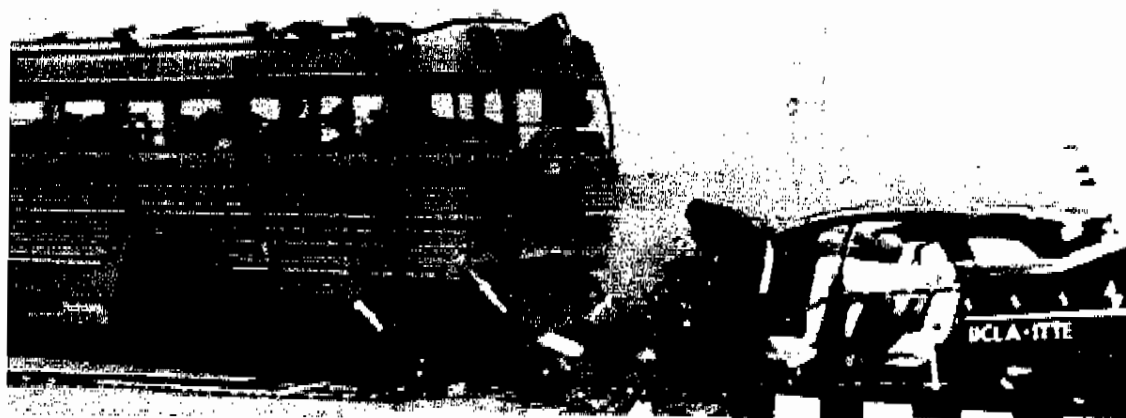
lack of follow-through movement for the striking vehicle commonly associated with rear-end collisions (Fig. 64 (d)). No braking was applied to the bus; however, the bus's forward movement following impact was resisted by a collision-distorted front end and eccentric front wheels. The position of rest for the bus following collision roll-out was 143 ft forward and 8 ft to the left of the point of impact, and the position of rest for the 1960 Plymouth was 16 ft forward and 1-1/2 ft to the right of the point of impact.

The school bus rear bumper was damaged most at its center with a 22 in. permanent indentation caused by the underriding Plymouth engine. A pattern from the right dual headlights of the Plymouth was embossed on the rear of the bus body sheet metal, 20 in. to the left of the right side. The bus frame was displaced 8 in. forward, relative to the chassis. The rear door of the bus was dented; dents and paint transfers were observed 10 in. above the base of the door, or 43 in. above the pavement. The bus was accelerated by this rear-end collision reaching a peak of 10 G at 45 ms.

Fig. 64(c) - The 4,400-lb striking car's position of rest, 16 ft from contact; 17,500-lb school bus rolled to a stop 143 ft after impact

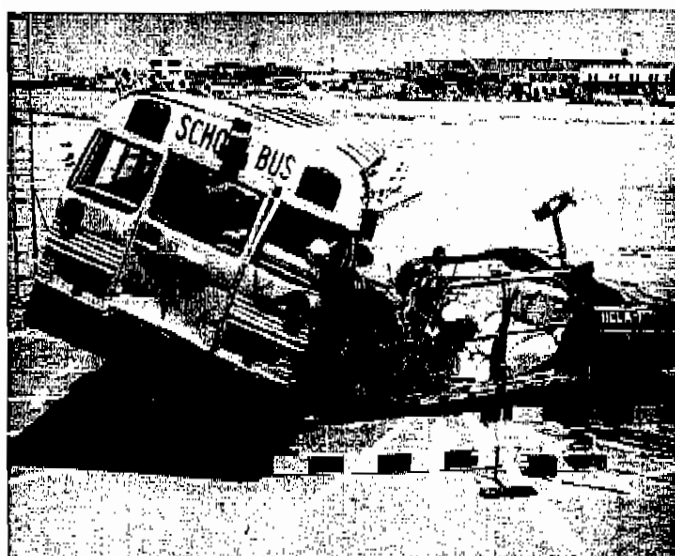
Fig. 65(a), (b) - Sixty mph into the side of a 60-passenger school bus nearly topples it

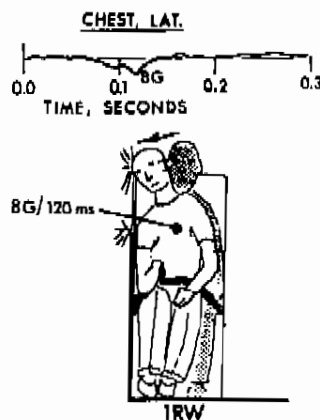
a. Seat 1R, a Martin air seat (see Fig. 3 (j)), was occupied by an adult (No. 3, Table 5), restrained by a lap belt that was anchored to the floor. At the onset of impact the adult was thrown to his right against the side of the bus, sustaining an 8 G chest blow at 120 ms (Fig. 68). His head grazed the window with a flailing motion and the elastic rebound forced him toward the aisle. After coming to rest, he was still restrained at the hips by the lap belt but leaning into the aisle over the left edge of his seat.

Fig. 68 - Adult in air seat impacted right side of bus and struck window as a result of flailing head motion

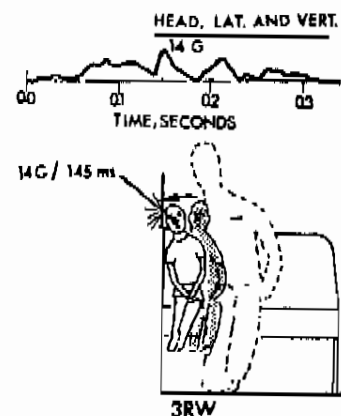
6-year-old in position 3RW struck the window with his head. His biaxial head accelerometers recorded 14 G at 145 ms (Fig. 71(a)). At 120 ms later, he was forcibly struck by the adult in 3RA shifting laterally. Owing to this pinning action against the side by the adult, the 6-year-old remained substantially in his normal seated position. He then rebounded to a prone position in his seat. His injuries were considered moderate for this head contact and impact by adult 3RA. At the time of impact with the 6-year-old, the adult received a head blow of 31 G at 260 ms (Fig. 71(b)). He did not, however, receive his peak chest acceleration at this time since he was cushioned by the 6-year-old. His peak chest deceleration of 4 G occurred at 685 ms, when he rebounded back to his seat with a rotational motion about the hips and struck his head against the seat across the aisle. He remained in this reclined position across the aisle with his buttocks in his original seat position. His injuries were judged moderate to severe from the head blow with the window.

Fig. 71(a) - Six-year-old impacts window with his head and is subsequently crushed by adult No. 5, thrown against him

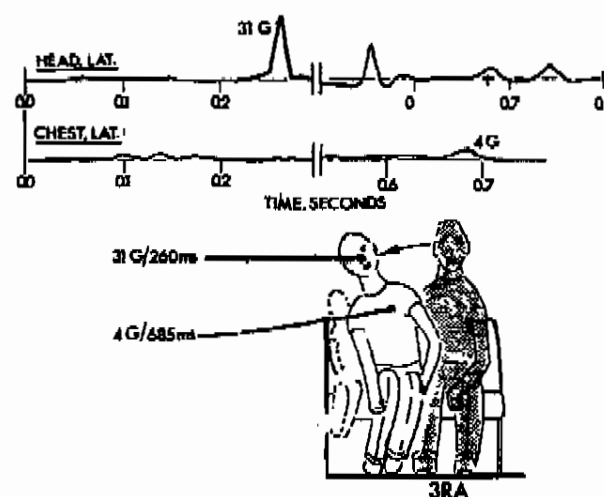
Fig. 71(b) - Adult 3RA forcibly strikes his smaller companion who cushions adult's initial impact

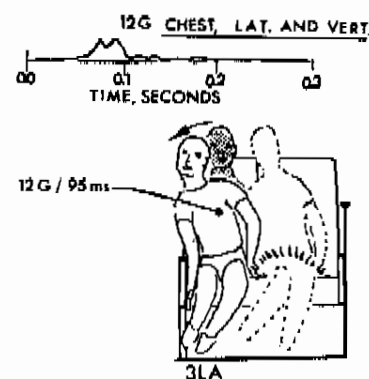
Fig. 72(b) - Partially restrained by armrest, 3LA remains in his seat for this forward seat position

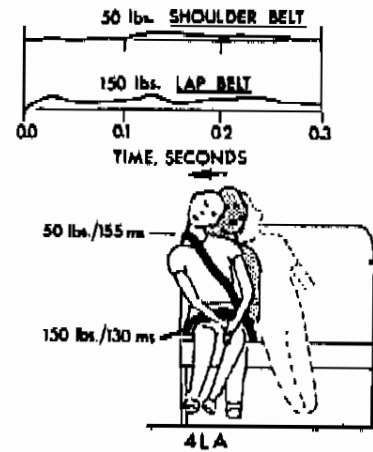
g. Seat 4L, a high back Superior seat (see Fig. 3 (c)), carried two 13-year-old passengers; 4LA had a type-3 restraint and 4LW was unrestrained. The diagonal strap passed over the right shoulder of 4LA and was anchored to the seatback. The 13-year-old in position 4LA did not have accelerometers but had tensiometers on his three-point belt combination. At 130 msec he loaded the lap belt to 150 lb, and the diagonal strap to 50 lb at 155 ms (Fig. 74(a)). The load on his diagonal cross-chest strap was augmented by his unrestrained companion, 4LW (Fig. 74 (b)). He received abusive lacerative forces to his throat as the belt passed

Fig. 74(a) - Diagonal belt loads augmented by impact of unrestrained companion

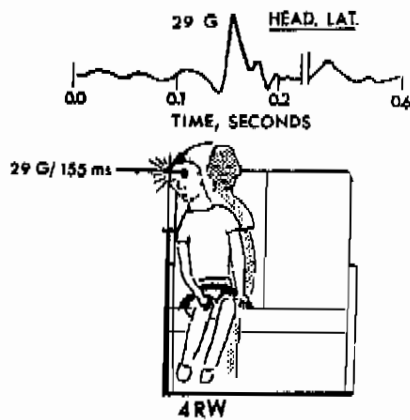
Fig. 73(b) - Before impacting window, this 13-year-old rotates his head 60 deg to his right, owing to his shoulder contacting bus side initially

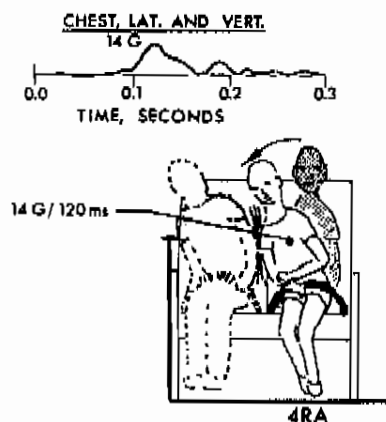
When 4RA struck his companion, he received a chest acceleration of 14 G at 120 ms (Fig. 73(c)). He glanced slightly to the front ahead of 4RW and on rebound struck his head on the seatback of seat 3R. He continued this circular motion about his hips to an almost original seated posture. His injuries were minor as the head blow on the seatback ahead was only a glancing blow; his belt kept him from contacting the seat across the aisle on rebound. Additionally, the rebound action of the 13-year-old's was less violent because of the reduced magnitude of bus acceleration as the bus commenced its skidout to a position of rest.

Fig. 73(c) - Restrained by a lap belt, this 13-year-old forcibly struck his companion

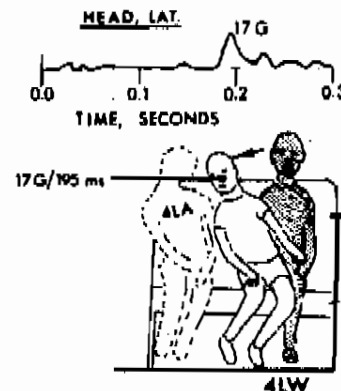
Fig. 74(c) - Unrestrained 13-year-old, cushioned by restrained passenger, struck head-to-head

The unrestrained passenger in position 4LW was thrown laterally and contacted 4LA head-to-head with a 17 G head blow at 195 ms (Fig. 74(c)). The resistance of his belted companion caused 4LW to rotate with his left side coming forward to a position of rest across the lap of 4LA. Then he rebounded to floor with his head and shoulders remaining on his original seat position. His injuries were minor since his companion's restraint stopped lateral movements for both passengers.

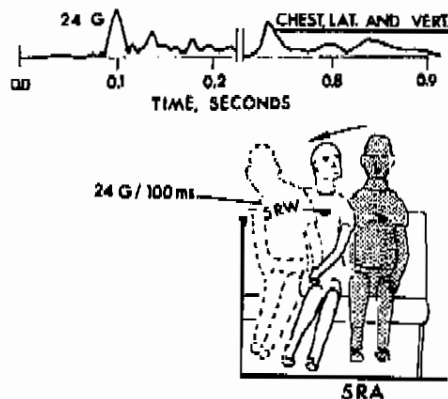
Fig. 75 (b) - Aisle-seated 13-year-old hurled violently to his right, glancing off to back side of window-seated passenger

The aisle-seated occupant, 5RA, was hurled violently to his right and glanced off the left shoulder of 5RW passing in front of him. Thirteen-year-old 5RA received a 24 G chest acceleration when he struck his companion at 100 ms (Fig. 75 (b)). He continued his projectile-like movements to the right side of the bus then rebounded toward the aisle. Thereafter, he slumped rearward into the aisle with his buttocks on the inboard edge of his seat cushion. His injuries were diagnosed moderate because he received considerable cushioning from the window-seated passenger.

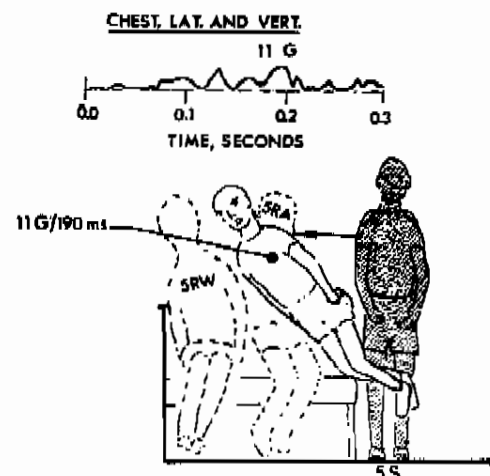
i. Standee 5S, a 13-year-old standing in the aisle between seats 5L and 5R, was thrown violently to his right and remained almost standing as he went in between seats 5R and 6R. He received an 11 G chest blow as he impacted the 13-year-old, 5RW, at 190 ms (Fig. 76). His rebound was almost as violent because he landed over the armrest of seat 5L in a jackknifed posture. His injuries were unexpectedly minor, considering his rapid movements. However, his actions were exceptional in that he cushioned his impact using another passenger initially and subsequently did not contact any seat frames on rebound.

Fig. 76 - Thirteen-year-old standing in aisle pitched violently to his right in an almost upright posture

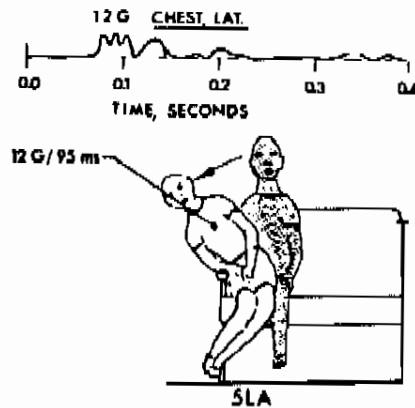
j. Seat 5L, a conventional Superior seat with an armrest restraint (see Fig. 5 (h)), was occupied by two 13-year-olds, both unrestrained. On impact 5LA was partially restrained by his armrest and received a 12 G chest acceleration at 95 ms (Fig. 77(a)). He then rotated about his left hip, upward and around the armrest as 5LW attained an almost standing position behind him (Fig. 77 (b)). Occupant 5LA continued to his right and struck seat 5R across the aisle. He collapsed face down in the aisle and did not experience the rebound action of the bus. He received minor inferred injuries for his limited movements.

Fig. 77(a) - Aisle-seated 13-year-old was partially restrained by armrest

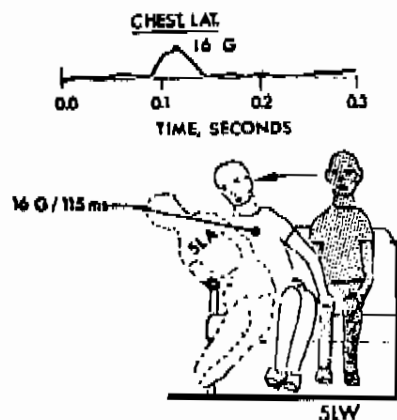
When 5LW shifted to his right he impacted 5LA who was momentarily stopped by the armrest. At 115 ms, 5LW received a chest acceleration of 16 G (Fig. 77 (c)). Then at

Fig. 77(c) - Thirteen-year-old 5LW thrown against companion, who was stopped by armrest

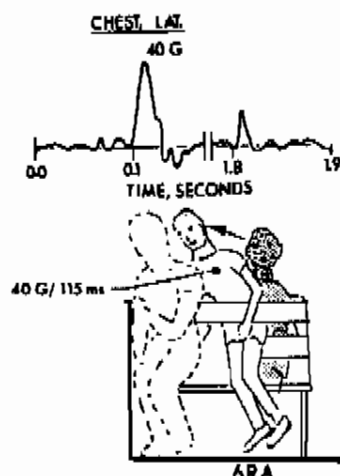
Fig. 78(b) shows the maximum elevation of this swing-bar restraint that allowed 6RA to strike his adult companion violently. Thirteen-year-old 6RA received a 40 G chest acceleration at 115 ms (Fig. 78(c)). During the bus skid-out phase to the side, the acceleration reversed its direction causing the 13-year-old to be rebounded toward the aisle. He also sustained a vertical component of acceleration (Fig. 78(d)). This lifting of the hinged swing-bar restraint allowed the 13-year-old 6RA to slide out from under this device. He rebounded across the bus, struck adult 6LW and landed on the floor in front of seat 6L. His injuries were considered severe from his initial impact with adult 6RW and his rebound across the bus.

Fig. 78(c) - Thirteen-year-old is thrown to right underswing-bar restraint, striking adult

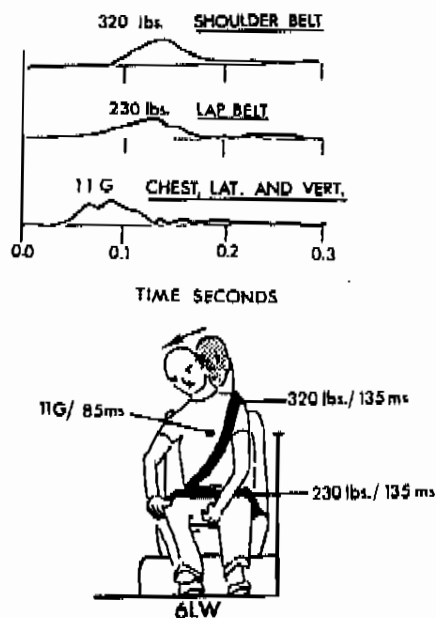
shift to the right. The retention of the cross-chest belt against the forces tending to move the passenger out from under the diagonal loop passing over his left shoulder, was attributed to the fact that the belt wraps around the shoulder to its anchor point for this adult size, instead of up to some higher point of attachment, which would allow the individual to slip out from under it more readily. Due to the seat design and the adult dummy's weight, he was pocketed approximately 2 in. into the cushion and this provided lateral restraint sufficient to develop his peak chest acceleration before his three-point belt system was completely loaded (Fig. 79(a)). His two chest accelerometers recorded 11 G at 85 ms before the lap-belt tensiometer loads increased to 230 lb at 135 ms and the diagonal-strap load, 320 lb at 135 ms (Fig. 79(b)). Even though adequately restrained, the adult was struck forcibly by 13-year-old 7LW who rebounded

Fig. 79(b) - Adult pocketed in his seat back cushion developed peak acceleration 50 msec before three-point belt loads became maximum

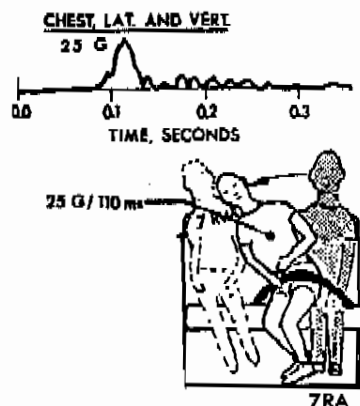
Fig. 80(a) - Although restrained by a lap belt, head and torso of 7RA is thrown against companion

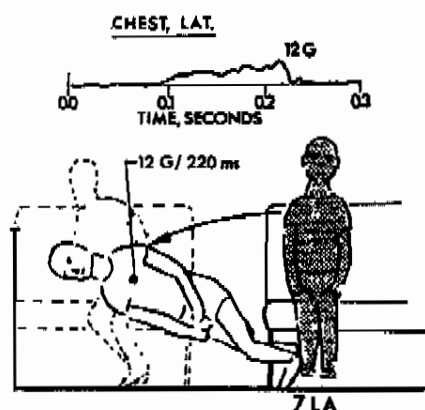
taining a 12 G chest accelerometer load at 220 ms (Fig. 81 (a)). When the bus completed its skidding spin-out, it rocked back onto the pavement and caused a shift of all passengers on the right side, throwing them violently to their left. Thirteen-year-old 7LA rebounded to his original seated position, facing slightly to his left. From there he fell forward to the floor between seats 7L and 6L. His injuries were judged minor based on his limited movement and low accelerometer values.

Fig. 81(a) - Thirteen-year-old 7LA impacts seat across aisle and then rotates about its cushion

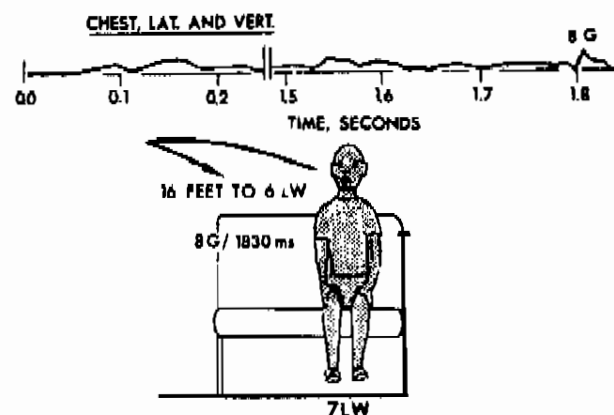
When 13-year-old 7LW impacted and rolled over the top of 7LA he sustained 6 G at 160 ms; this was not his peak acceleration as will be explained. After 7LW rotated over 7LA he was vertically accelerated toward the roof, with his buttocks striking the roof. While the bus was spinning to the left he fell on seat 6R and struck his tibia on the swing-bar restraint in a manner that would probably have resulted in a broken leg (Fig. 81 (b)). On rebound he was violently thrown to the far side of the bus where he struck adult 6LW and recorded an 8 G peak chest deceleration at 1830 ms (Fig. 81 (c)). His injuries were judged severe owing to the

Fig. 81(c) - Thirteen-year-old 7LW received peak chest deceleration on rebound to left side of bus

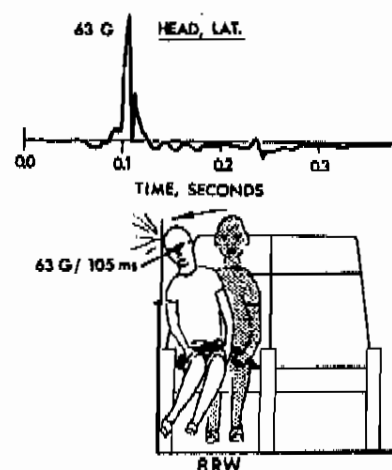
Fig. 82(a) - Restrained 13-year-old receives high head loading from tempered glass side window

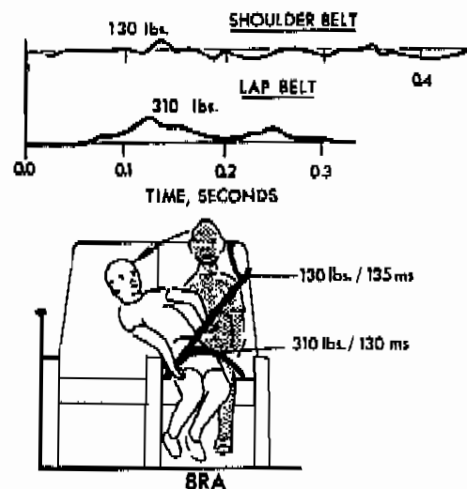
Thirteen-year-old 8RA did not have head or chest accelerometers but did have tensiometers on his diagonal chest-lap belt combination. During impact, he loaded the diagonal strap to 130 lb at 135 ms and the lap belt to 310 lb at 130 ms (Fig. 82(b)). Thereafter, he slid out from under the diagonal chest strap and was flailed laterally to the right against the window-seated 13-year-old passenger. As with his companion, he was also rebounded to a normal seated posture. His injuries were considered minor owing to the

Fig. 82(b) - Thirteen-year-old partially loaded diagonal strap before he slipped from under it and then struck companion

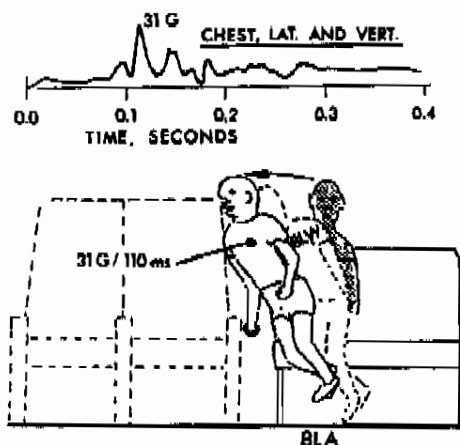
Fig. 83(a) - Thirteen-year-old pitched violently across aisle against seat and passengers

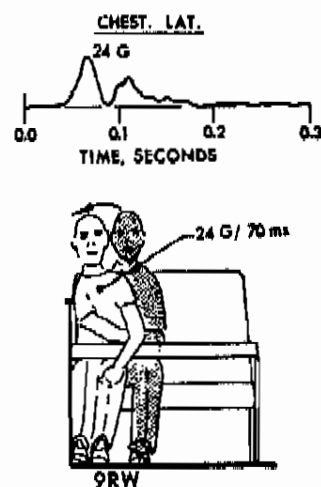
Fig. 84(a) - Adult slides sideways under gate-bar and impacts side of bus

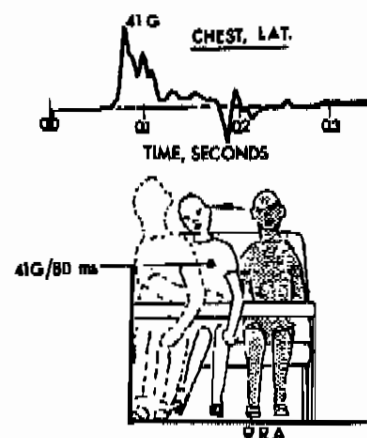
Thirteen-year-old 9RA also slid to his right under the gate-bar restraint and impacted the back of adult 9RW. He received a 41 G chest acceleration at 80 ms (Fig. 84(b)). Thirteen-year-old 9RA thereafter rebounded to his left, but remained in his seat. He came to rest slumped over in the aisle. His injuries were considered moderate to severe owing to the high chest accelerations derived on impacting the adult.

Fig. 84(b) - Thirteen-year-old slides sideways under gate-bar and forcibly impacts his adult companion

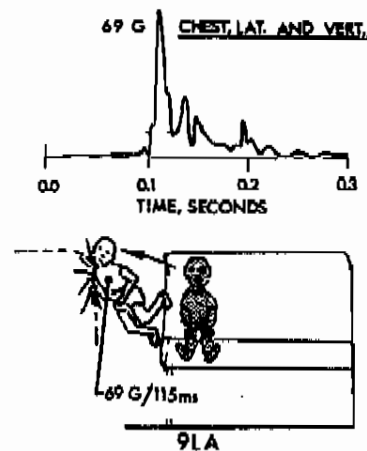
r. Seat 9L, a conventional Superior seat, had a 3-year-old, 9LA, and a 13-year-old, 9LW, both unrestrained. They were shifted violently from their seat to the right and then received a vertical acceleration as the bus continued its skidding spin-out on the pavement. Three-year-old 9LA struck the 9R seatback across the aisle and sustained a 69 G chest blow at 115 ms (Fig. 85(a)). He then fell to the aisle floor between seats 9L and 9R and was struck from above

Fig. 85(a) - Three-year-old impacts seatback across aisle

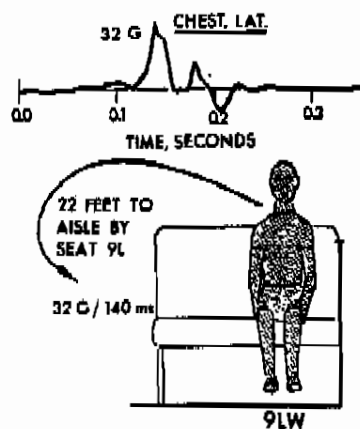
he impacted the seat and occupants across the aisle in seat 9R. He sustained a 32 G chest acceleration at 140 ms (Fig. 85 (b)). He then assumed an almost lying down position across the seat when he received a vertical acceleration toward the roof. Thereafter, he became airborne and was partially ejected through the roof port, head first. Later he rotated and came vertically downward, head first, striking 13-year-old 8LA who was arched over the back of seat 8L. He then slid from the seatback of 8R and landed on top of his companion, 3-year-old 9LA, on the floor, some 2 sec after initial impact. His injuries were considered severe owing to his airborne impacts and his impact with seatback of 8R. However, his initial impact with this seatback was cushioned somewhat by occupant 8LA.

Fig. 85(b) - Window-seated 13-year-old struck passengers across aisle

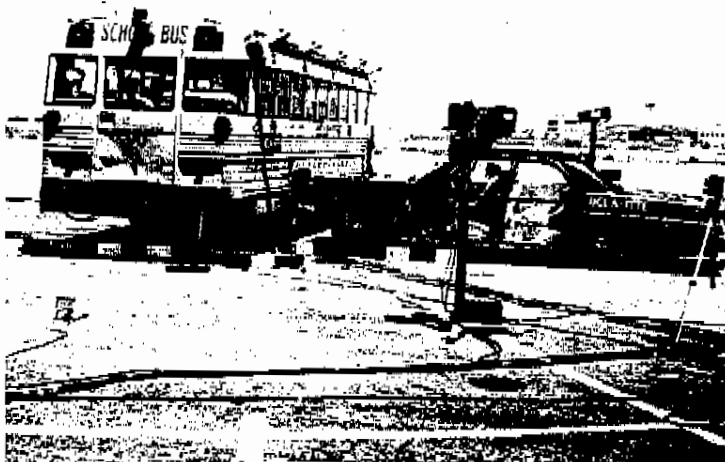
3. Collision Performance - A 1965 GMC-Superior bus having a gross weight of 17,500 lb was positioned at the impact center with its right side perpendicular to the striking car and its rear dual wheels centered on the path of the striking car (Fig. 86 (a)). A 1966 Chevrolet Bel Air 4-door sedan with a gross weight of 4500 lb, traveling 60 mph struck the right side of the stationary bus, 23 ft behind the front bumper, in a manner corresponding to an intersection-type collision

Fig. 86(a) - Traveling 60 mph, a 1966 Chevrolet contacts right-rear dual wheels of 1965 GMC-Superior bus

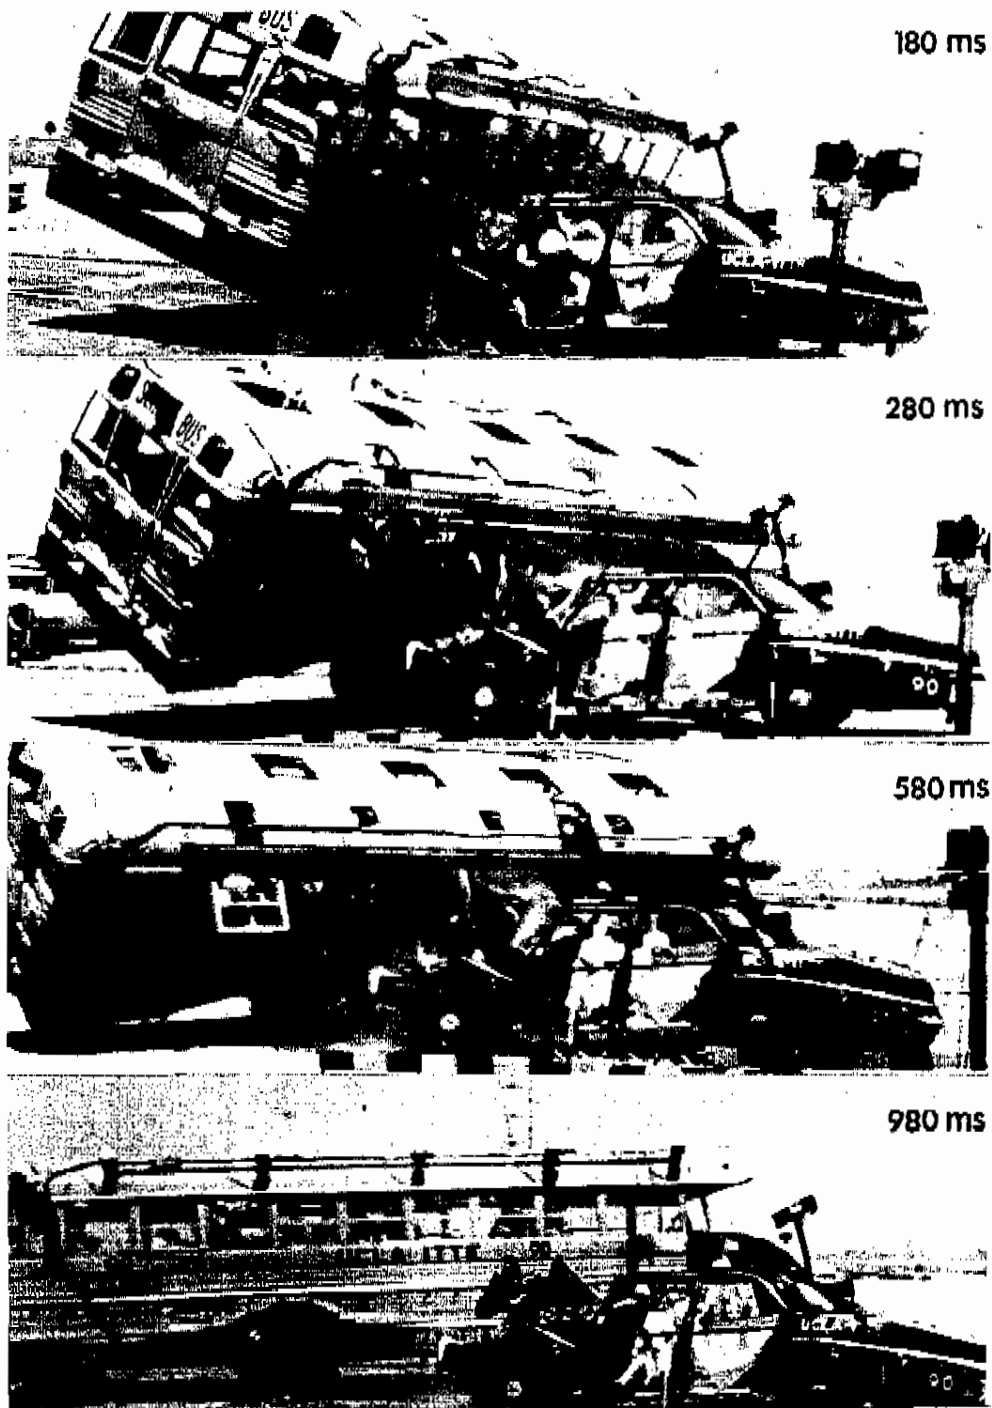
(Fig. 86 (b)). The lower edge of the bus sidesill was 18 in. above the pavement and the leading edge of the front bumper on the striking car was 22 in. above the pavement. The bus rear dual wheels were inset 4 in. relative to its apron side rail.

Fig. 86(b) - Vehicle dynamics
of intersection collision

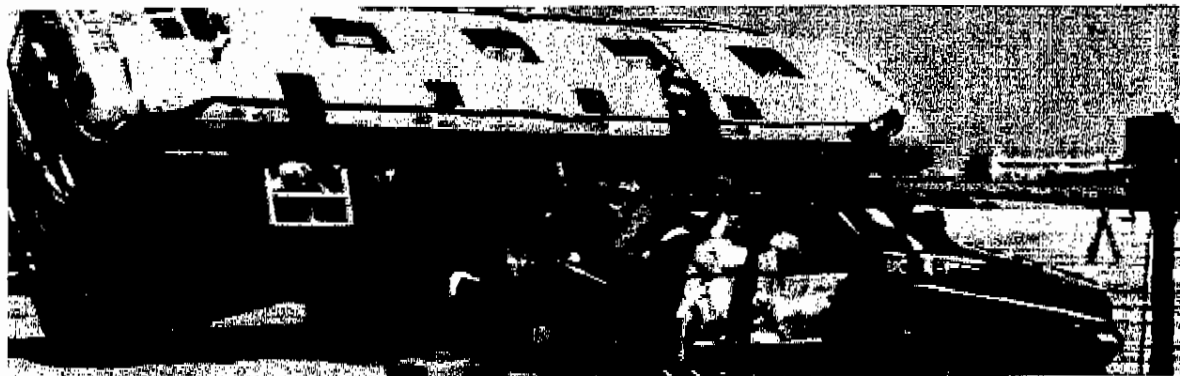
During the rotation and broadside skidding of its rear, the bus violently rolled about its long axis onto its right side to an inclination of 30 deg with the left side attaining a vertical height of 5-1/2 ft off the pavement (Fig. 86 (c)). The drag coefficient of its tires with the pavement arrested its near upset and thereafter rocking back onto its wheels. The bus then rear-end skidded leftward from its original position in a clockwise direction approximately 50 deg. It reached a position of rest with its right rear dual wheels displaced

Fig. 85(c) - Near upset follows side impact
