## **Seven Hills Engineering, LLC.**

RE: Docket No. NHTSA-2023-0012 Side Underride Guards

Docket No. NHTSA–2023–0012 Side Underride Guards

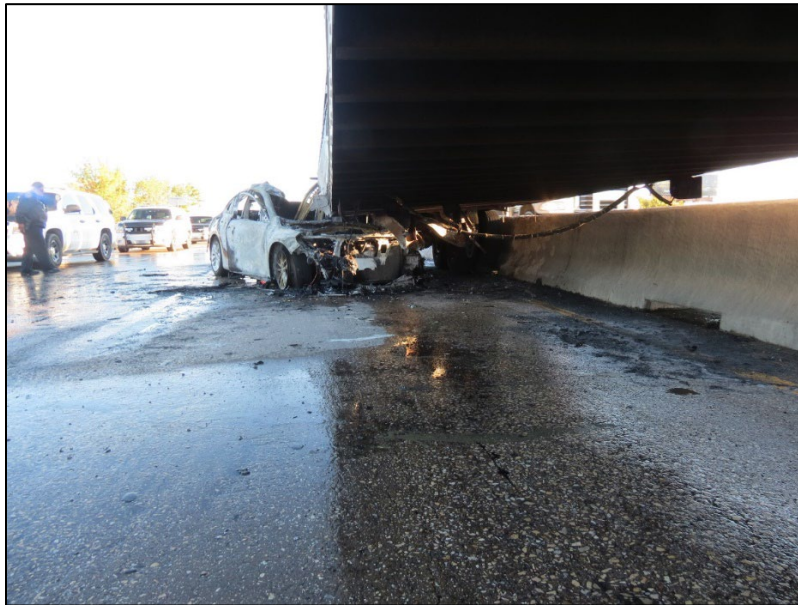
**Police photograph from Texas Crash ID 2018524661  
(See Attachment A)**

1. **Injury Target Population:** The logic applied by NHTSA to extract the injury target population from the data is overly restrictive for at least a couple reasons. First, the included Police Crash Reports (PCRs) are limited to two-vehicle crashes. Second, inclusion in the target population requires frontal or top damage coding of the Light Passenger Vehicle (LPV) in the PCR. Attachment A includes two side underride crashes occurring in 2018 which I investigated that each capture both issues. Texas crash report, Crash ID 2018524661 reflects a three-vehicle fatal side underride crash involving two LPV's and one Combination Truck (CT). The initial collision between the two LPVs precipitated a loss of control by one of the LPVs which then moved left laterally and underneath the trailer's right side. The LPVs left side was then simultaneously crushed, trapped and dragged by the trailer wheels to final rest, subsequently catching fire and burning. In the crash report the damage to underriding LPV was coded as "LD-5" and "VB-7." According to the Texas Peace Officer's Crash Report Code Sheet "LD" is code for left door and "5" represents the severity scale (out of 7); and "VB" is the code for vehicle burned and "7" for severity. This side underride would be excluded from the target population because it's a 3-vehicle crash *and* the LPV damage is not coded as frontal or top. A photo below from the crash depicts the underride.
