# Hydro Concept RIG

**SAPA RIG 2017 Testing**

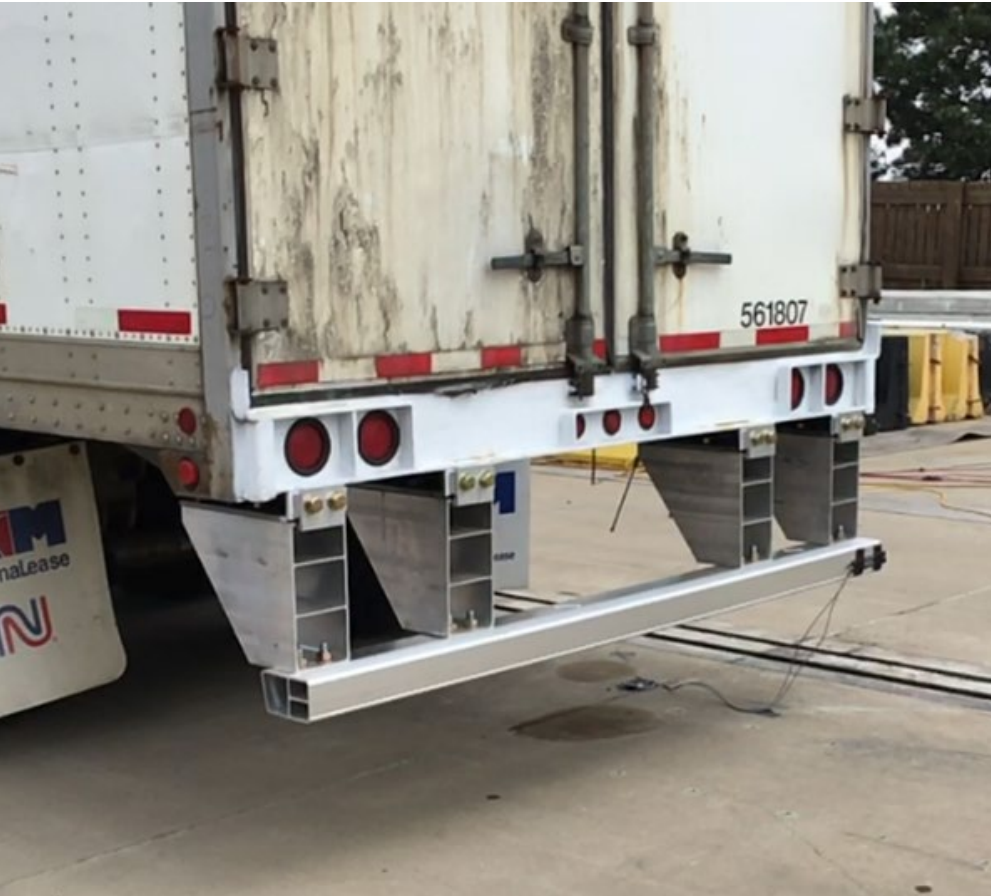
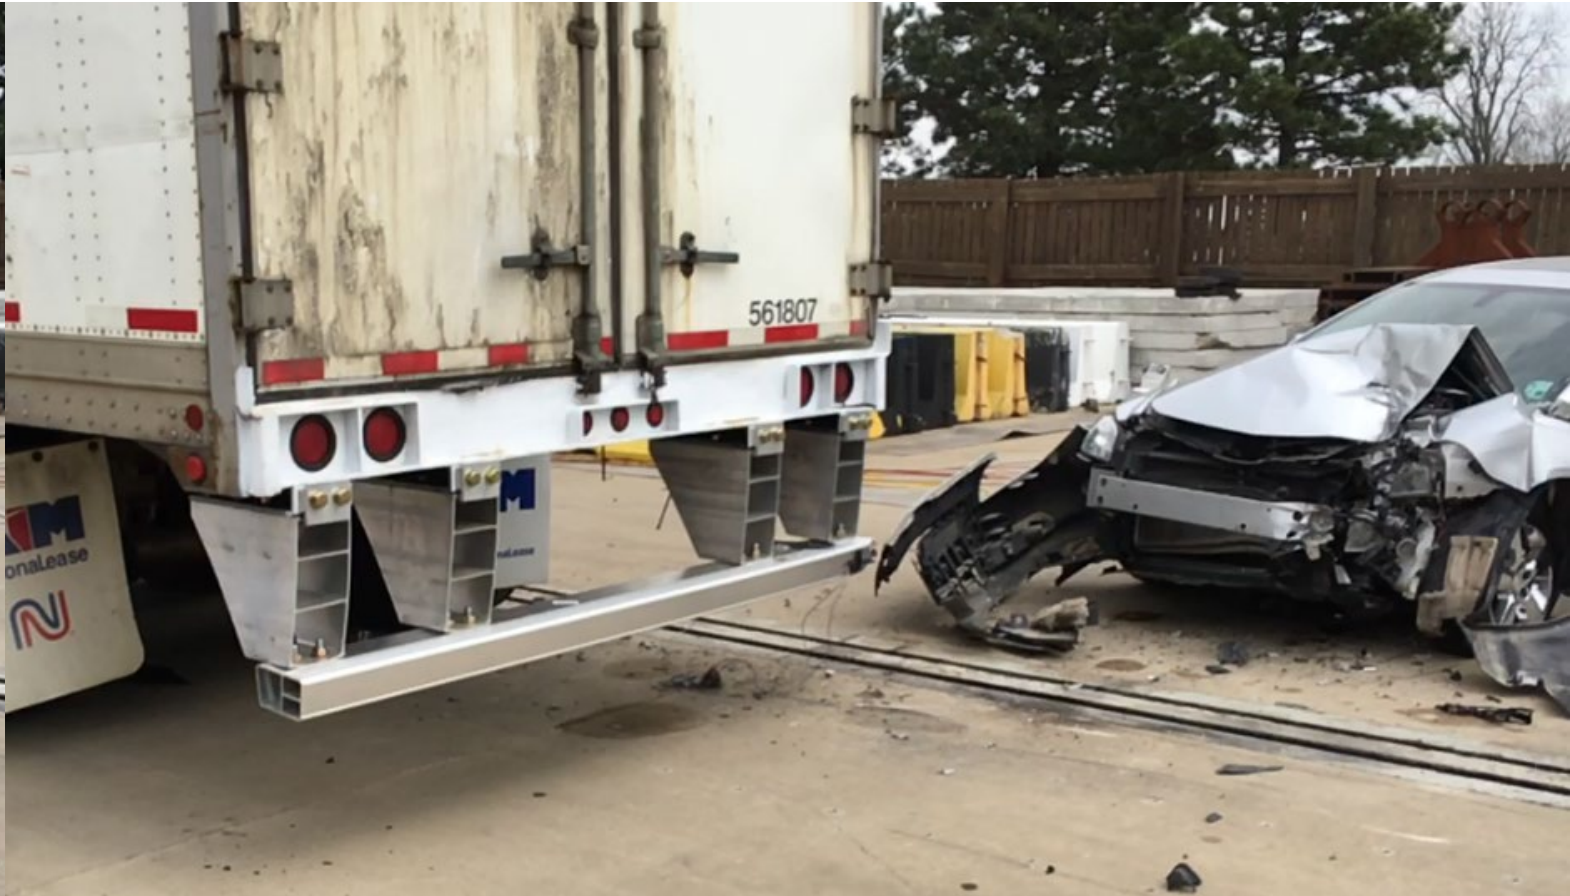
Before

After

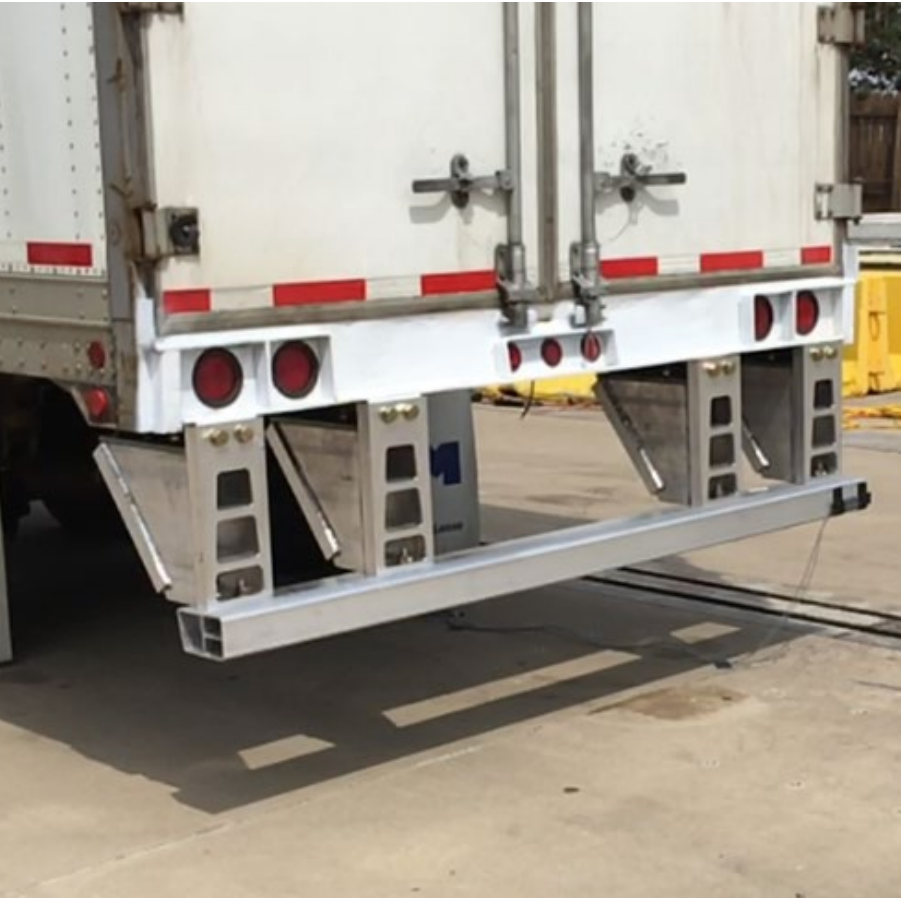
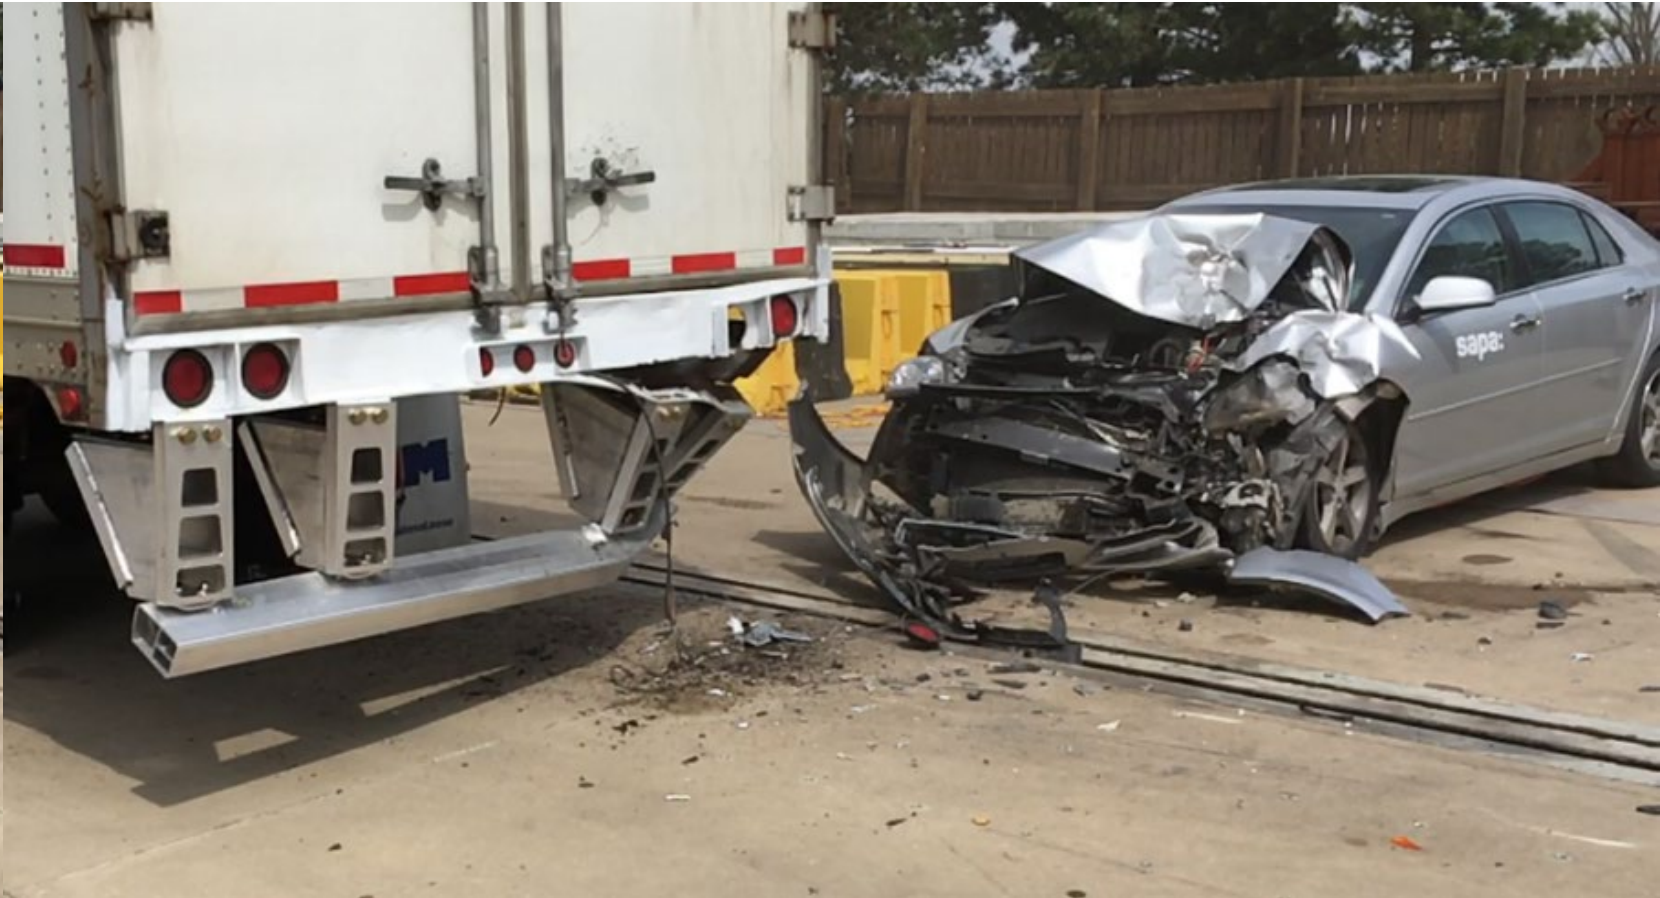
Before

After

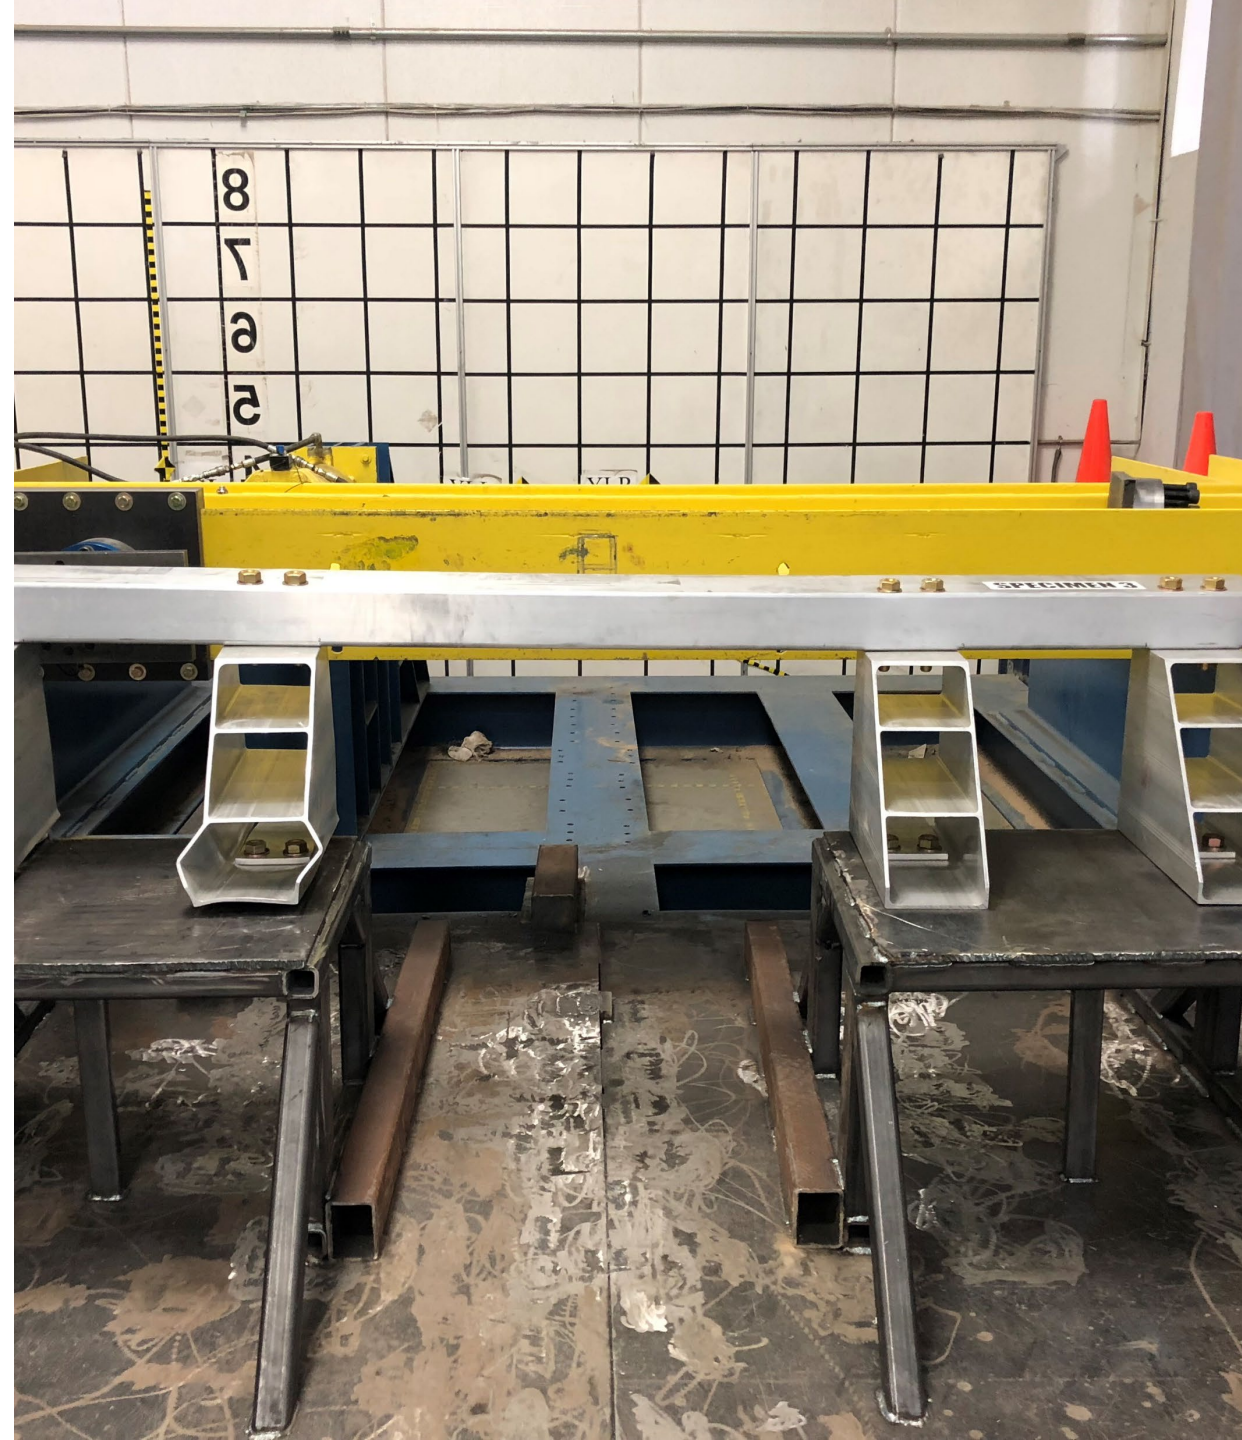
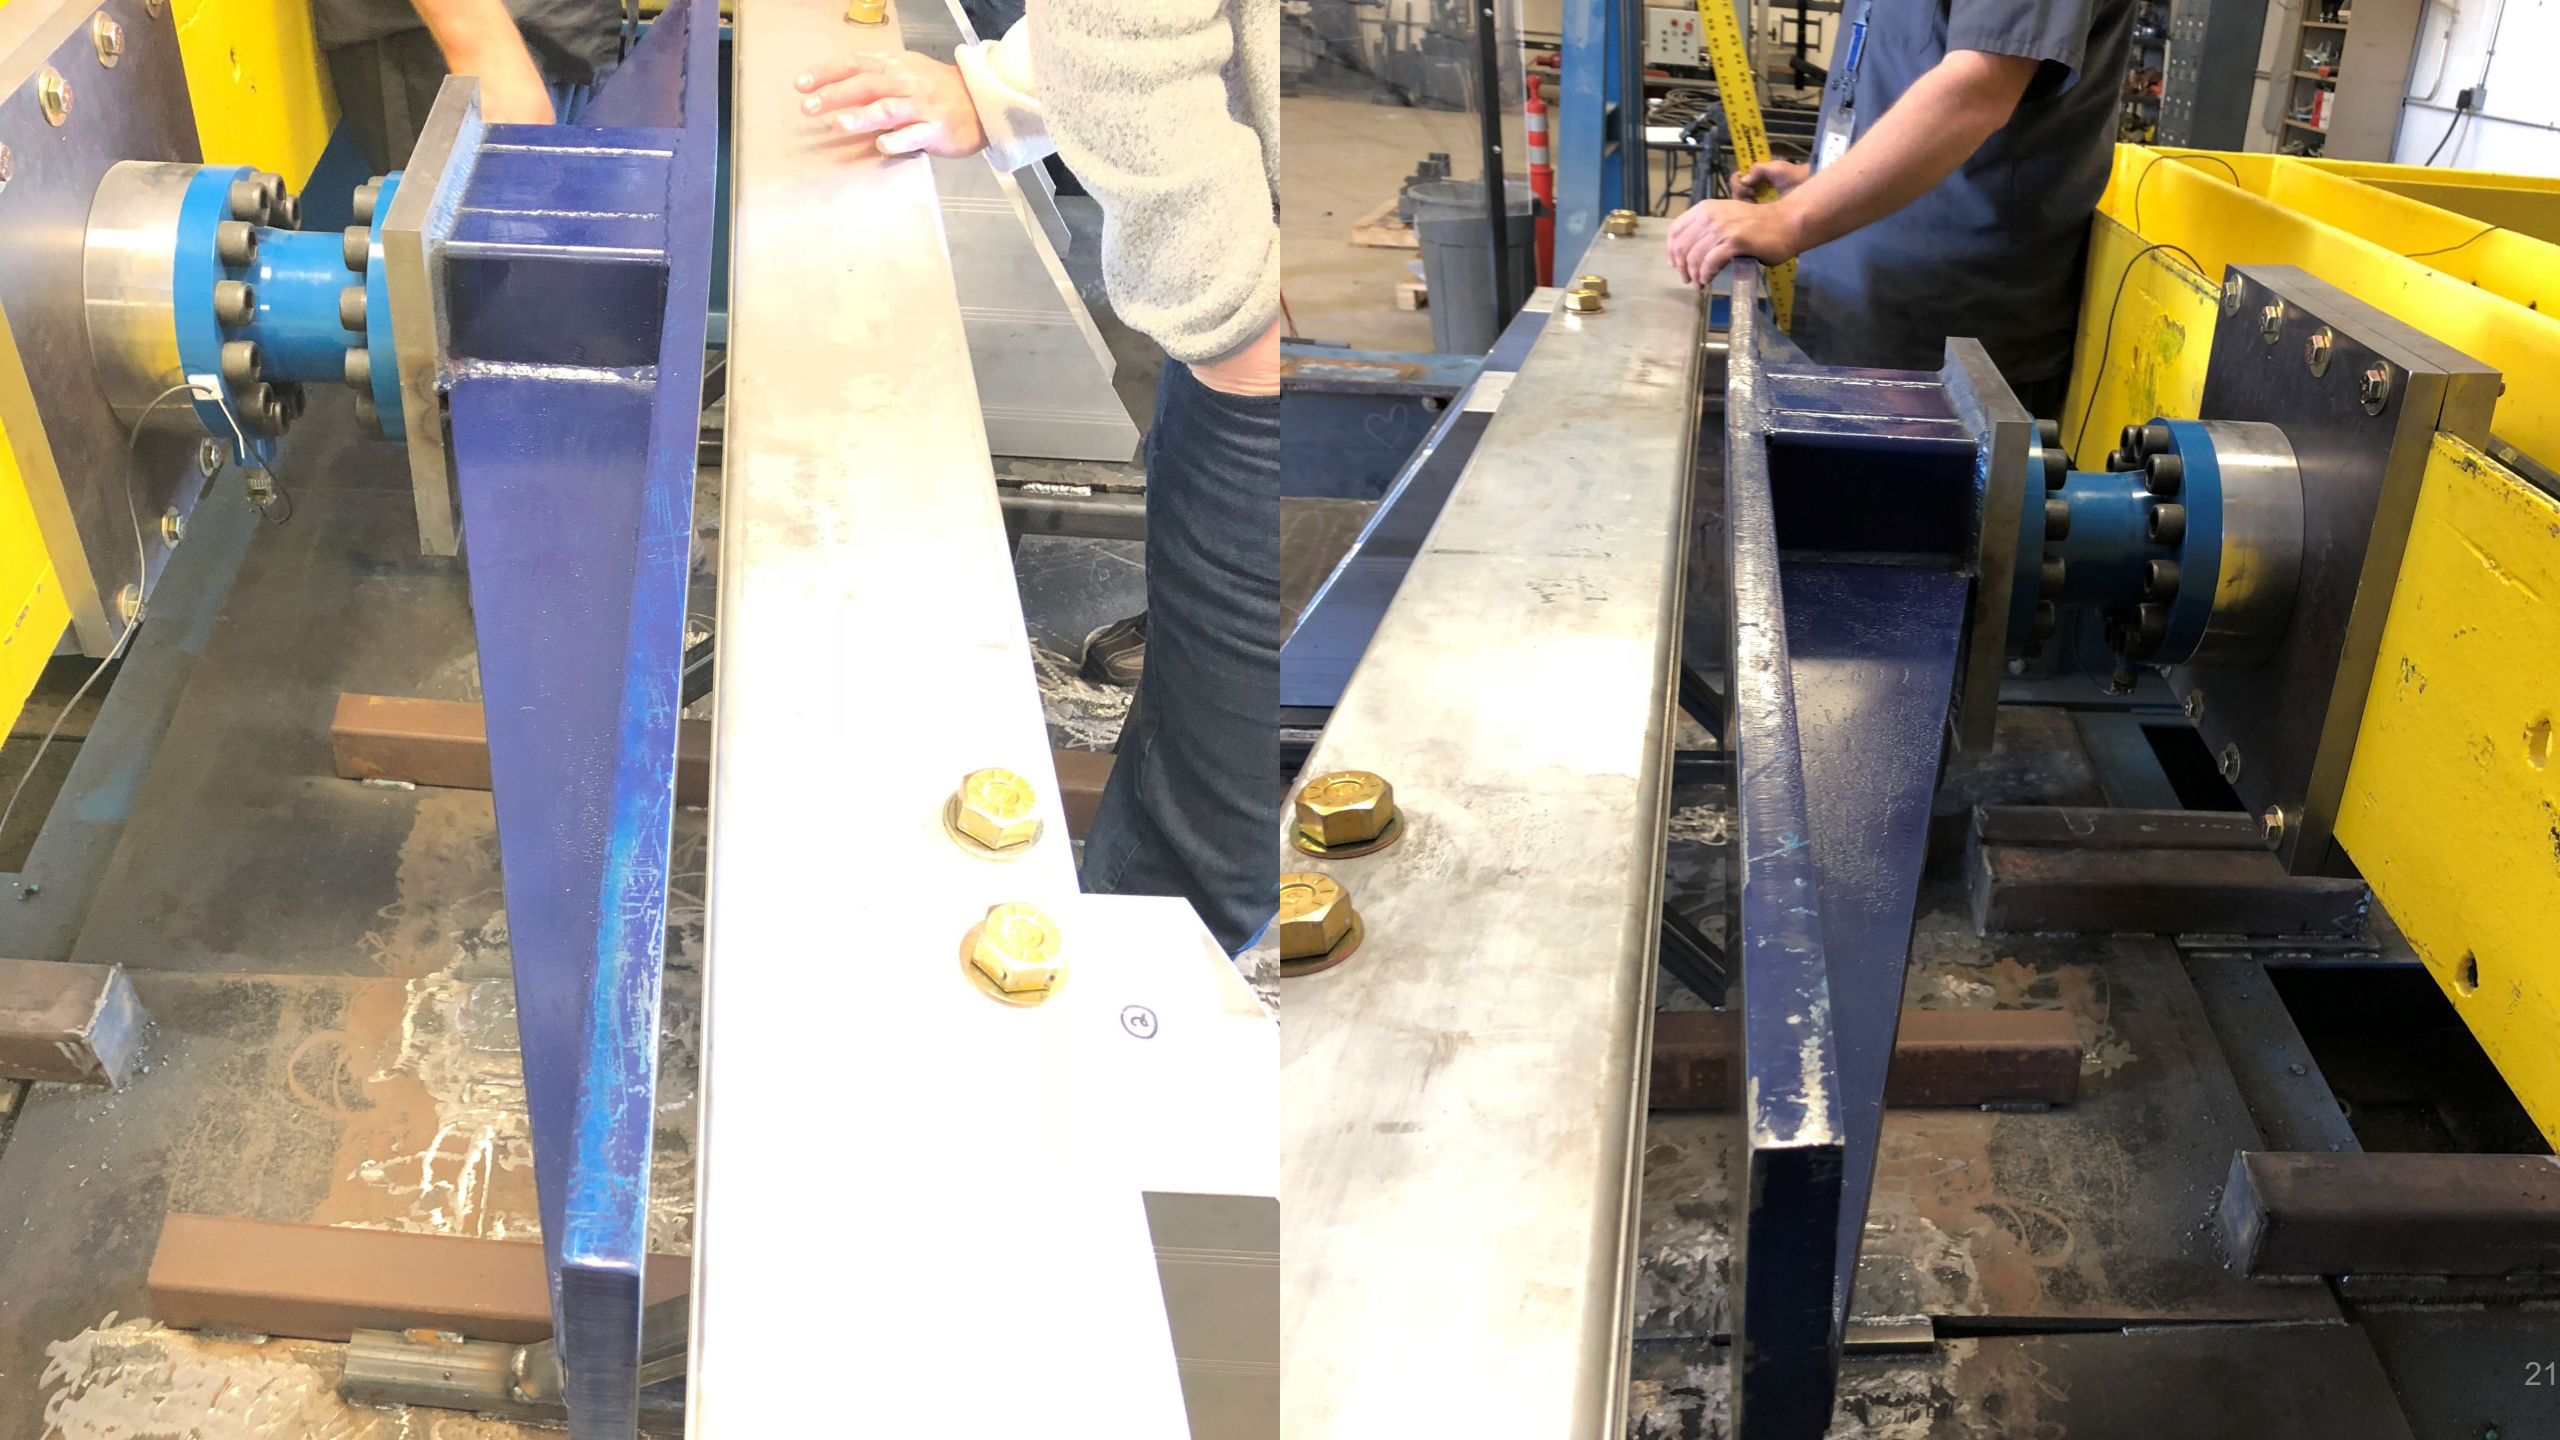
# NHTSA Testing 3530

- NHSTA purchases both designs for testing
- Karco eventually completes 3530 RIG testing in all standard configurations
- First test 3530 bends steel fixture pusher plate on 1<sup>st</sup> test

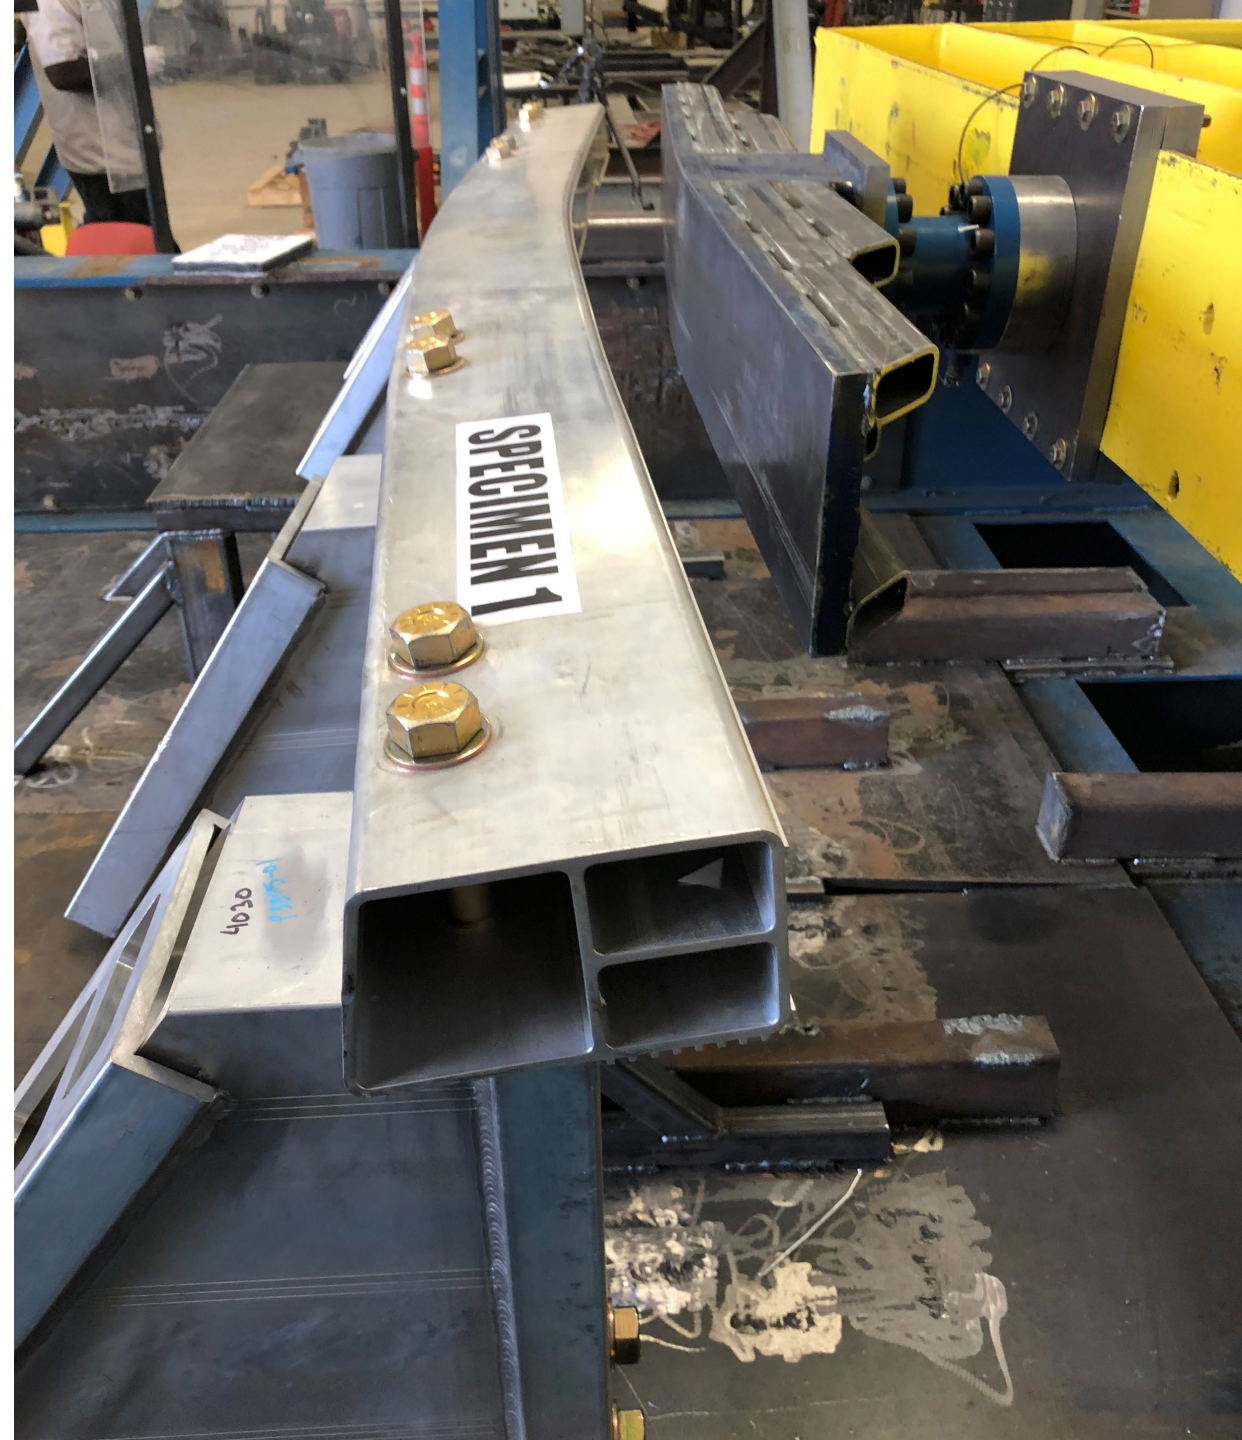
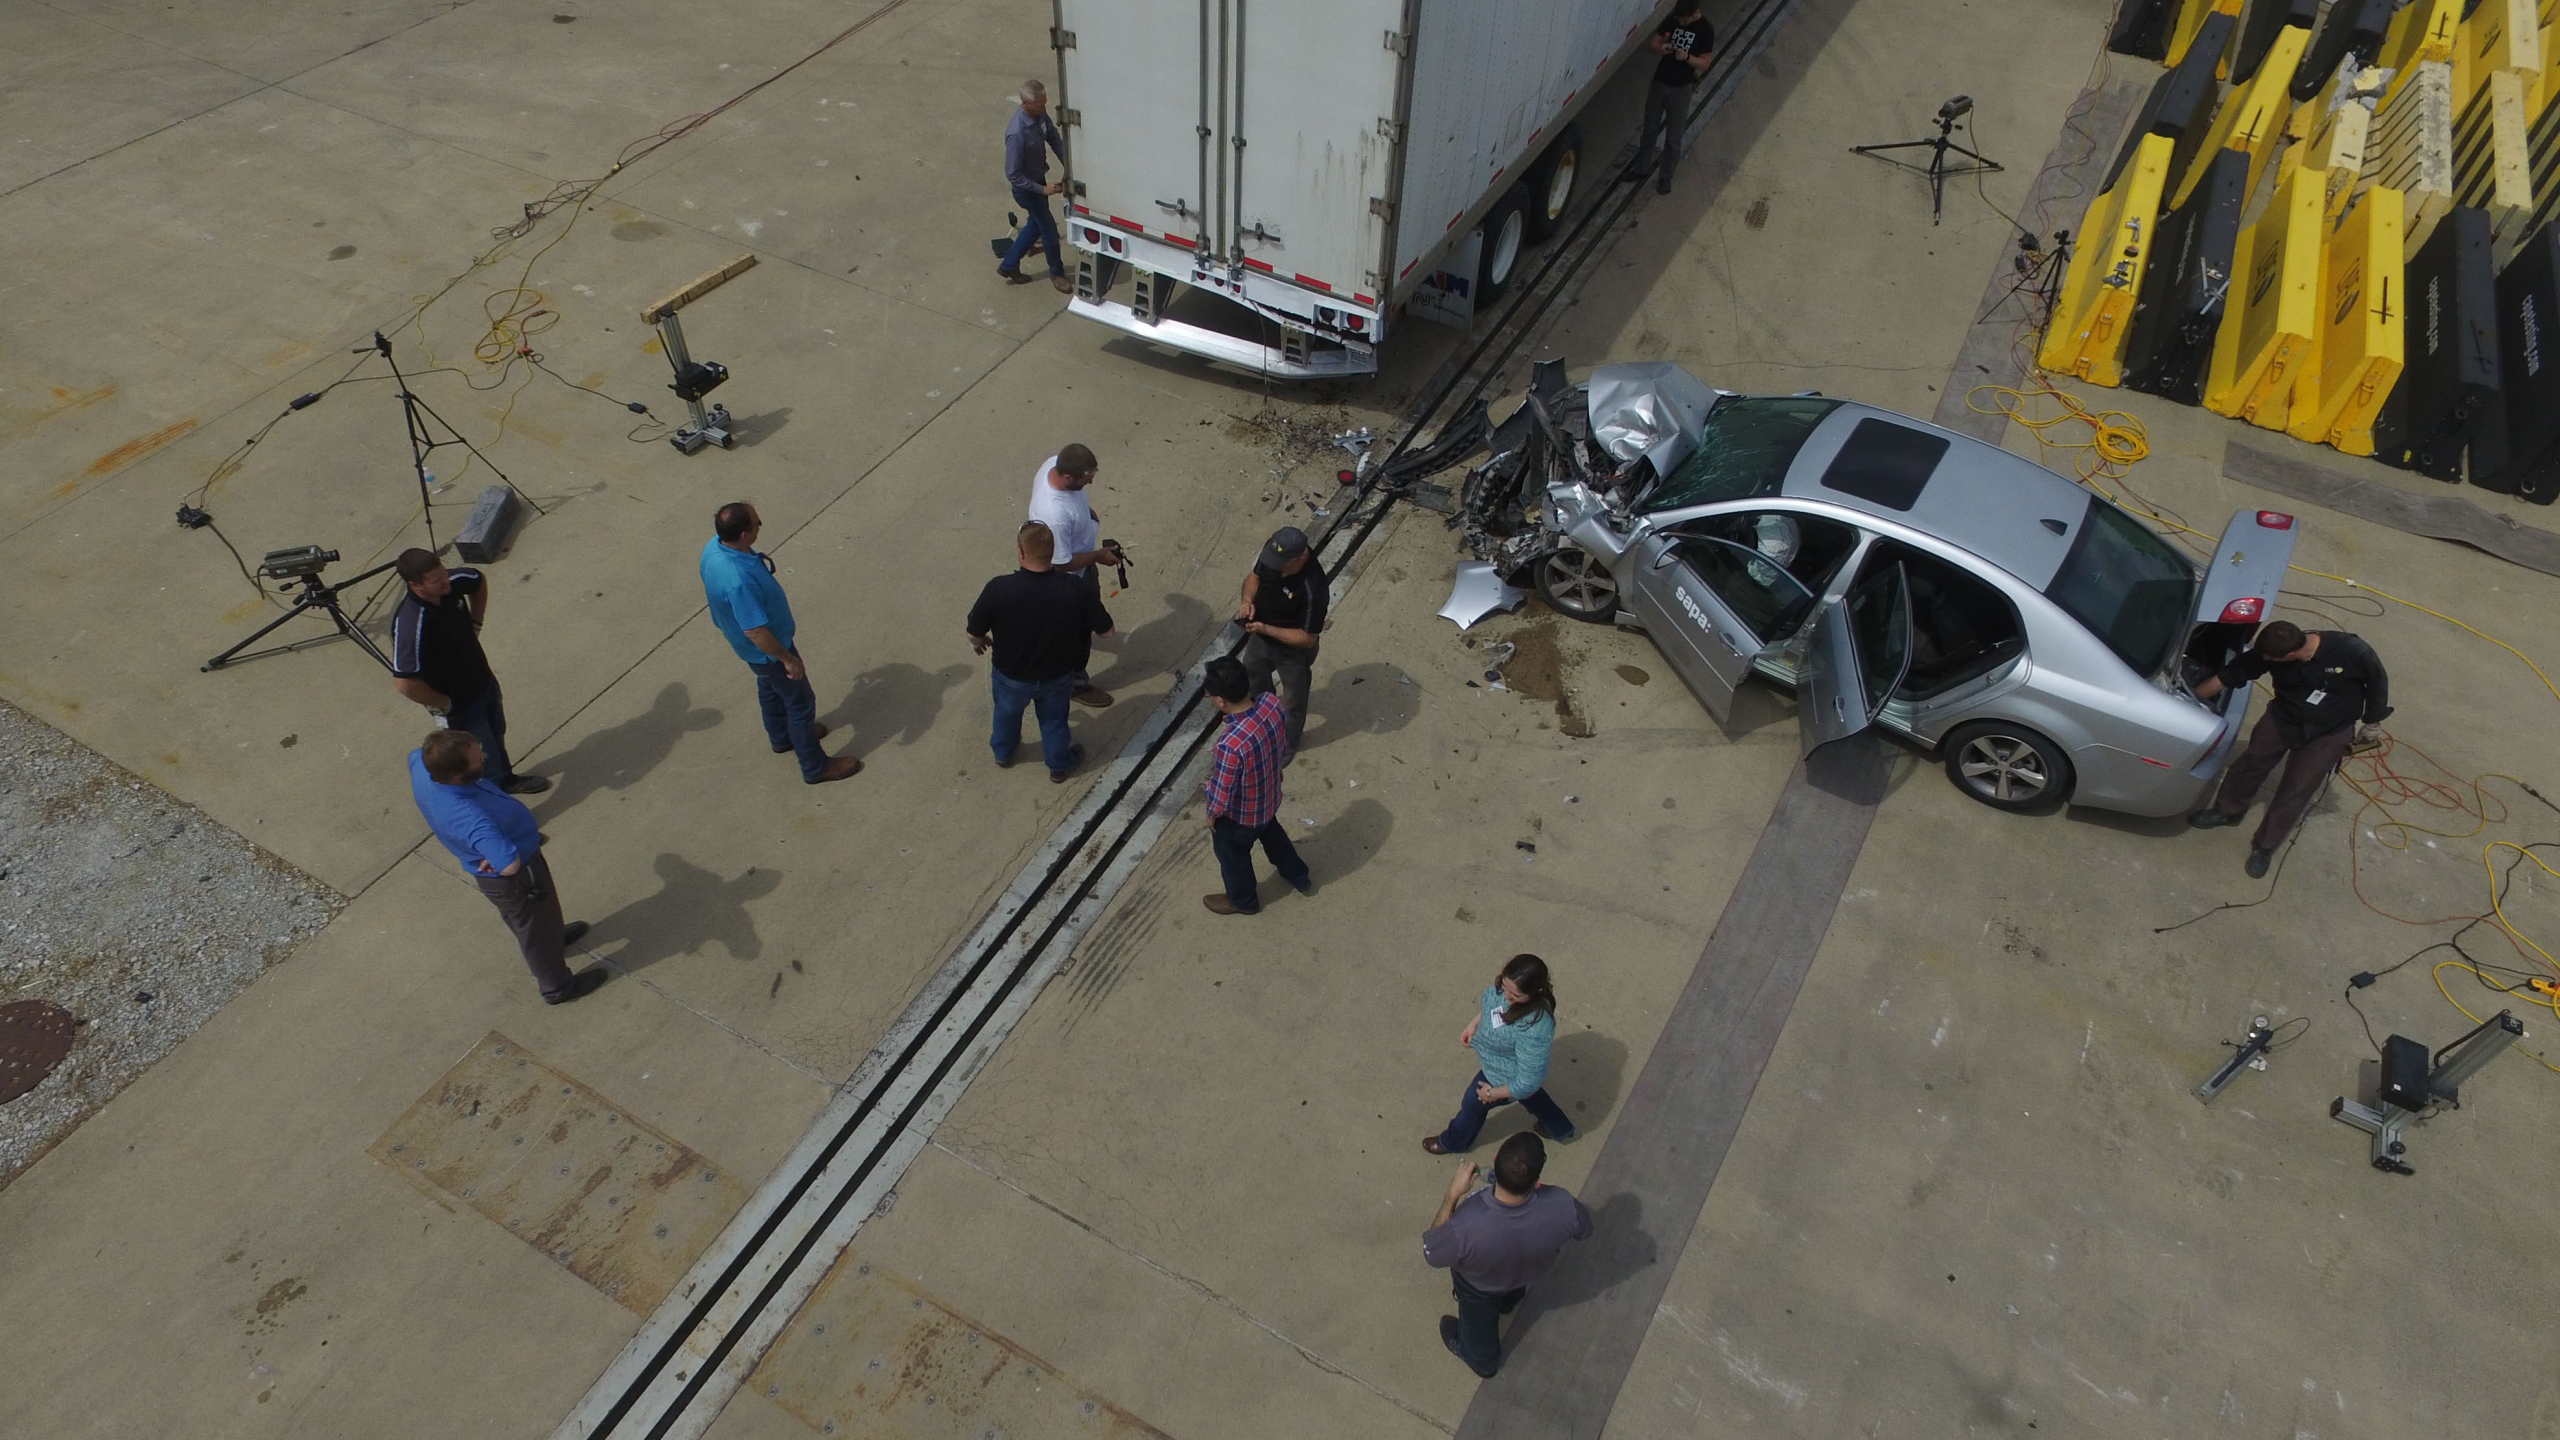
# NHTSA Testing 4030

- One test was made on 4030 before irreparably damaging the entire testing fixture
- Canadian overlap 60" centered load
- 665kN (125mm) displacement
- Bent loading plate severely (1.5" each end)
- Bend steel fixture mount .5" down and sideways
- Further testing was not possible with damage to the fixture, pusher, and press floor
